Rapid Descent Into Terrain
Island Express Helicopters Inc.
Sikorsky S-76B, N72EX
Calabasas, California
January 26, 2020

NTSB/AAR-21/01
PB2021-100900

Aircraft Accident Report

Abstract: This report discusses the January 26, 2020, accident involving a Sikorsky S-76B helicopter, N72EX, being operated by Island Express Helicopters Inc. as a Title 14 *Code of Federal Regulations (CFR)* Part 135 on-demand flight, that crashed into terrain in Calabasas, California. The pilot and the eight passengers died. Safety issues identified in this report include the pilot's preflight weather and flight risk planning, the flight's entry into instrument meteorological conditions and the pilot's inadequate adverse weather avoidance, the pilot's spatial disorientation, influences on the pilot's decision to continue the flight into adverse weather, Island Express' incomplete implementation of its safety management system (SMS), the benefits of a mandatory SMS, the benefits of flight simulation devices for pilot training in adverse weather avoidance, the benefits of a flight data monitoring program, and the value of crash-resistant flight recorder systems in preventing future accidents. As a result of

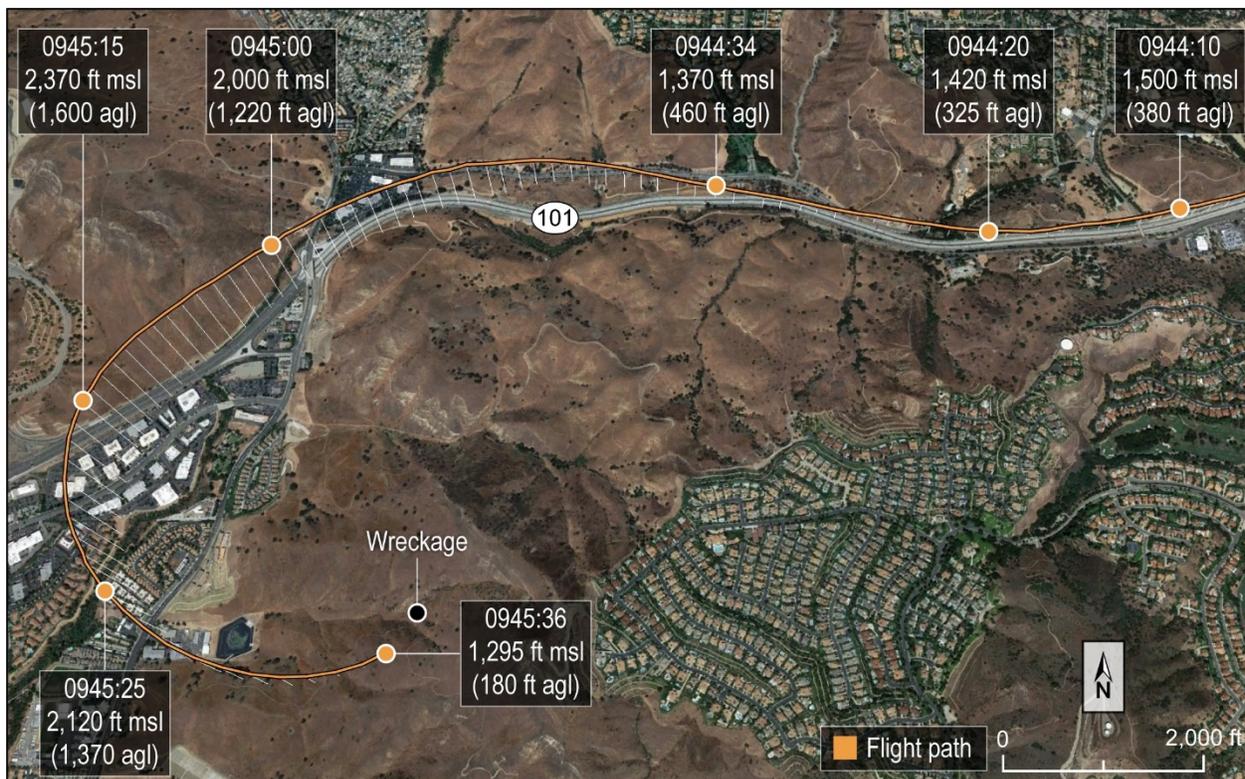
About 0945:10, as the helicopter continued its climb, it started a left turn away from US 101 and reached its maximum altitude of about 2,370 ft msl (about 1,600 ft agl) about 0945:15 before it began to descend rapidly while remaining in the left turn. At 0945:17 (while the helicopter was descending), the SCT controller asked the pilot to “say intentions,” and the pilot replied that the flight was climbing to 4,000 ft msl. The controller asked the pilot his plans once at that altitude but received no further communication from the pilot. The last ADS-B data point for the flight was recorded at 0945:36, and the accident site was about 500 ft east of this point at an elevation of about 1,100 ft msl in hilly terrain (see figure 4).

Figure 4. Accident flight’s climb, left turns, rapid descent, and wreckage location.

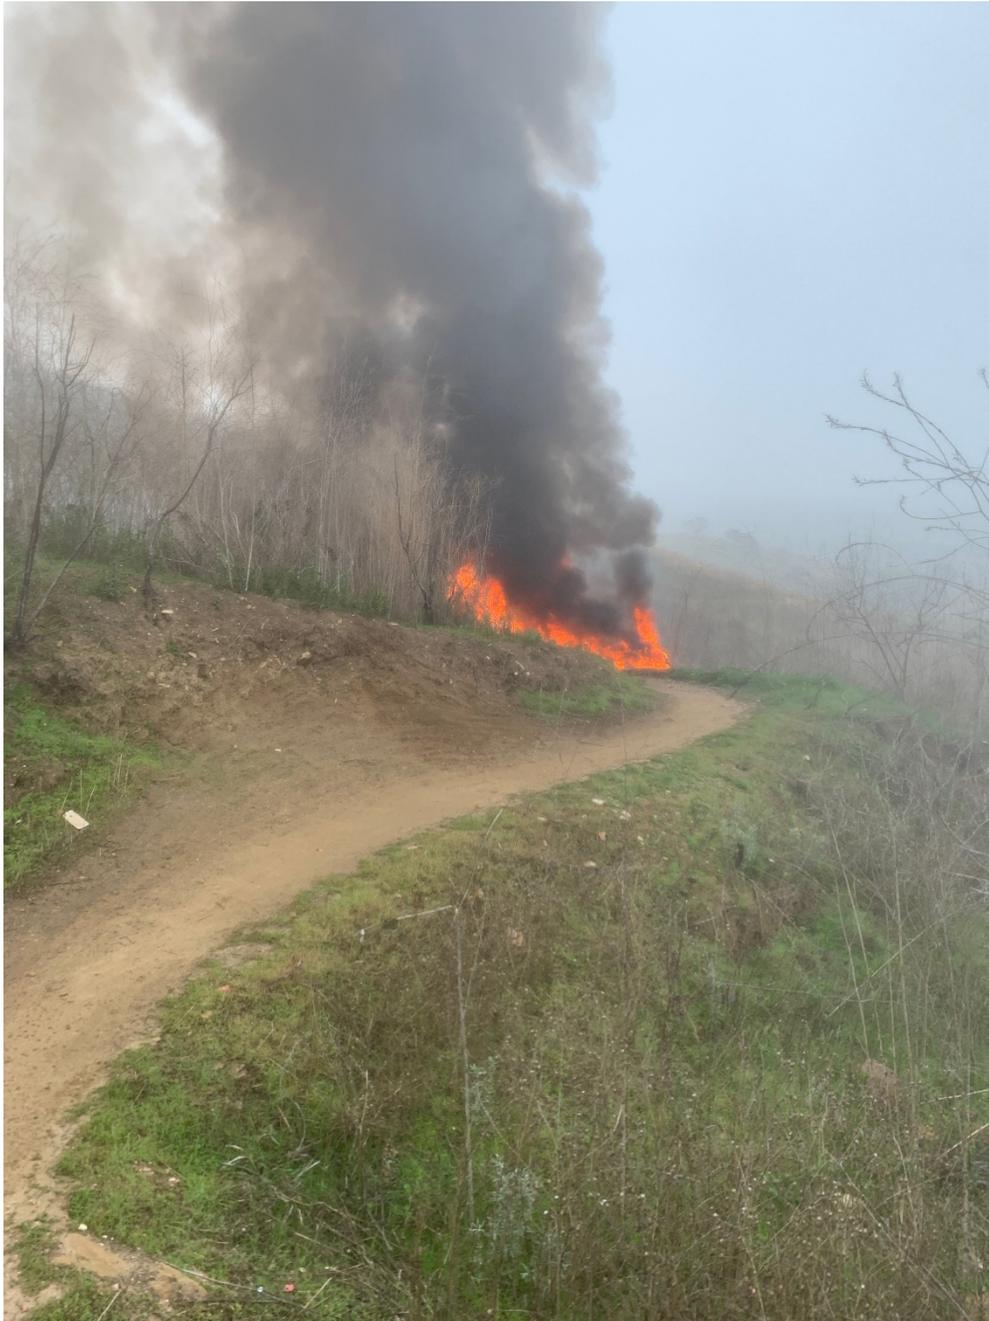
He approached the accident site and found no survivors. He provided a digital still image he captured with his camera about 3 minutes after the accident (see figure 5).

Figure 5. Image of accident site taken by witness about 3 minutes after the crash.

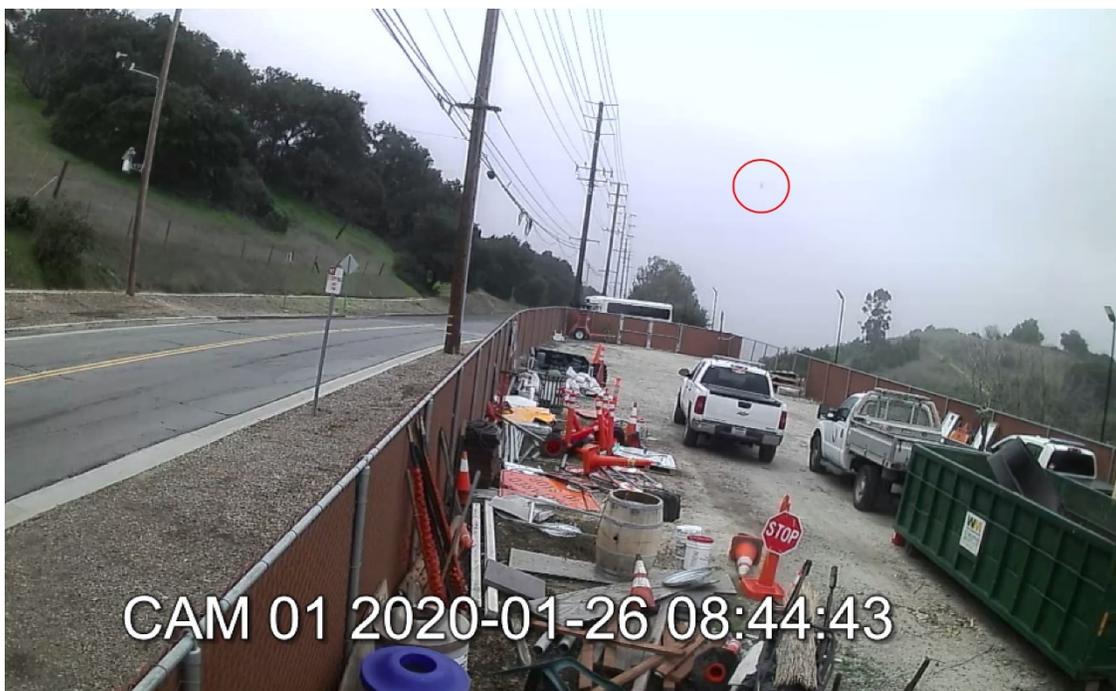
A west-facing video camera operated by the City of Calabasas located about 1.8 miles northeast of the accident site on US 101 captured the accident helicopter in video imagery between 0944:16 and 0944:22 as it flew west (away from the camera). According to the helicopter performance study, the helicopter was flying at an altitude of about 1,400 ft msl (300 to 400 ft agl over varied terrain) during the time it was within the camera's view. The study determined that its height above the terrain was about 325 ft agl at 0944:20 (see figure 7) and 300 ft agl (its minimum cruising height) 1 second later.

Figure 7. Image from a camera on US 101 at 0944:20 of the accident helicopter (circled in red).

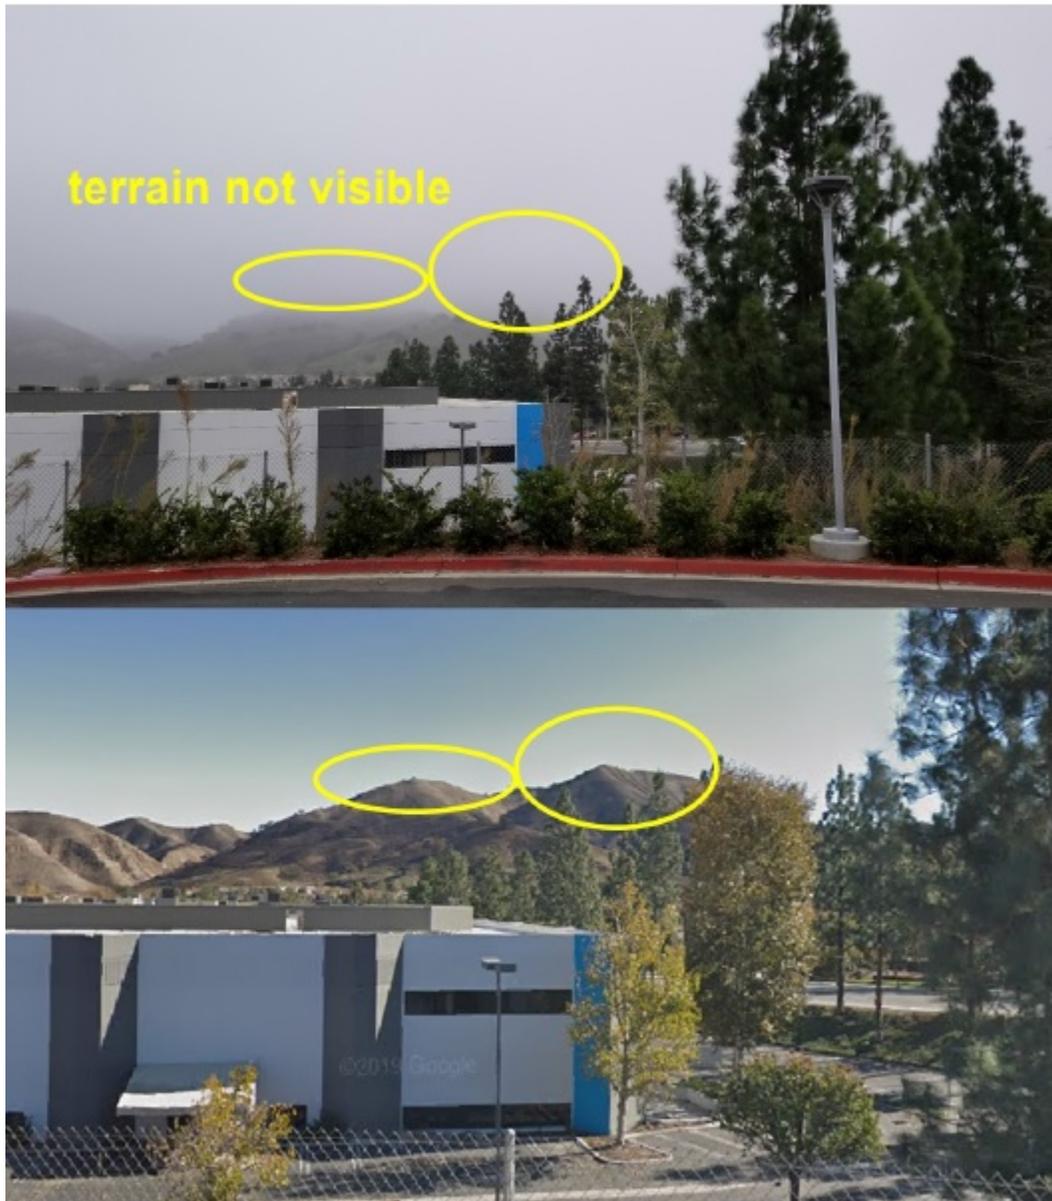
A ground witness located about 0.25 mile west of the accident site at the time of the accident reported hearing the helicopter flying then seeing the wreckage and flames on the hillside after it crashed. (A friend of this witness immediately called 911.) The witness provided a still image reportedly taken about 2 minutes after the accident while facing east toward the accident site. The image showed that the tops of two peaks (elevation 1,375 and 1,425 ft msl) near the accident site were not visible (see figure 8).

Figure 8. Images taken about 2 minutes after the accident (top) and on a clear day (bottom).

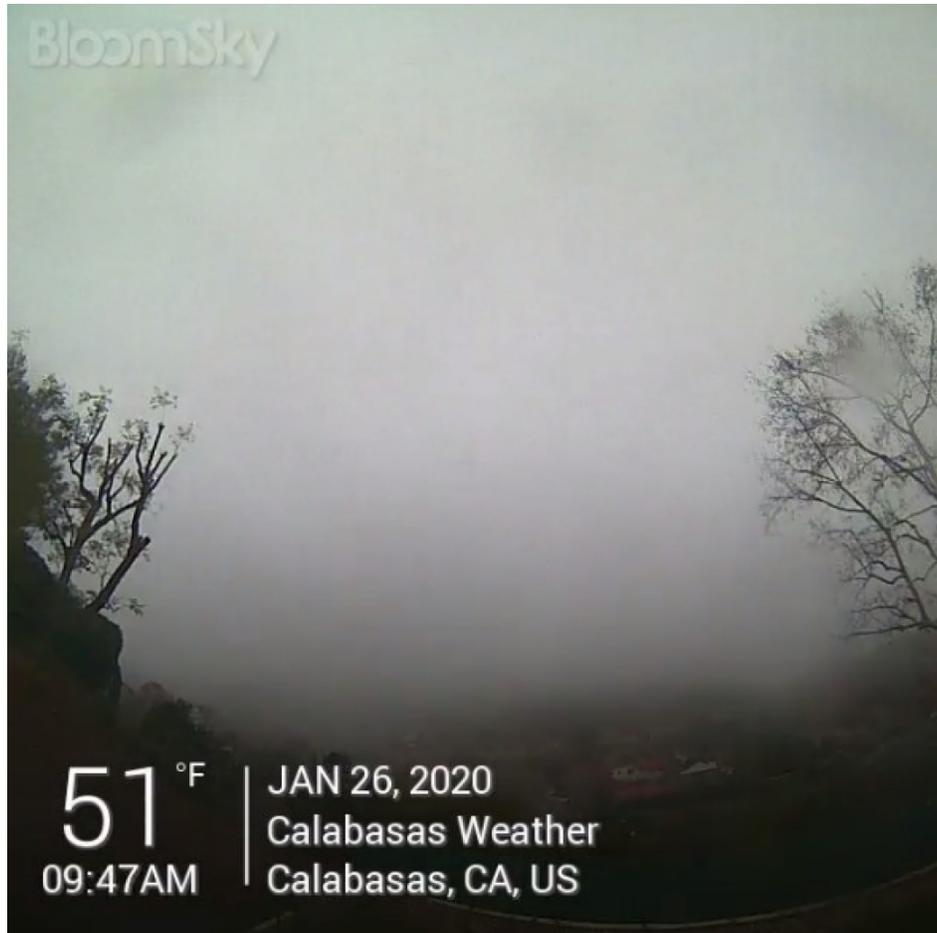
A privately owned, networked weather camera located about 1.9 miles east of the accident site at an elevation of 1,320 ft msl captured a west-facing, still image at 0947 (see figure 9).

Figure 9. Image taken by a west-facing camera 1.9 miles east of the accident site at 1,320 ft msl.

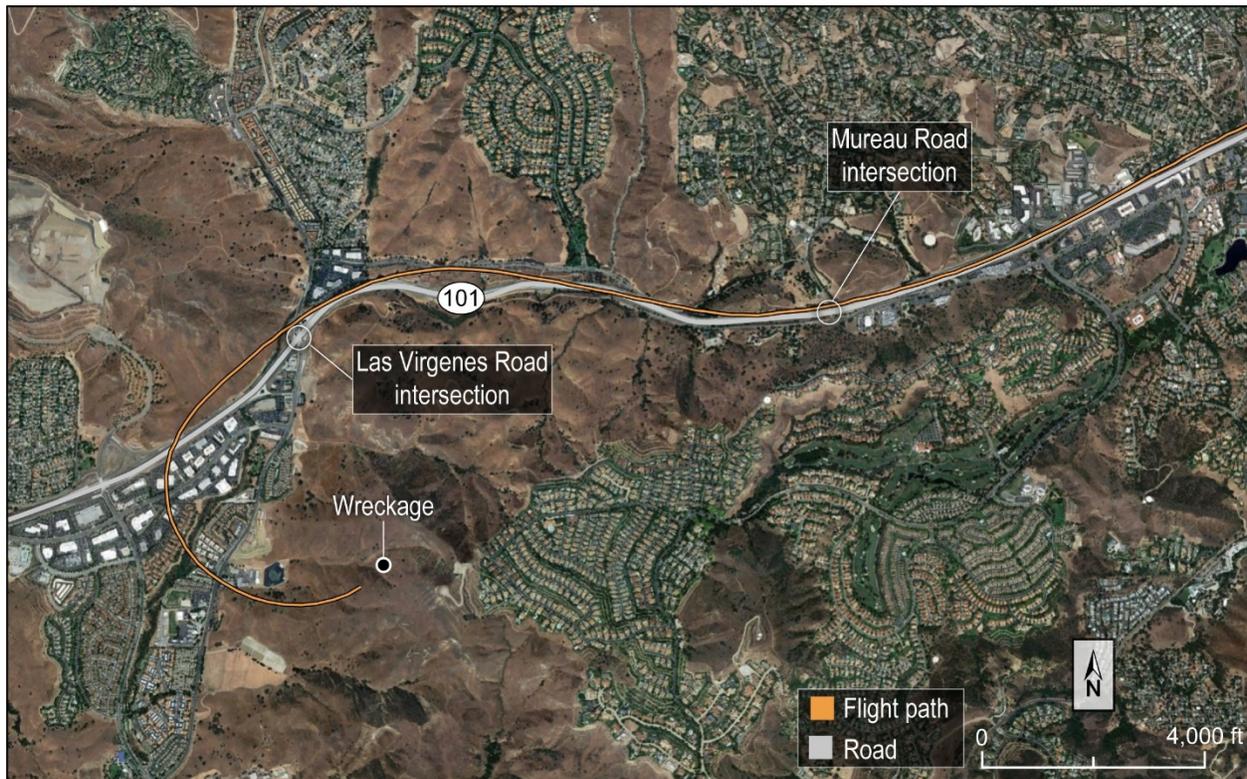
The local NWS forecaster said that visibilities along US 101 near the accident site were commonly lower than what is observed in the surrounding regions when VNY had ceilings of 1,000 ft agl (about 1,800 ft msl) or lower. He said that this would occur because the mountainous area near the accident site can have lower temperatures than the valley area to the east from which the accident flight came. He said that a lower elevation area in the mountains, in which relatively cool air tends to sink and pool at night, was located on US 101 almost directly under the accident helicopter's flightpath and less than a mile northwest of the accident site. He said that, when such cool air approaches (or reaches) saturation, visibility can become lower. Based on his evaluation of the available information, the forecaster concluded that, if such conditions existed at the time of the accident, the area near the accident site would have had lower ceilings and visibilities than those reported at VNY and CMA.

A private pilot who resided near and frequently drove along US 101 near the accident site said the topography in the area tended to channel fog up from the coast (from the west) that would stack up against the hills in that area. He said such fog would accumulate along US 101 west of Mureau Road (the approximate high point on US 101 in that area) and would be particularly dense in the area near Las Virgenes Road. He said that, under such conditions, a pilot flying VFR west above US 101 would likely enter dense fog rather suddenly near Mureau Road and then very quickly lose visual contact with US 101 as the road descends down the hillside west of that location (see figure 10).

Figure 10. Area near the accident site reportedly subject to localized reduced visibility.

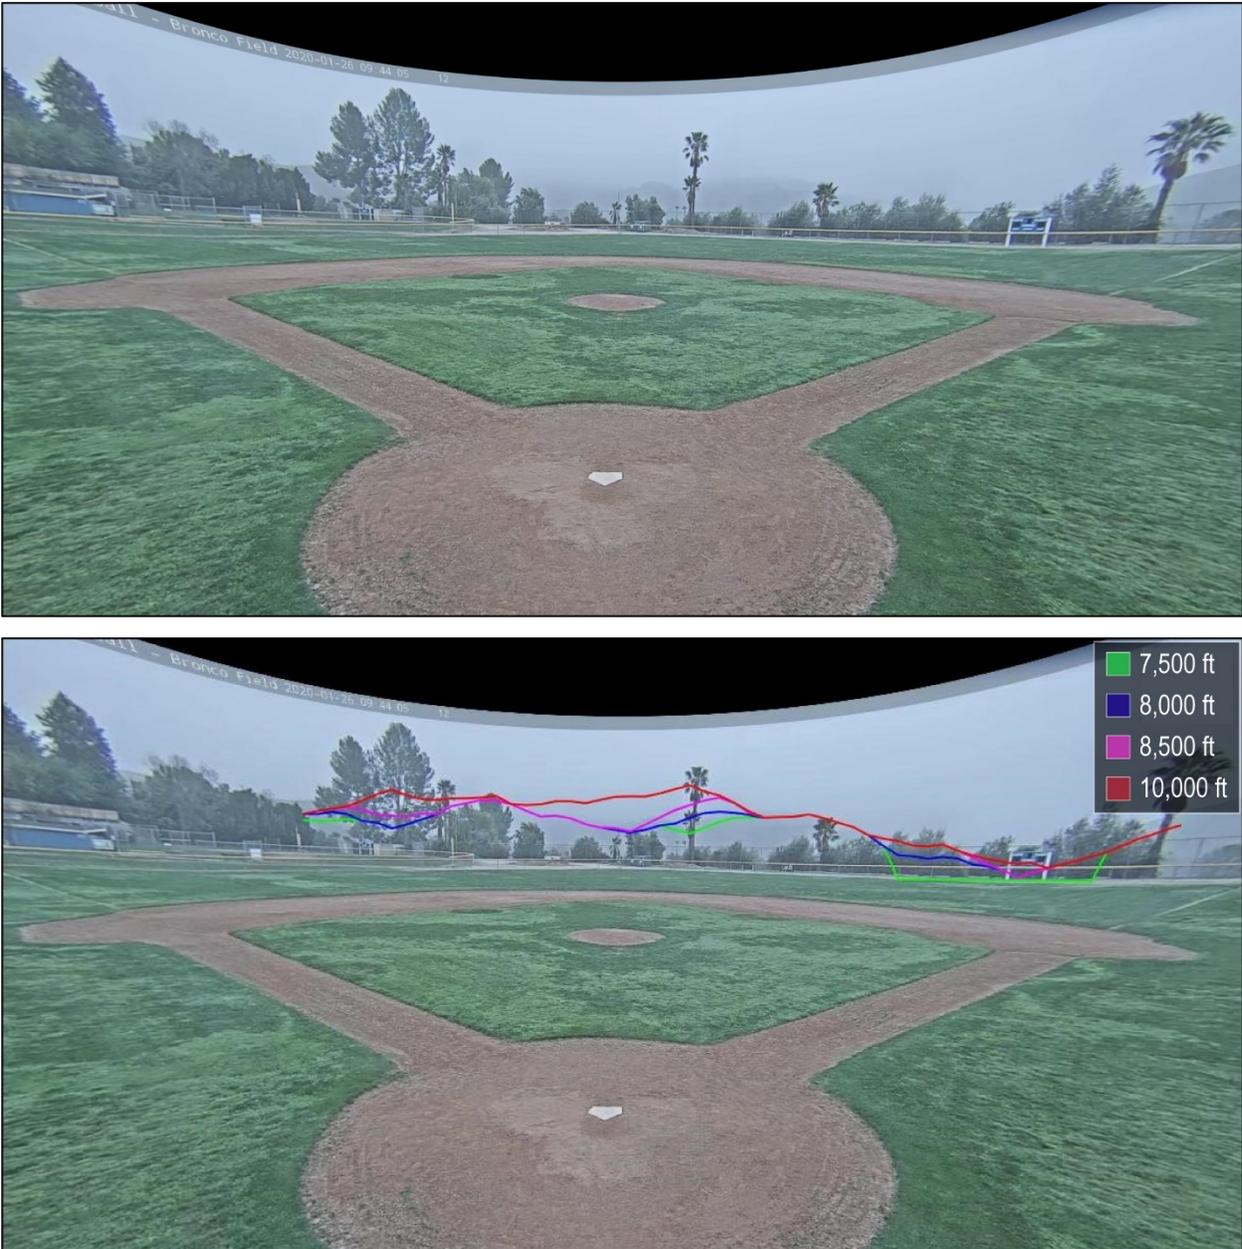
Video from all three cameras captured audio that was attributed to the accident helicopter in flight, but the helicopter was not seen in any of the imagery. Based on the study's determination of distances from each camera to discernable terrain details in the imagery at the times when the helicopter would have been within each camera's field of view, the study estimated that the visibility beneath the clouds in the vicinity of the accident site was between 1 and 1.5 miles (about 5,000 ft and 8,000 ft respectively, see figure 12).

Figure 12. A distortion-corrected image from video captured by Camera A at the accident time (top). Terrain outline curves are superimposed on the same image for the specified computed visibility ranges (bottom).
