**AIRCRAFT ACCIDENT REPORT, LEXINGTON AIR
TAXI, INC. BEECH C-45H, N3727G NEAR BLUE
GRASS FIELD LEXINGTON, KENTUCKY, APRIL 3,
1967**

**NATIONAL TRANSPORTATION SAFETY BOARD,
WASHINGTON, D. C**

AIRCRAFT ACCIDENT REPORT

LEXINGTON AIR TAXI, INC.
BEECH C-45H, N3727G NEAR BLUE GRASS FIELD
LEXINGTON, KENTUCKY
APRIL 3, 1967

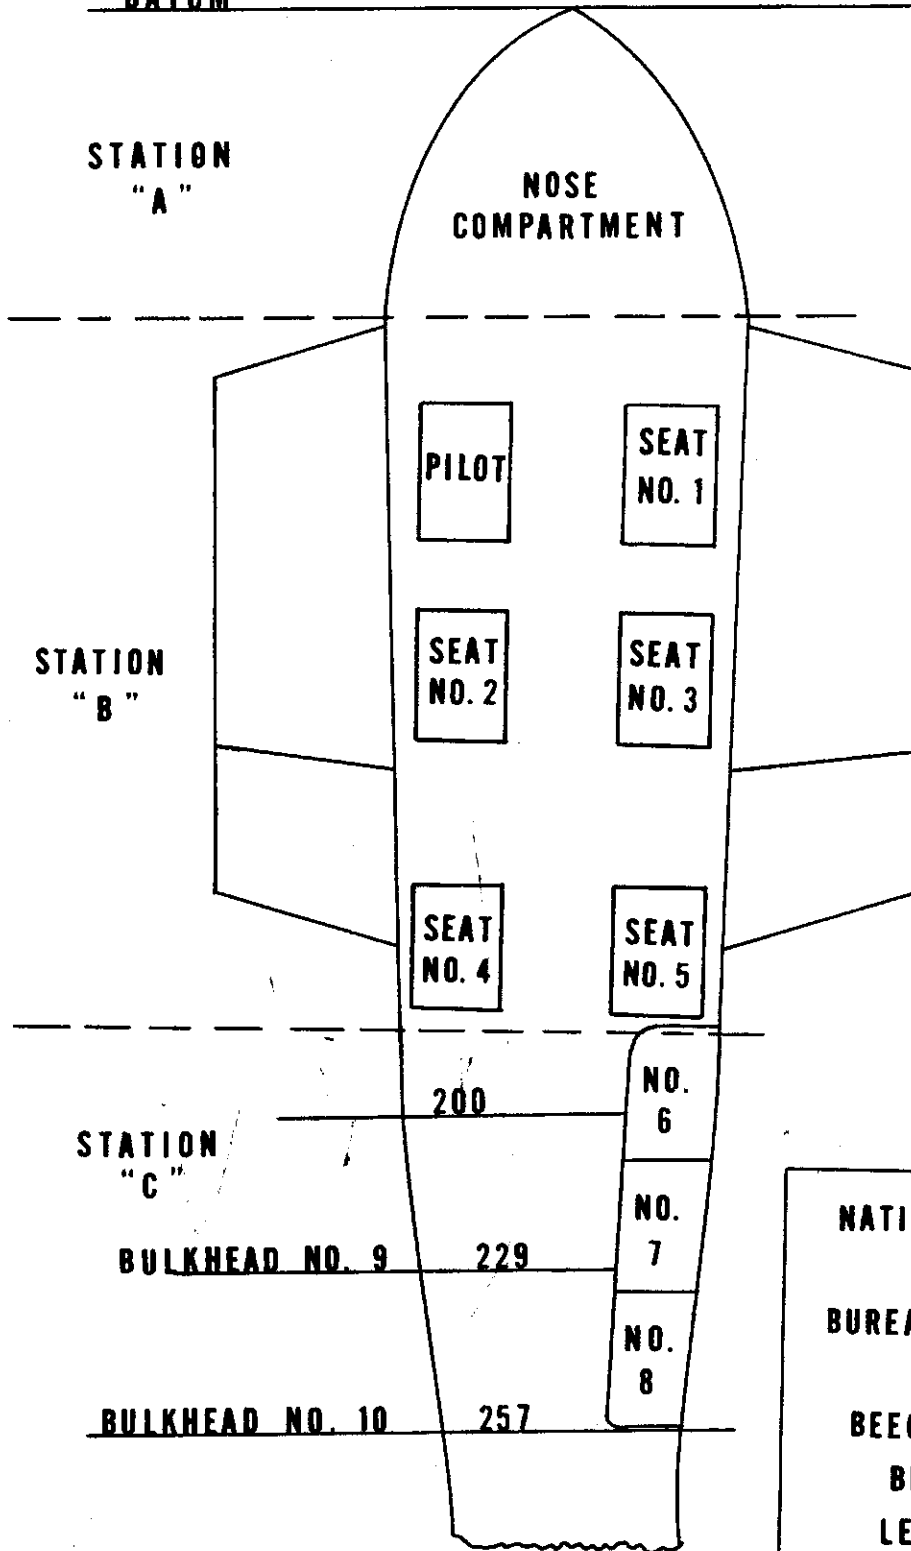
ATTACHMENT NO. 1

In order for the Board to determine the weight and center of gravity (c.g.) of N3727G at the time of the accident, it was necessary to review all available records and construct a weight and balance history for the aircraft. It was found that in the course of the original modification of N3727G by the Fort Wayne Air Service in March 1960, four seats (two facing two) and a three-place divan were installed in the aircraft (see Attachment No. 1). The installation of the divan in the rear right side of the aircraft required the removal of the aft bulkhead (No. 9) which formed the rear of the cabin-interior, and the placing of the divan just aft of the rear right-side seat extending back to bulkhead No. 10 which now formed the rear of the cabin-interior.

In view of the facts that the rear bulkhead (No. 9) of the passenger cabin had been removed during the conversion, and that a three-place passenger divan had been installed extending beyond this area, it would be expected that during the original certification process (March 1960) the effects of the modification on the c.g. and loading conditions would be
