AIRCRAFT ACCIDENT REPORT

DOUGLAS OC-3, N142D

NEW ORLEANS INTERNATIONAL AIRPORT

MARCH 20, 1969

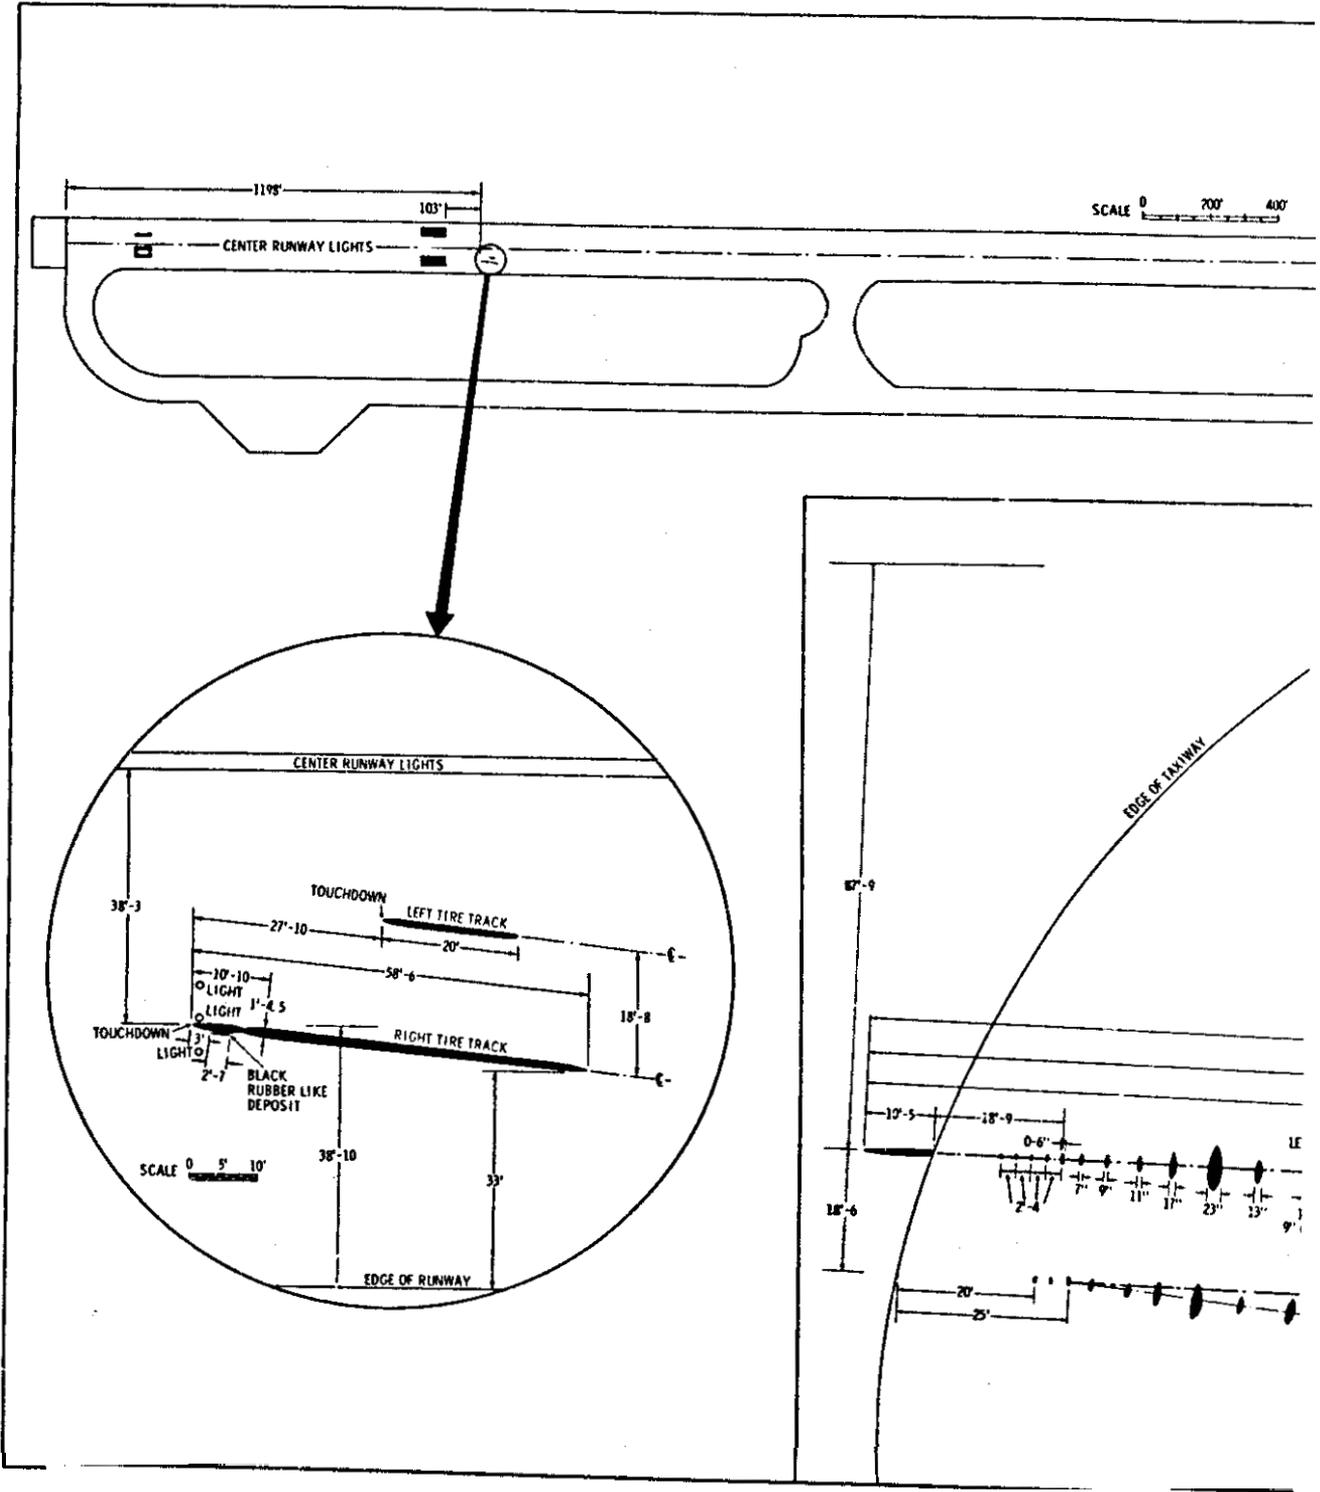
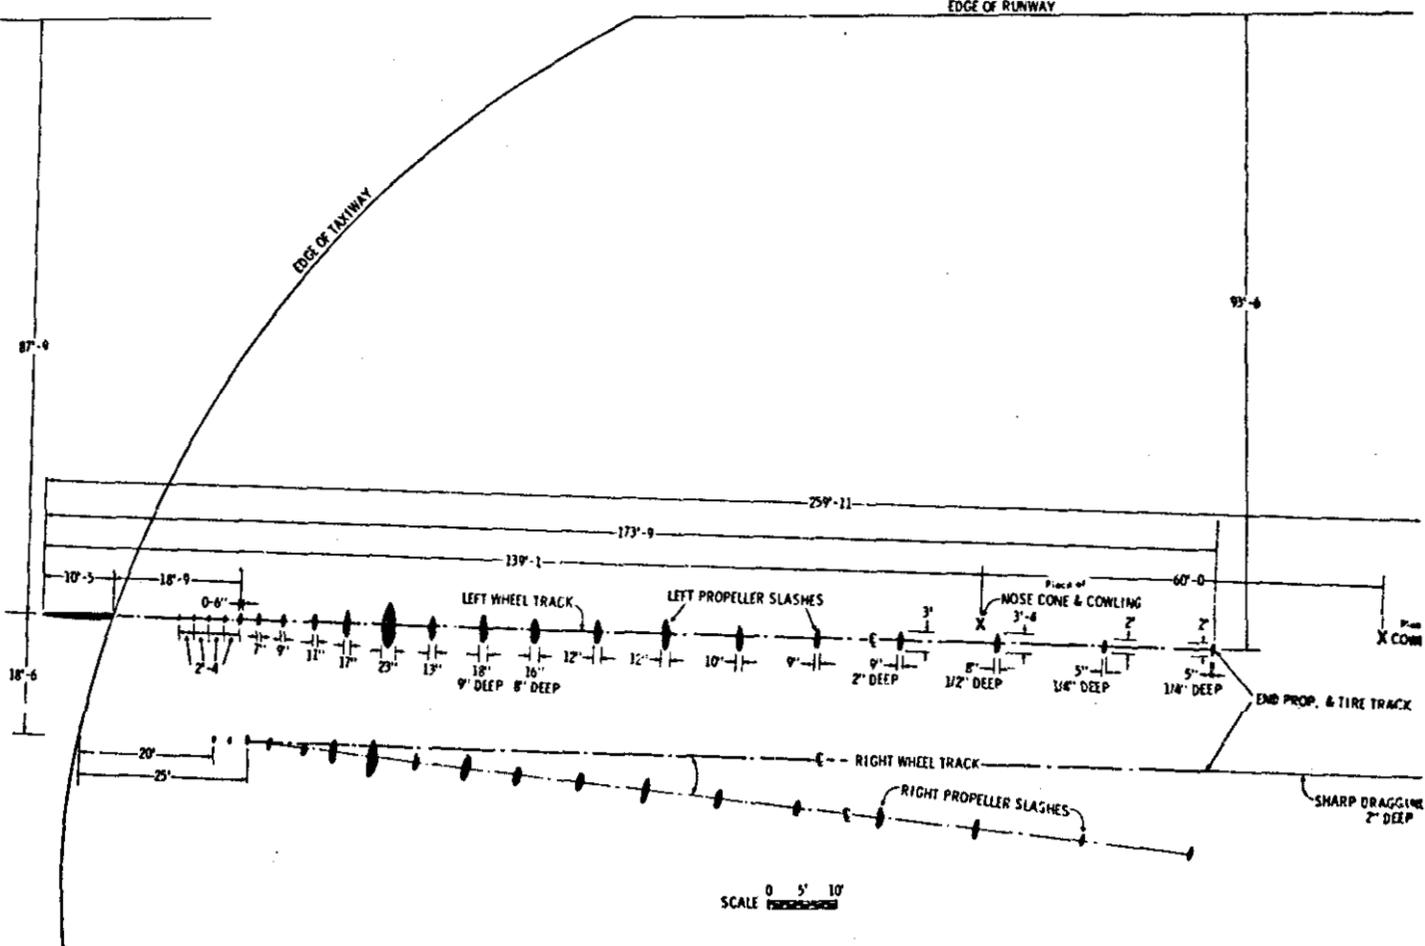
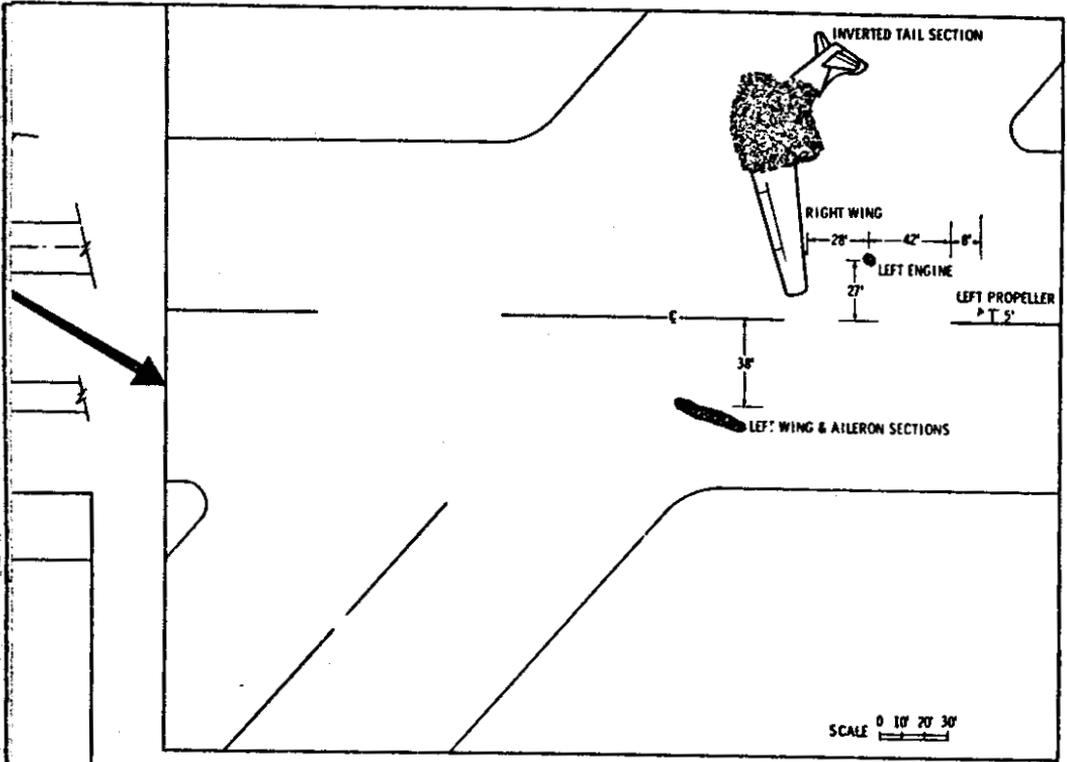
ATTACHMENT NO. 1

The first indication of ground contact was found on Runway 10 at a point 1,198 feet beyond the runway approach end. Two tire scuff marks, 18 feet 8 inches apart, centerline to centerline, were evident. These marks proceeded toward the right side of Runway 10 at an angle of approximately 25". (See Attachment No. 1, Runway Marks and Wreckage Distribution Chart for details.)

The second indication of ground contact was found 3,100 feet beyond the initial ground contact marks and 87 feet 9 inches right of the right edge of Runway 10. These second marks, consisting of tire scuff marks and propeller slash marks, were found on a taxiway. They began at a point 10 feet 5 inches from the east edge of the north-south oriented taxiway and continued off the taxiway and onto the ground in an eastward direction parallel to Runway 10. The scuff and propeller slash marks proceeded for a distance of 173 feet 9 inches, at which point the tire and propeller slash marks ended. However, a sharply defined groove, 2 inches wide and 1 inch deep, continued in the ground beyond the right landing gear track to a point 259 feet 11 inches from the start of the marks on the taxiway.

The next indication of ground impact was scrape and scuff marks on Runway 10 near the junction of Runways 5 and 10. These marks terminated under the main wreckage, which had come to rest on the north side of the junction. A red mass-like substance was imbedded in one of the scrape marks. This material was similar to the broken red cover from the left wingtip light.
