AIRCRAFT INCIDENT REPORT

AR FRANCE
BOEING 747-128, F-BPVD
ST. JEAN, P.Q., CANADA
AUGUST 17, 1970

Report Number: NTSB-AAR-70-26

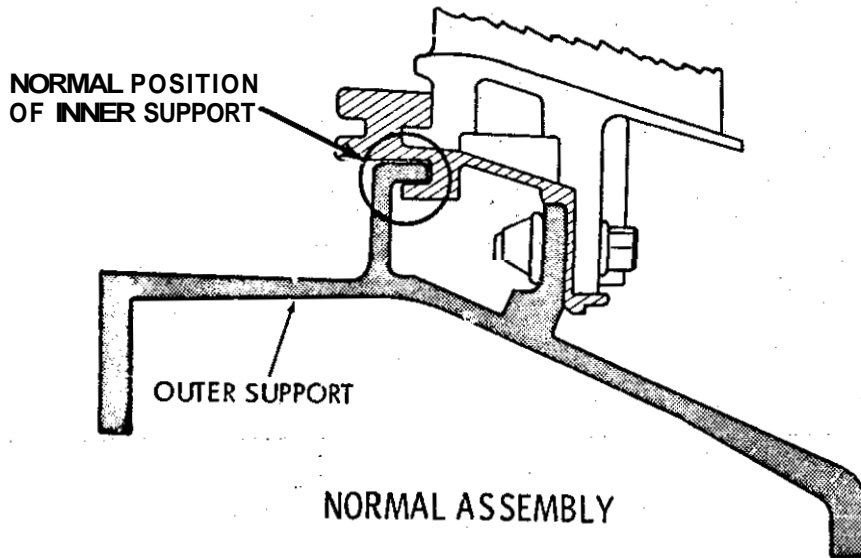
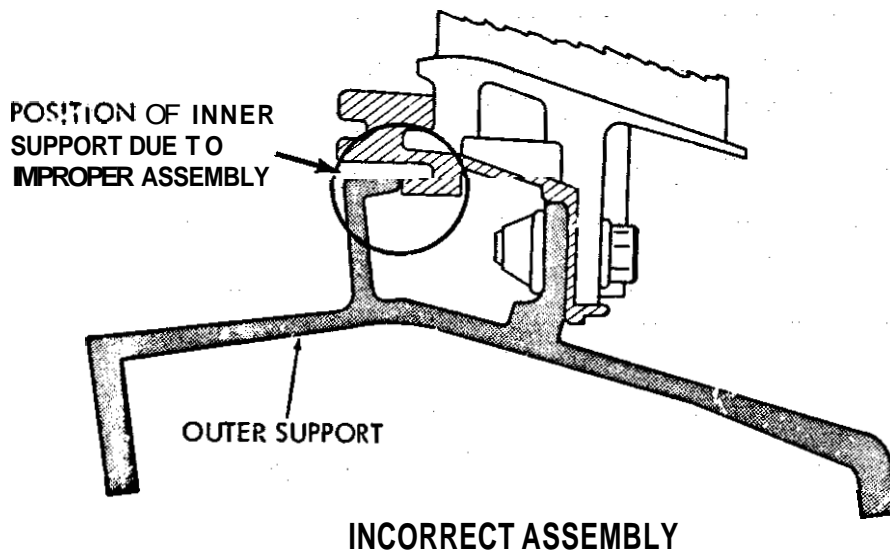
NATIONAL TRANSPORTATION SAFETY BOARD
DEPARTMENT OF TRANSPORTATION
WASHINGTON, D.C.
JT9D-3A, S/N P662498
AIR FRANCE-BOEING 747-128 F-BPVD

Review of assembly and inspection procedures disclosed that there were written and pictorial instructions for torquing the 90 bolts securing the 30 vane segments. These instructions, however, did not provide for any specific sequence for accomplishing this operation. Also at the time the HPT module underwent final assembly, there were no provisions for making dimensional checks which could have detected improper positioning of mating parts.

5/ See Attachment 1 for illustration of proper and improper engagement.

installed in this engine, was not correctly assembled. The result was a transient condition of second-stage turbine disk rub against the second-stage turbine vane?, causing grooving of the disk in the rim area. This occurred during application of takeoff thrust when maximum gas velocities in a rearward direction existed. Progressive weakening of the disk around its periphery resulted in separation of the disk rim, and fragments of the rim penetrated the high-pressure turbine case and caused varied degrees of secondary damage and localized fire.

As a result of this incident and identification of the failure mechanism, the manufacturer's assembly and inspection procedures were revised to provide for sequence torquing of the 90 bolts securing the second-stage nozzle guide vanes and a measurement of critical axial dimension to ascertain correct assembly and fits.
