AIRCRAFT ACCIDENT REPORT

TEXAS INTERNATIONAL AIRLINES, INC.

DOUGLAS DC-9, N1308T

JANUARY 11, 1970

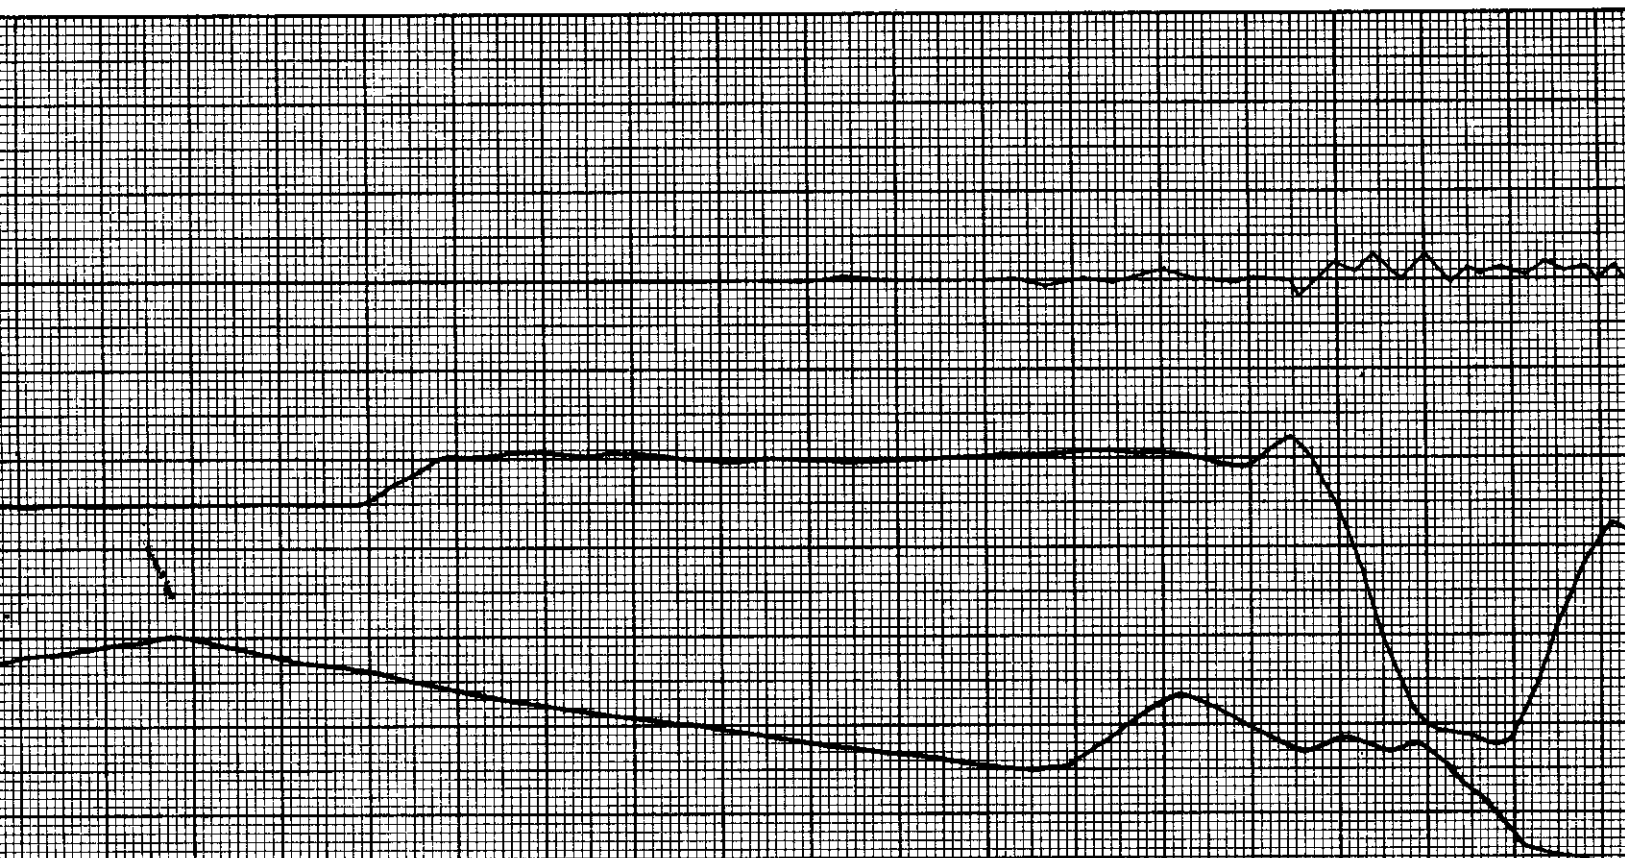
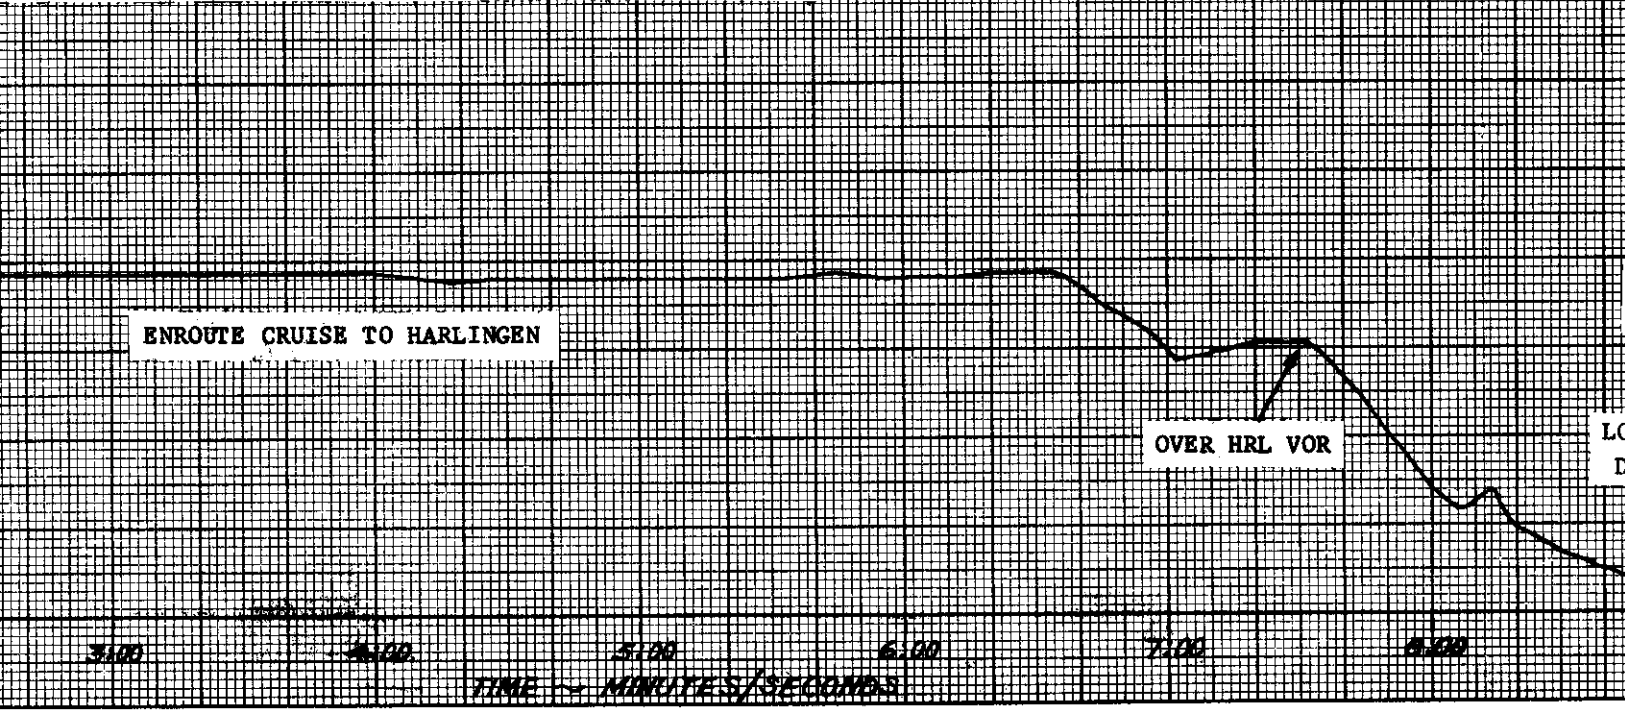
dicted on this graph was taken from the original data
 flight recorder readout which was based on Fairchild
 data and reflected an altitude of -75 feet for takeoff.
 poses of this graph, the altitude trace was shifted up-
 feet so that the takeoff portion coincides with the
 (McAllen) elevation of 106 feet MSL. The other three
 remain unchanged.

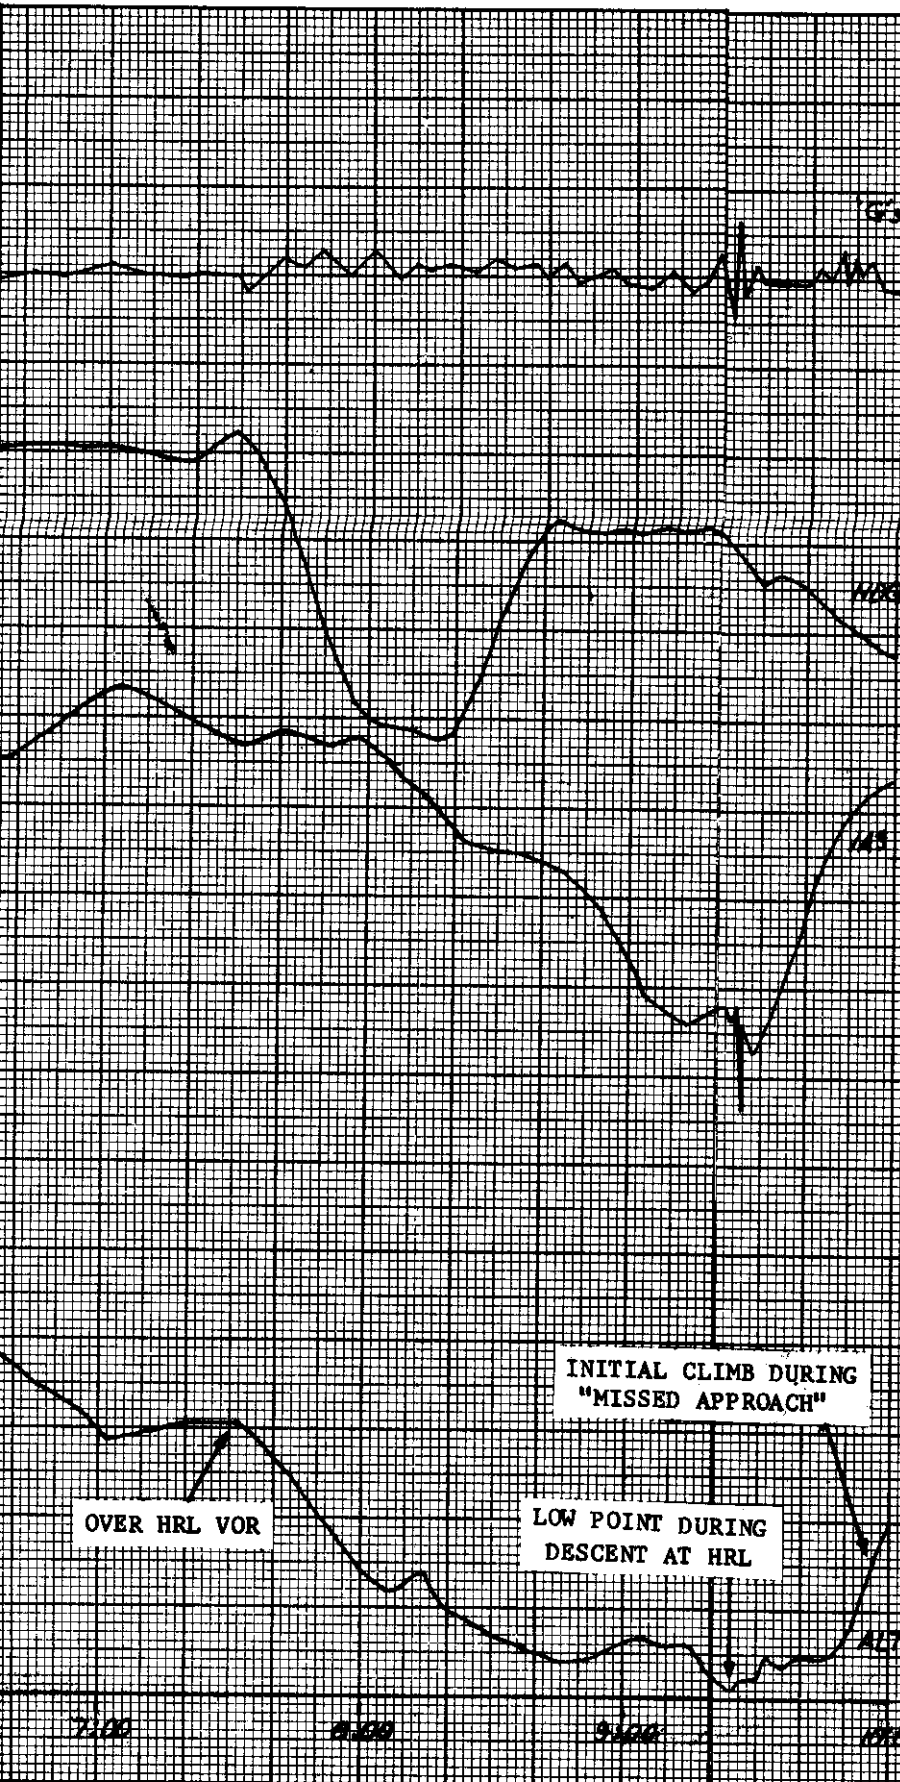
FLIGHT RECORDER DATA GRAPH

A readout of the FDR record disclosed that the altitude and air-speed parameters were substantially out of tolerance on the high side in relation to the most recent calibration data available, dated May 23, 1969. Consequently, the subject recorder **was** forwarded to the manufacturer, Fairchild Industrial Products, for examination. Their findings confirmed that the altitude and airspeed recording styli reference positions were permanently shifted to much higher values than the standard tolerances. Fairchild determined the calibration of the FDR in an "as is" condition. Subsequently the subject FDR **was** tested on another aircraft **of** the **same** type involved in the accident. The FDR readout of the record made during this test flight confirmed that the FDR **was** in the same condition as noted originally. The test flight readout data were computed using both the May 23, 1969, calibration and the Fairchild calibration data for comparison. Altitude and airspeed values derived from the Fairchild data matched closely with those listed in the flight log prepared **by** the Investigator-in-Charge while those derived from the May 23, 1969, calibration substantially exceeded the logged values.
