# AIRCRAFT ACCIDENT REPORT

COMMUTER AIRLINES, INC.  
BEECHCRAFT C-45H (INFINITE II), N497DM  
BROOME COUNTY AIRPORT  
BINGHAMTON, NEW YORK  
MARCH 22, 1970

NATIONAL TRANSPORTATION SAFETY BOARD

REPORT NUMBER: NTSB-AAR-71-13

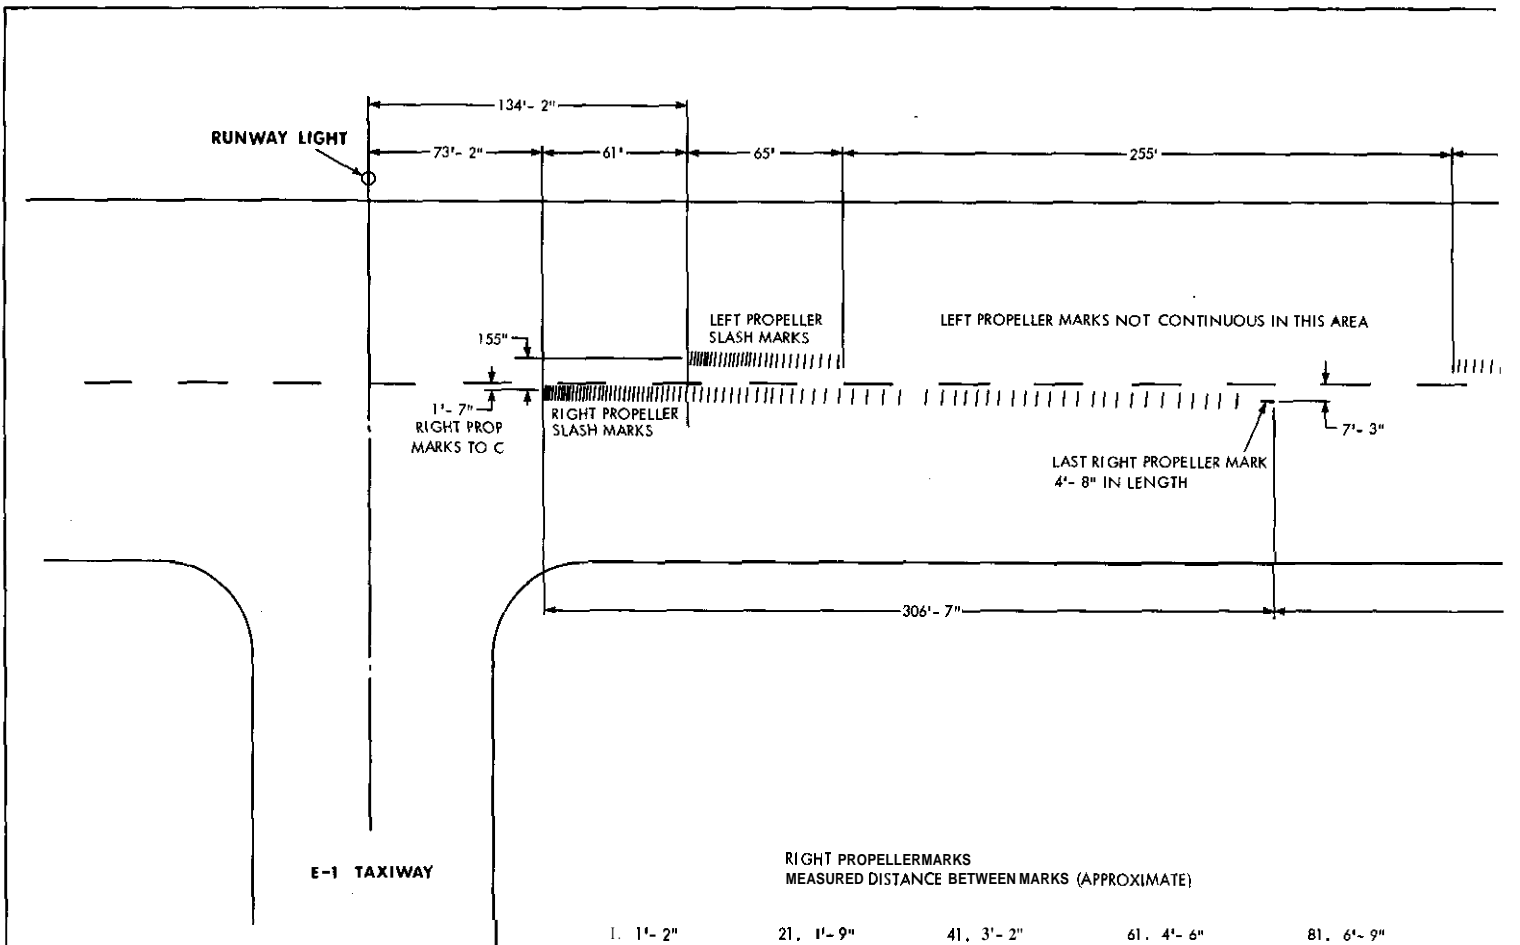
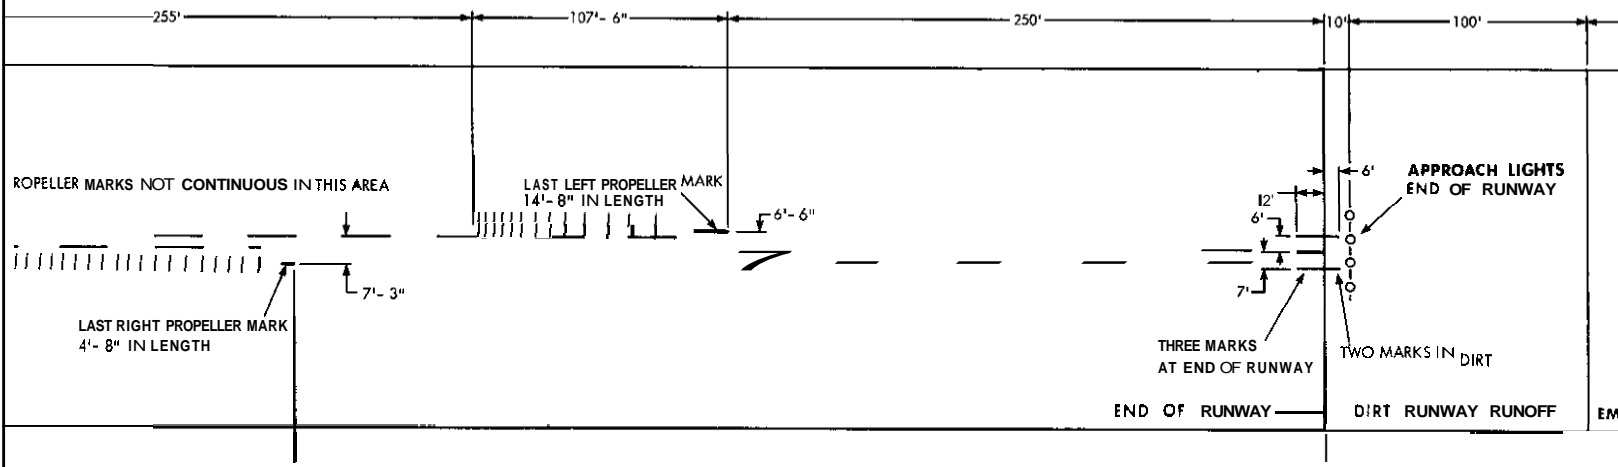
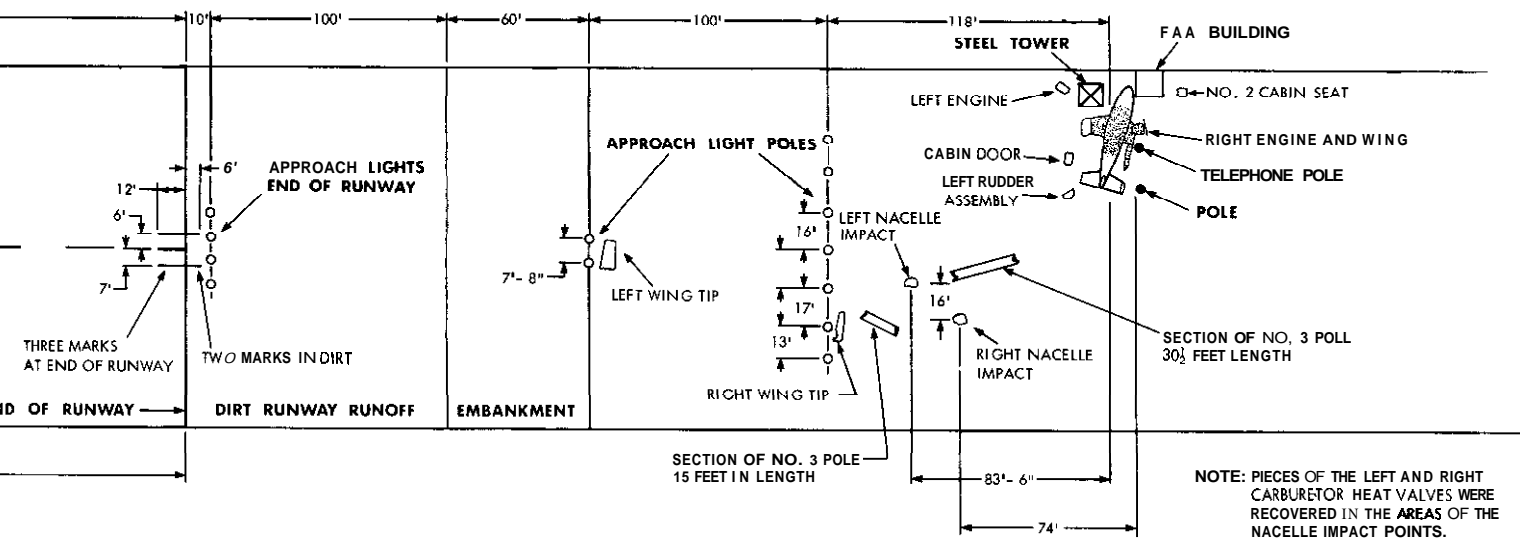
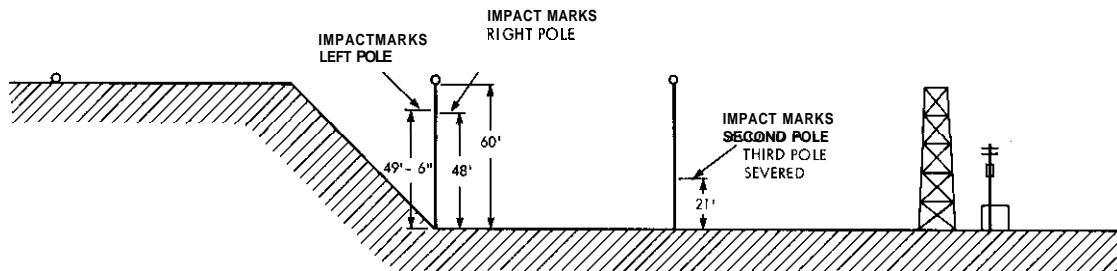
ATTACHMENT NO. 1

Propeller slash marks were found on the surface of the runway, starting at a point approximately **738** feet from the departure end and continuing for about **490** feet along the approximate center of the runway. One tip of the left engine propeller was recovered near the end of the runway.

RIGHT PROPELLERMARKS  
MEASURED DISTANCE BETWEEN MARKS (APPROXIMATE)

MARKS FOR 225'
