AIRCRAFT ACCIDENT REPORT

Delta Air Lines, Inc.
Douglas DC-9-32, N3329L
Louisville, Kentucky
September 8, 1970

NATIONAL TRANSPORTATION SAFETY BOARD
Washington, D. C. 20591
REPORT NUMBER: NTSB-AAR-71-15

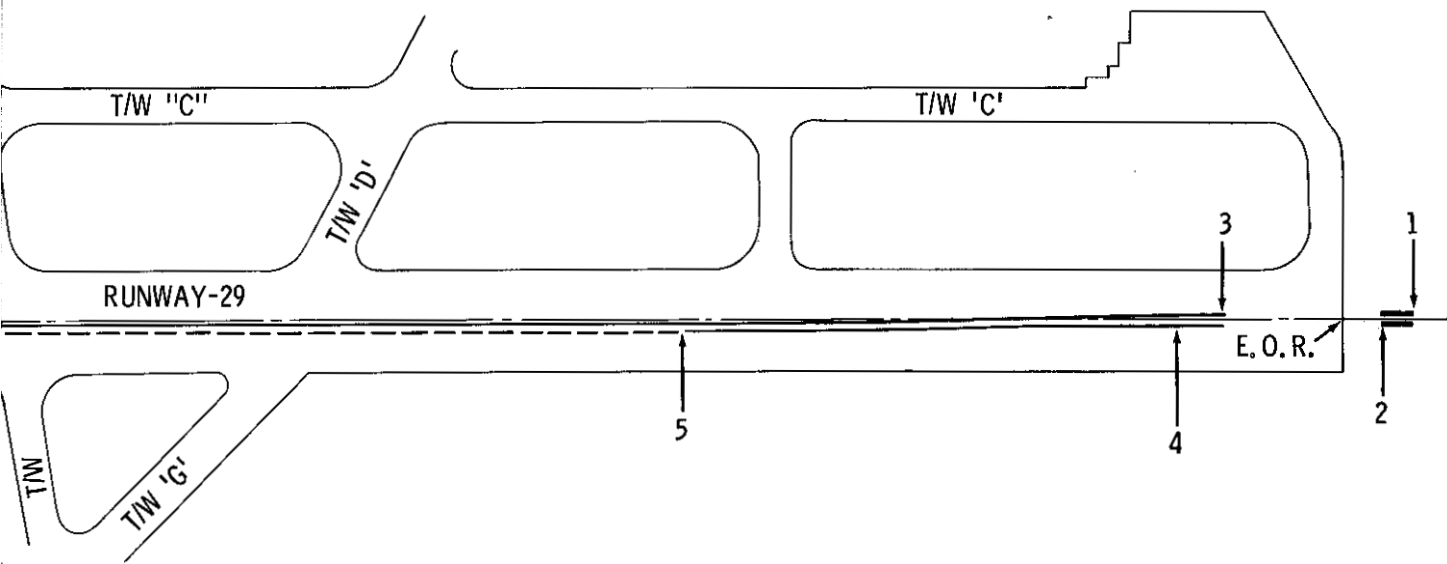
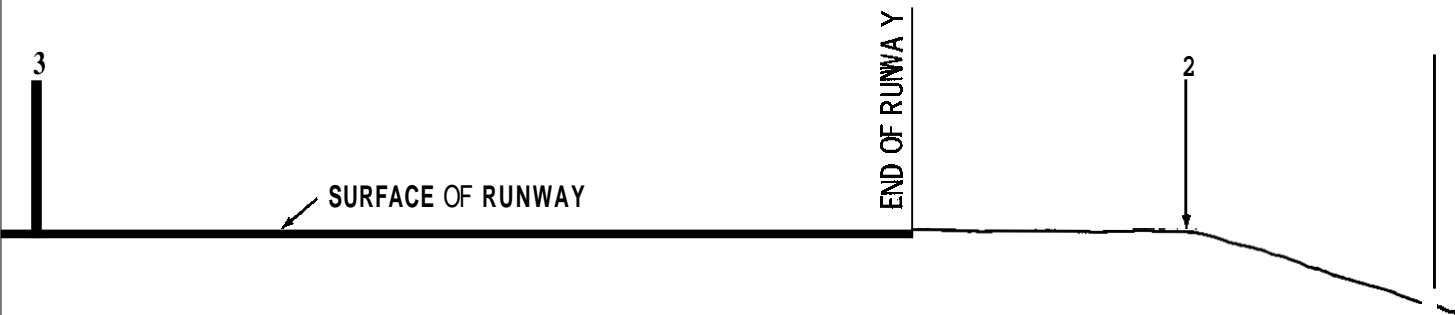
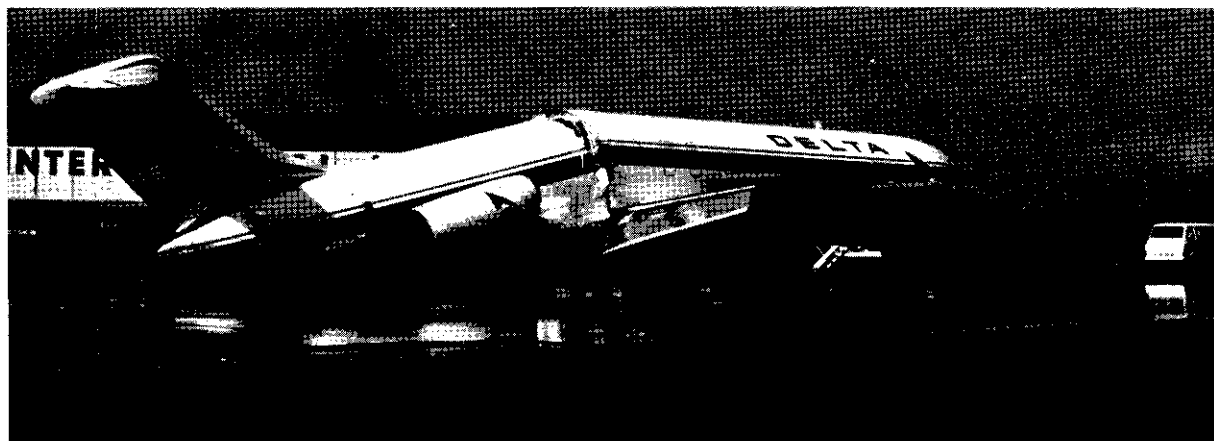
PLAN AND PROFILE VIEW OF RUNWAY 29

At approximately 2114 eastern daylight time September 8, 1970, Delta Air Lines Flight 439, Douglas Model DC-9-32, N3329L, touched down 156 feet short of Runway 29 at Standiford Field, Louisville, Kentucky, during a night landing visual approach. In the area of initial contact, the ground sloped upward toward the runway threshold at a measured 2° 44' or an approximate 5 percent gradient.

The aircraft made firm contact on the main gear, rolled 73 feet in the direction of the runway threshold and then became airborne. It touched down a second time on the runway, 62 feet beyond the runway threshold. From the point of second touchdown, ground marks continued approximately 4,457 feet to where the aircraft came to rest. The aircraft was substantially damaged by the initial ground contact but there was no fire.

Flight 439 made initial ground contact on this incline 156 feet short of the threshold of the runway, rolled forward 73 feet, and became airborne. The aircraft then contacted the runway 262 feet beyond the threshold and continued to roll/skid on the runway before it came to rest 4,457 feet beyond the threshold. (See Attachment 2.)

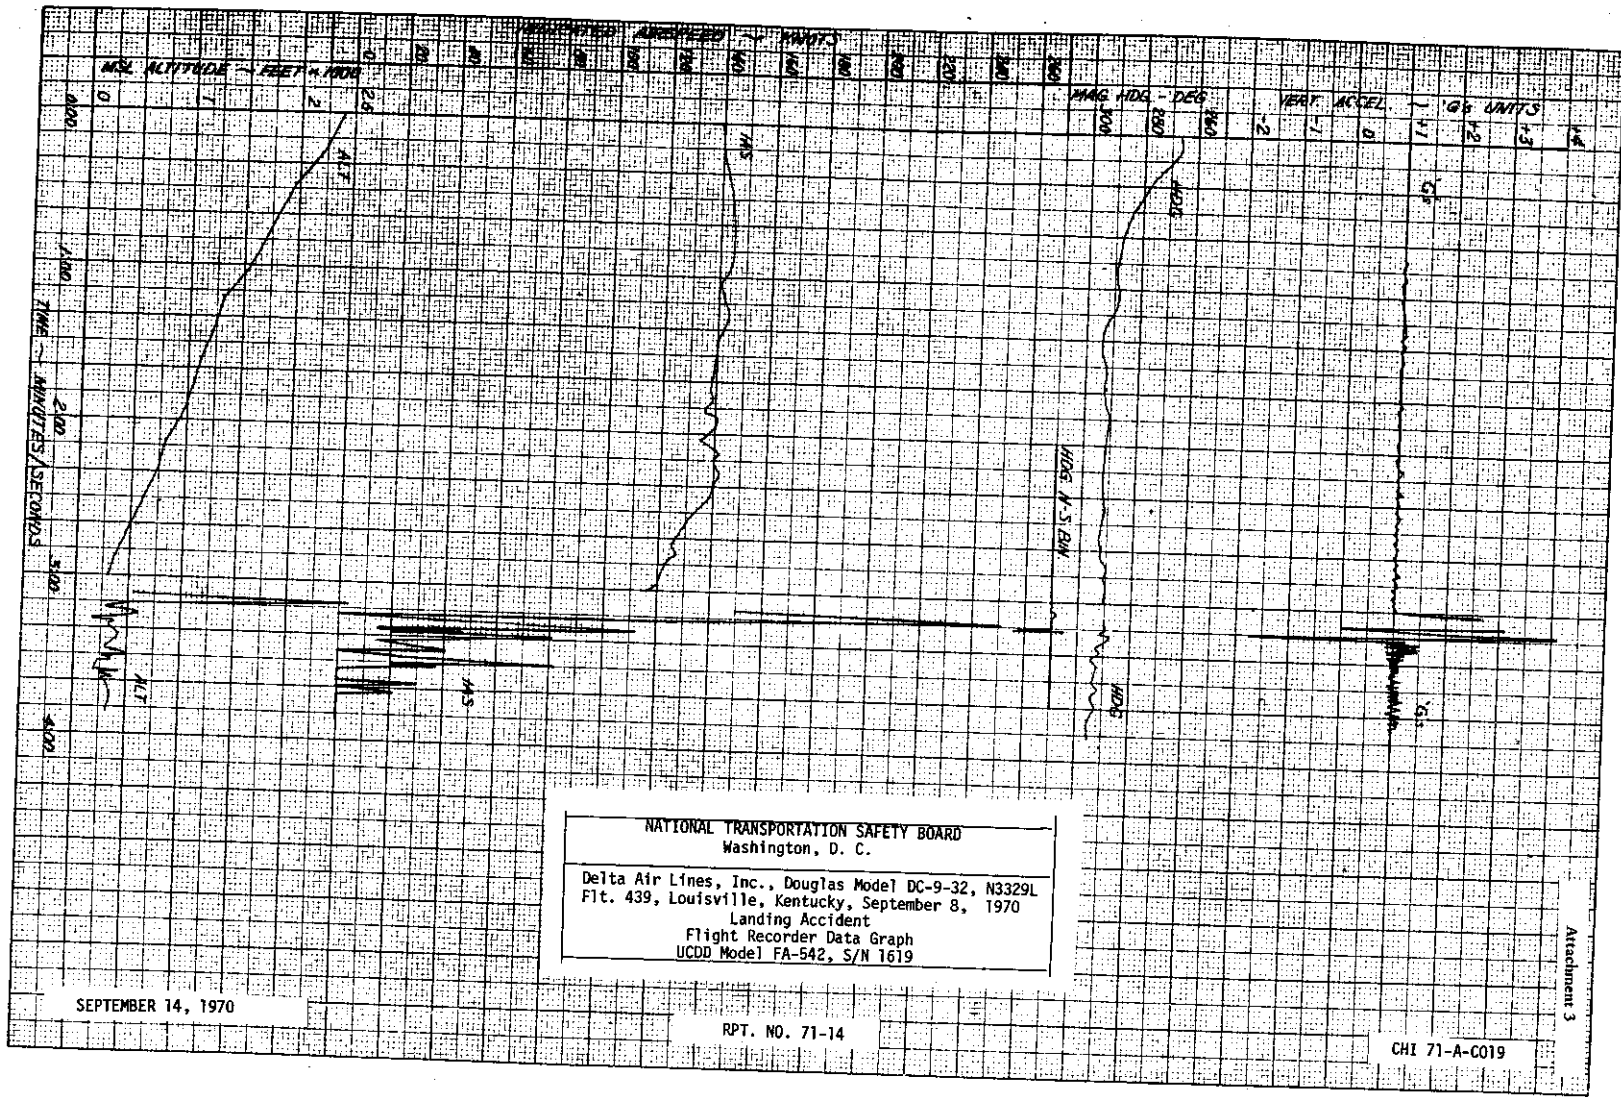
Attachment 3

The flight data recorder foil medium was undamaged. All parameters were active and clearly discernible. The trip and date/reference binary trace was missing. This trace is normally located near the bottom edge of the foil medium and provides the base for all vertical measurements.

The readout was accomplished by substituting an artificial reference line for the missing reference line, based on the standard position of 0.115 inch above the bottom edge of the recording medium. The tape was read out beginning approximately 3 minutes prior to the point where all parameter traces became aberrant and continued to the end of the recorded traces, comprising a total readout time of approximately 4 minutes. The altitude depicted on the flight data recorder graph was corrected to mean sea

The altitude shown at the point where all recorder traces became aberrant is 300 feet mean sea level. The actual altitude at point of impact is 472 feet mean sea level.
