AIRCRAFT ACCIDENT REPORT

CAPITOL INTERNATIONAL AIRWAYS , INC .

DC-8-63F, N4909C

REPORT NUMBER: NTSB-AAR-72-12

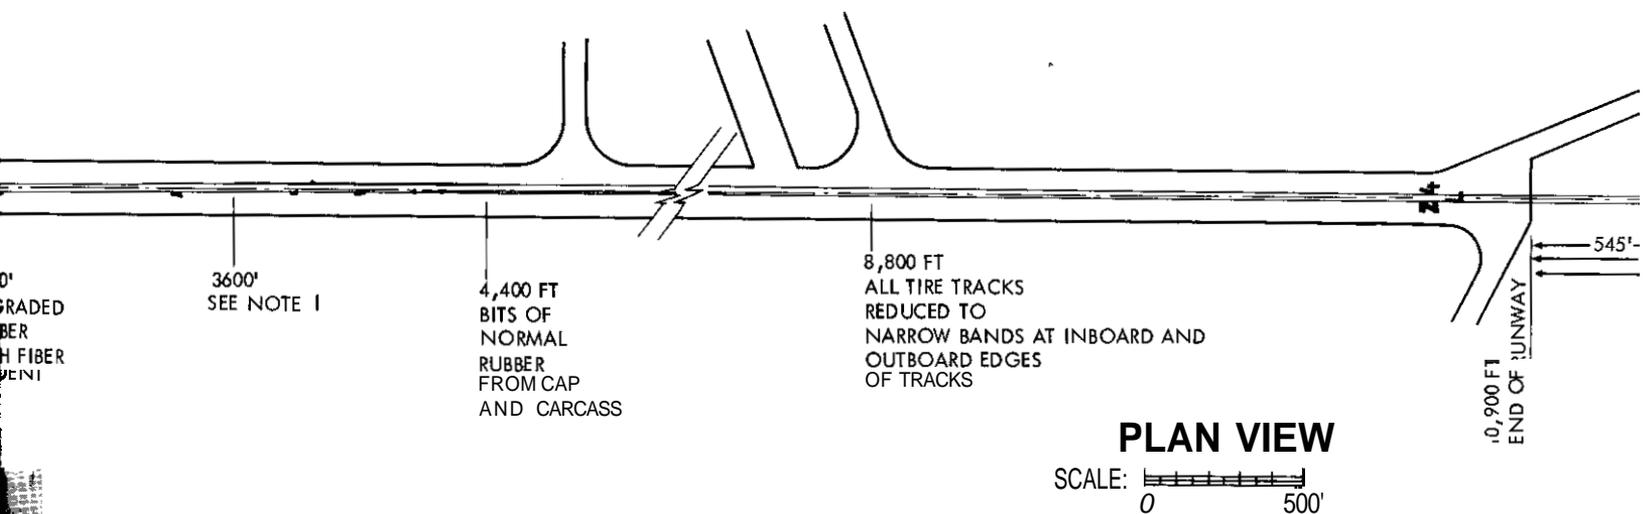
NOTE 1

LH INBD WHEEL TRACK LEAVING
DARK TRACK WITH DARK BAND
(1/2" TO 2") ON LH EDGE. TRACK
CEASED AT 4400', BUT NARROW
BAND AND SCORING OF RUNWAY
CONTINUED TO END OF RUNWAY

LHOB	LHIB	RHIB	RHOB
LINE-UP	12"	12"	13"	12"
1000 FT.	12"	13"	16"	14 1/2"
300 FT.	12"	-	18"	14"
4400 FT.	BEAD MARKS		-	
8800 FT.	BEAD MARKS & RIM MARK ON ☉ LIGHTS

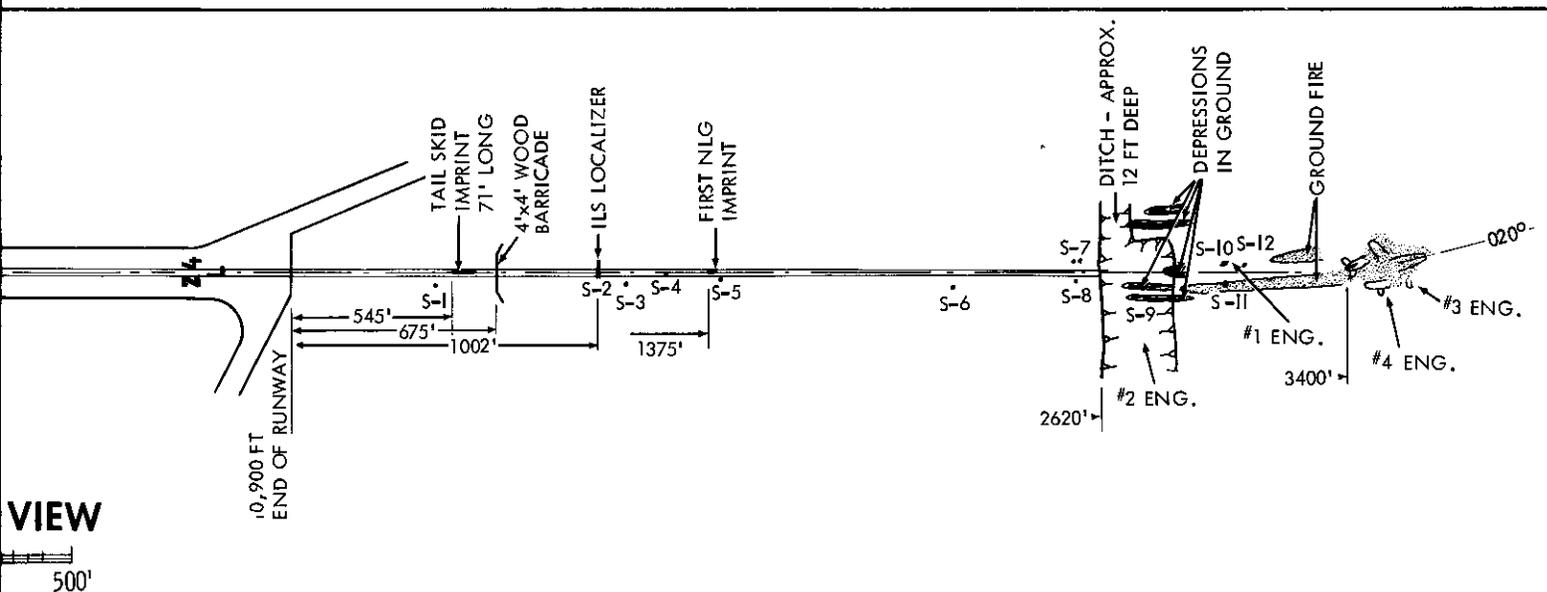
- S-1 FRAGMENTS OF A WHEEL WHICH EXHIBITED GROUND SURFACES
- S-2 PIECES OF WHEELS, AIRCRAFT FAIRINGS, ETC. SCATTERED AROUND LOCALIZER
- S-3 PIECE OF WING FLAP
- S-4 ENGINE COWLING
- S-5 LANDING GEAR DOOR
- S-6 MAIN LANDING GEAR WHEEL
- S-7 MAIN LANDING GEAR TIRES NOS 2 AND NO 6
- S-8 PIECE OF MAIN LANDING GEAR WHEEL NO 7
- S-9 NO 2 ENGINE, LANDING GEAR PARTS, ENGINE COWLINGS, ETC., SCATTERED ABOUT AREA
- S-10 PIECE OF LEFT-HAND OUTBOARD FLAP
- S-11 NO 1 WHEEL AND TIRE
- S-12 BRAKE ASSEMBLY

NOTE 1
 LHTNBD WHEEL TRACK LEAVING DARK TRACK WITH DARK BAND (1/2" TO 2") ON LH EDGE. TRACK CEASED AT 4400', BUT NARROW BAND AND SCORING OF RUNWAY CONTINUED TO END OF RUNWAY
