AIRCRAFT INCIDENT REPORT

EASTERN AIR LINES, INC.
BOEING 727-100, N8168G,
FLIGHT 9701
ATLANTA, GEORGIA
DECEMBER 21, 1971

NATIONAL TRANSPORTATION SAFETY BOARD
Washington, D. C. 20591
REPORT NUMBER: NTSB-AAR-72-22

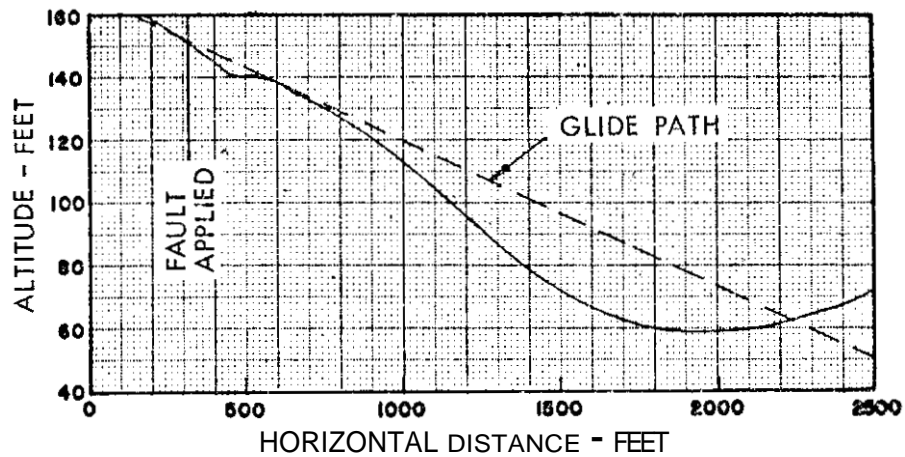
- (a) Altitude loss above 100 feet 24 feet below glide slope when recovery was initiated one second after pilot recognition. (See profile chart.)

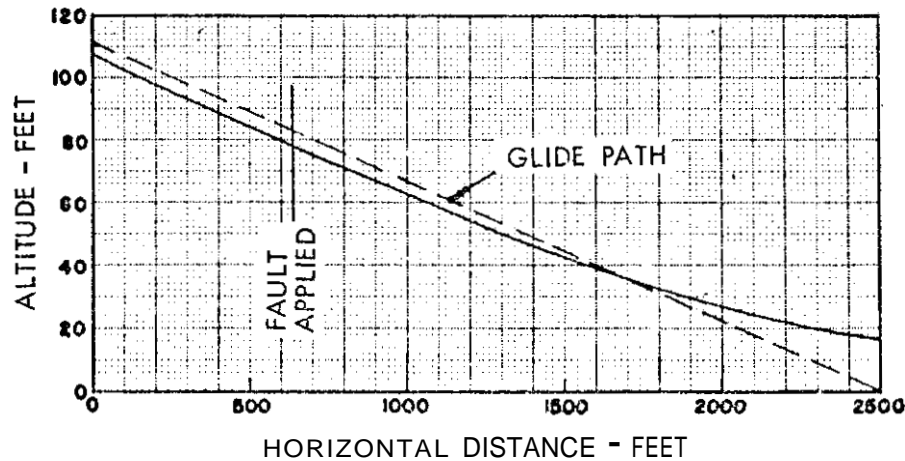
- (b) Altitude loss below 100 feet Negligible when recovery was initiated without delay after pilot recognition. (See profile chart.)
