AIRCRAFT ACCIDENT REPORT

ALII AIR HAWAII, INC.

BEECH D18S, N5642V, KALOHI CHANNEL

FEBRUARY 22, 1972

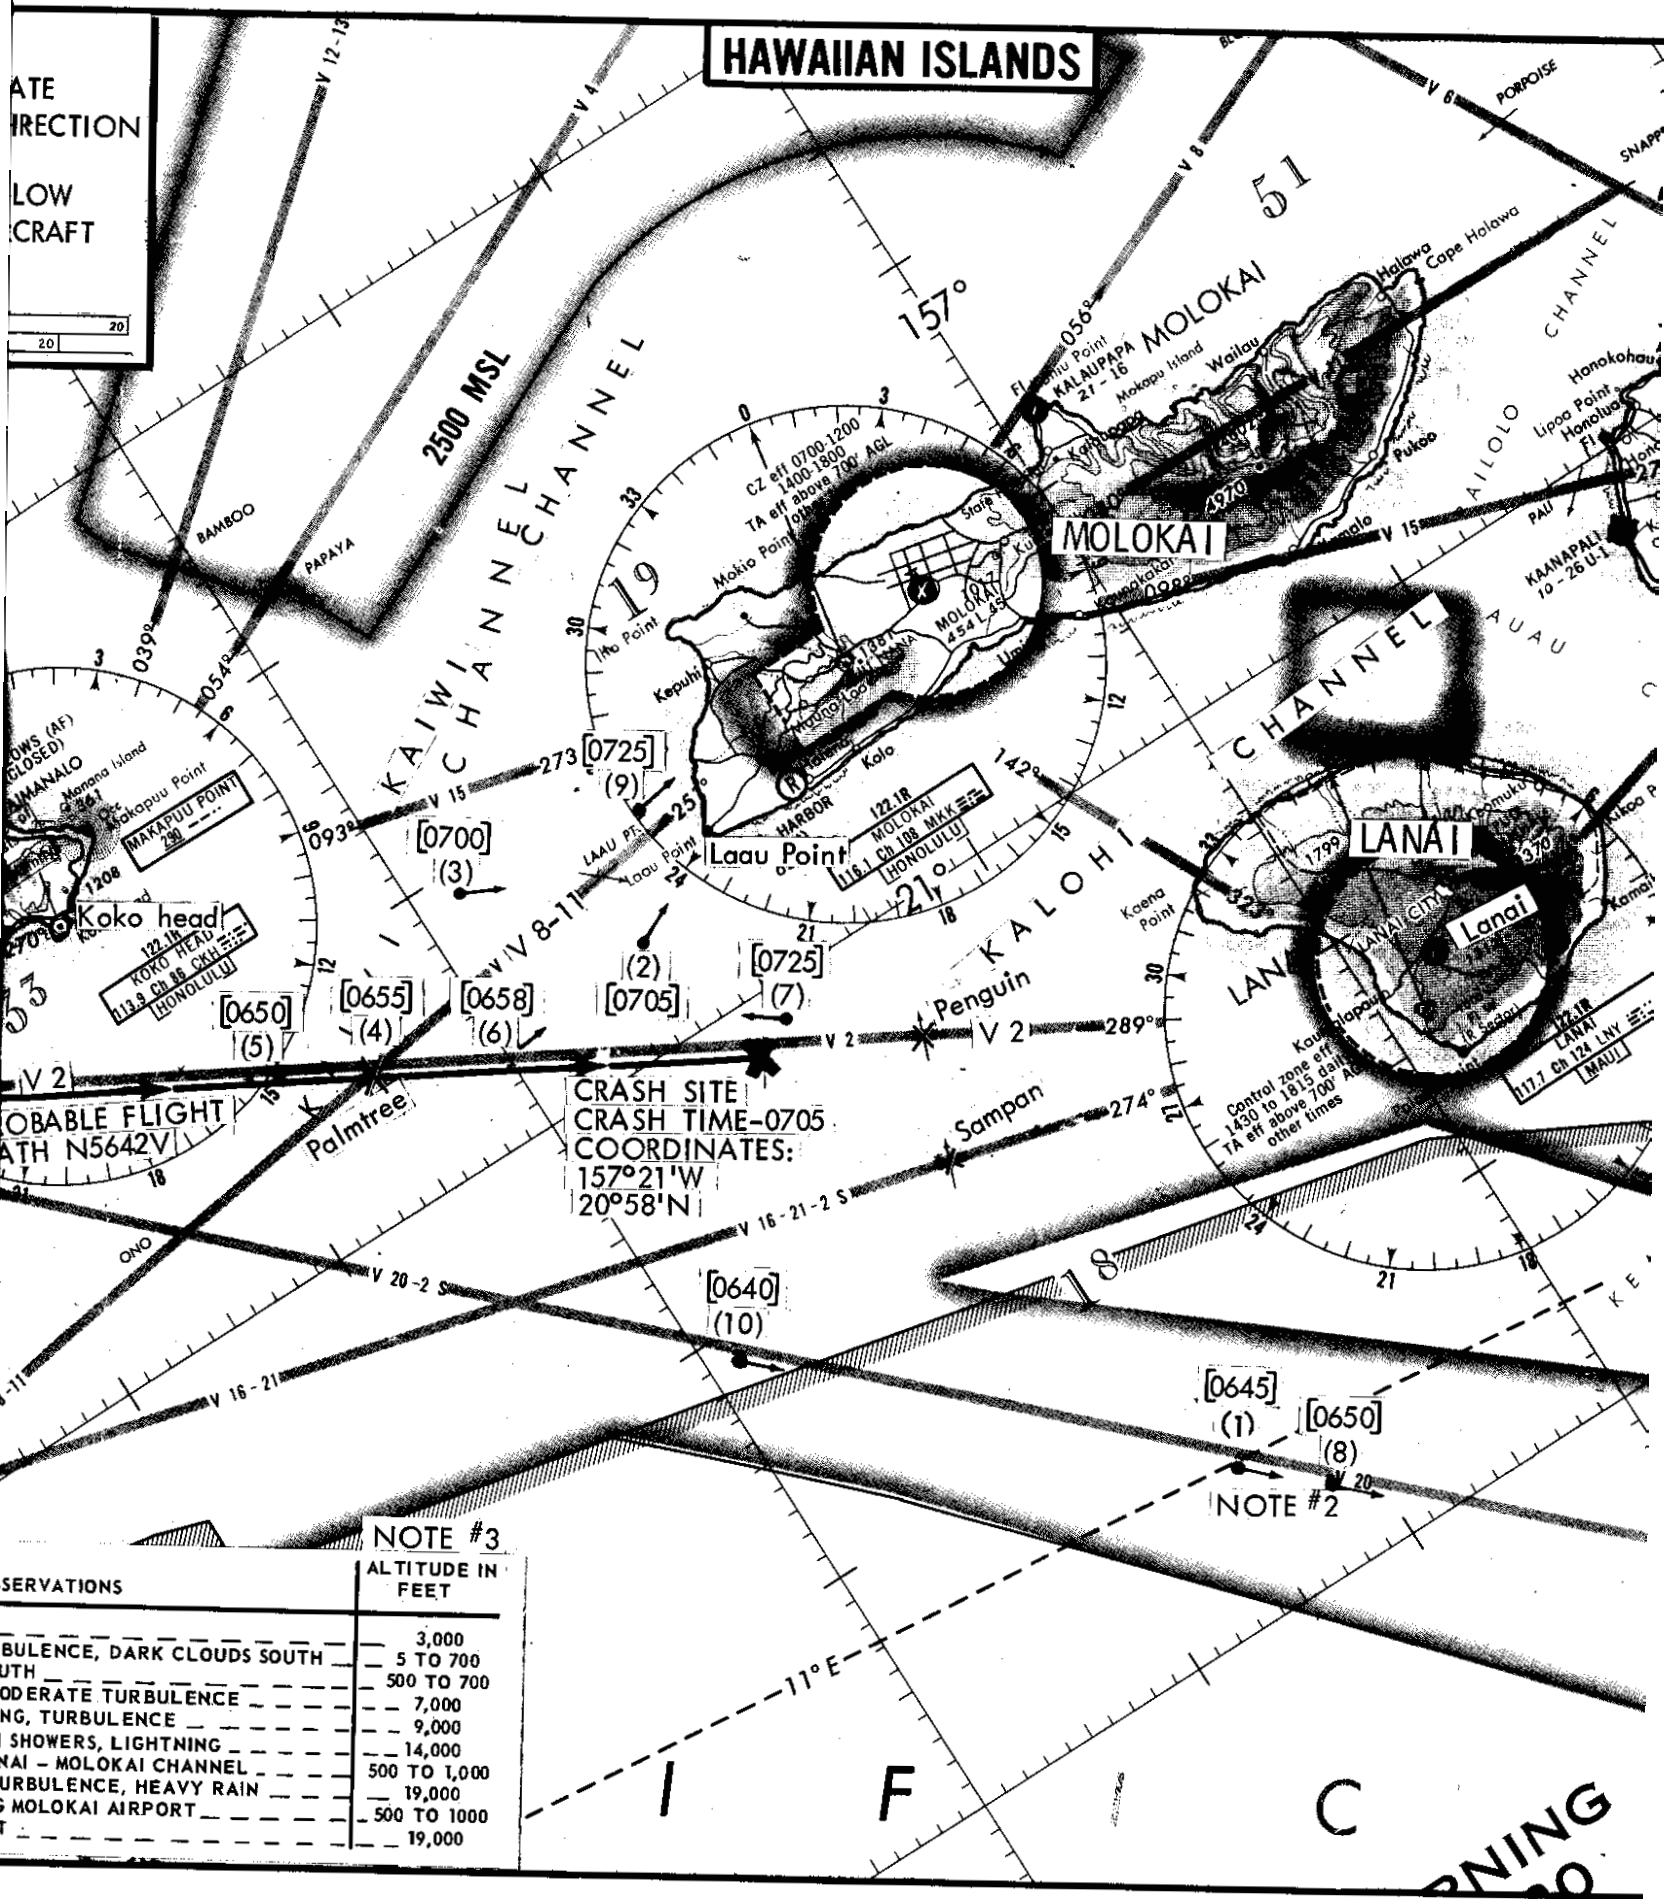
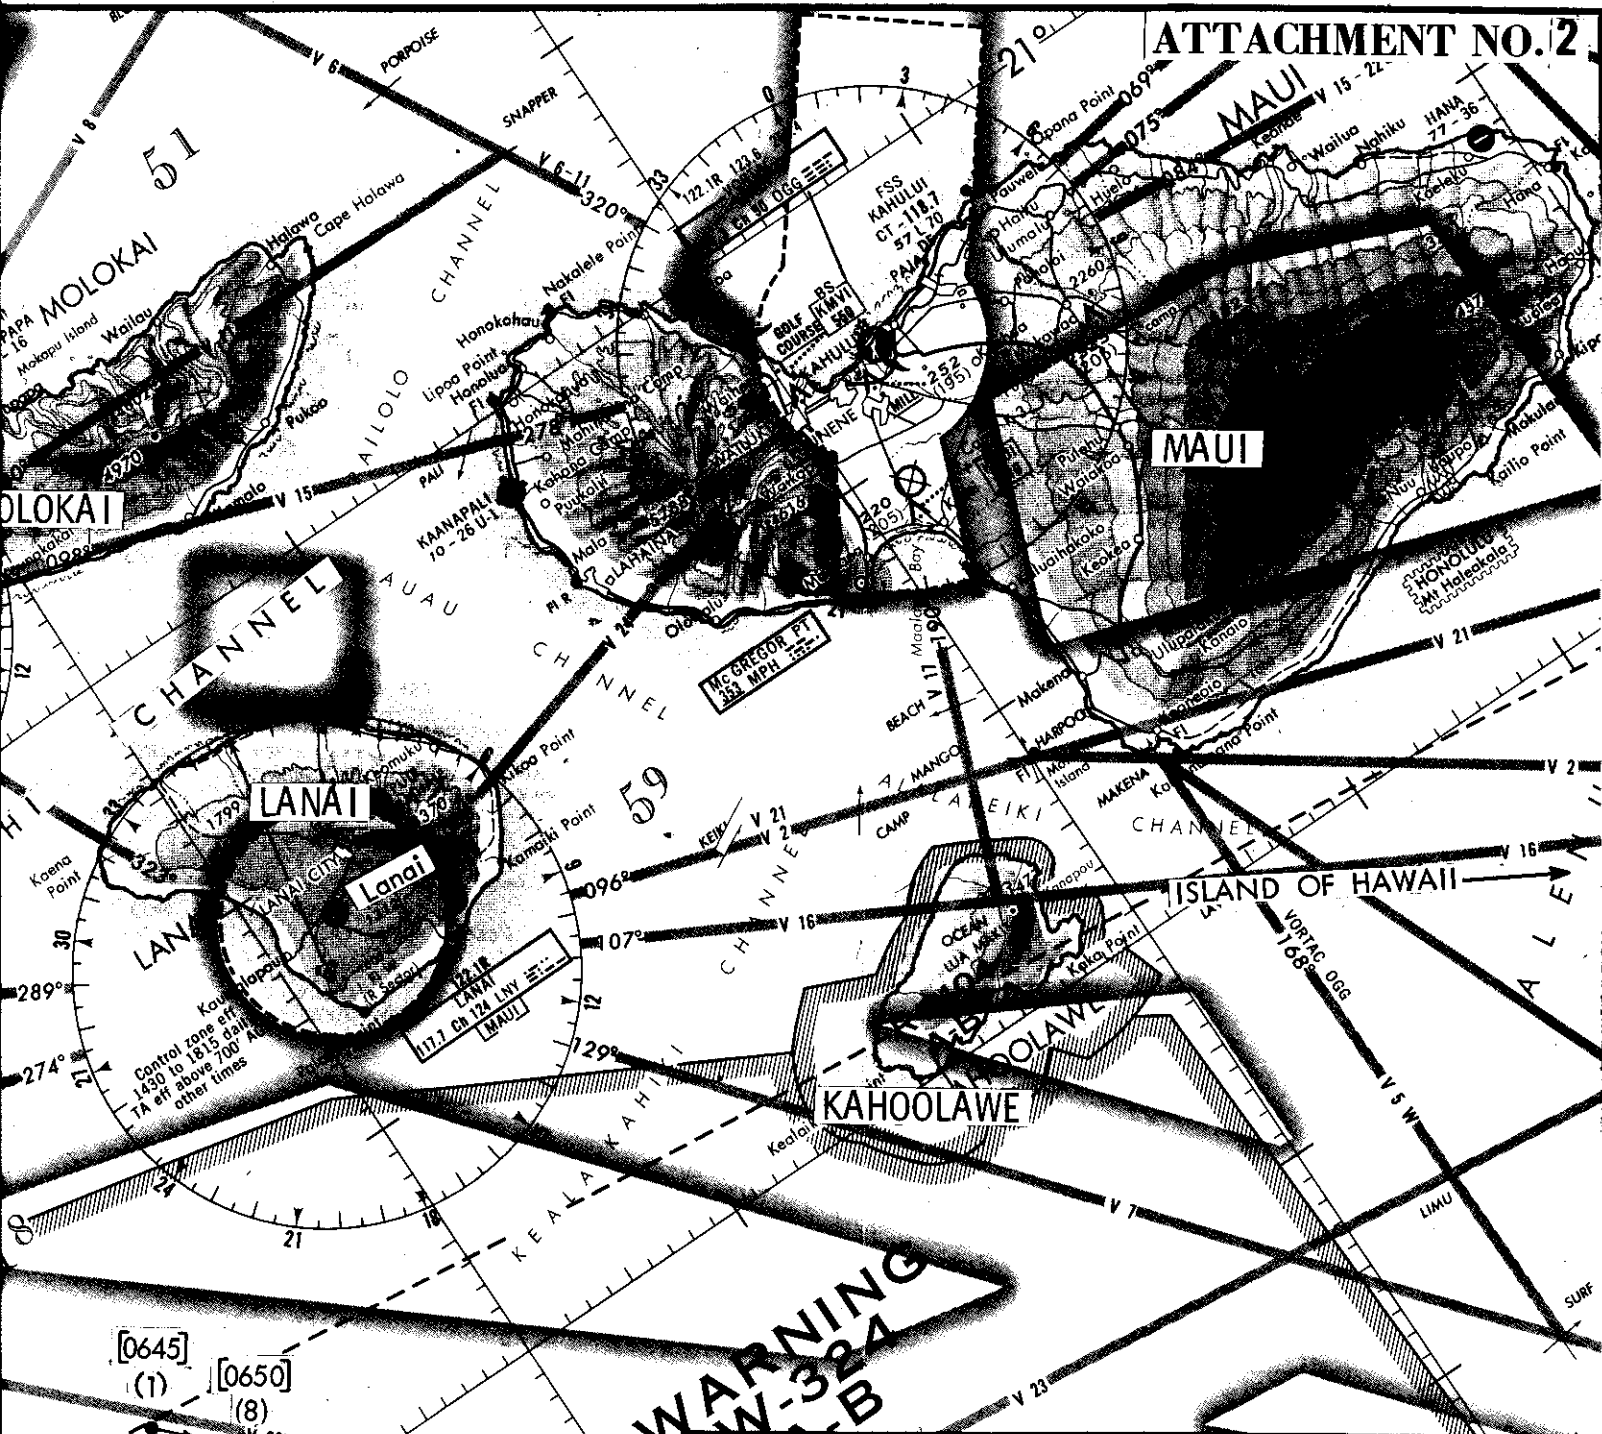
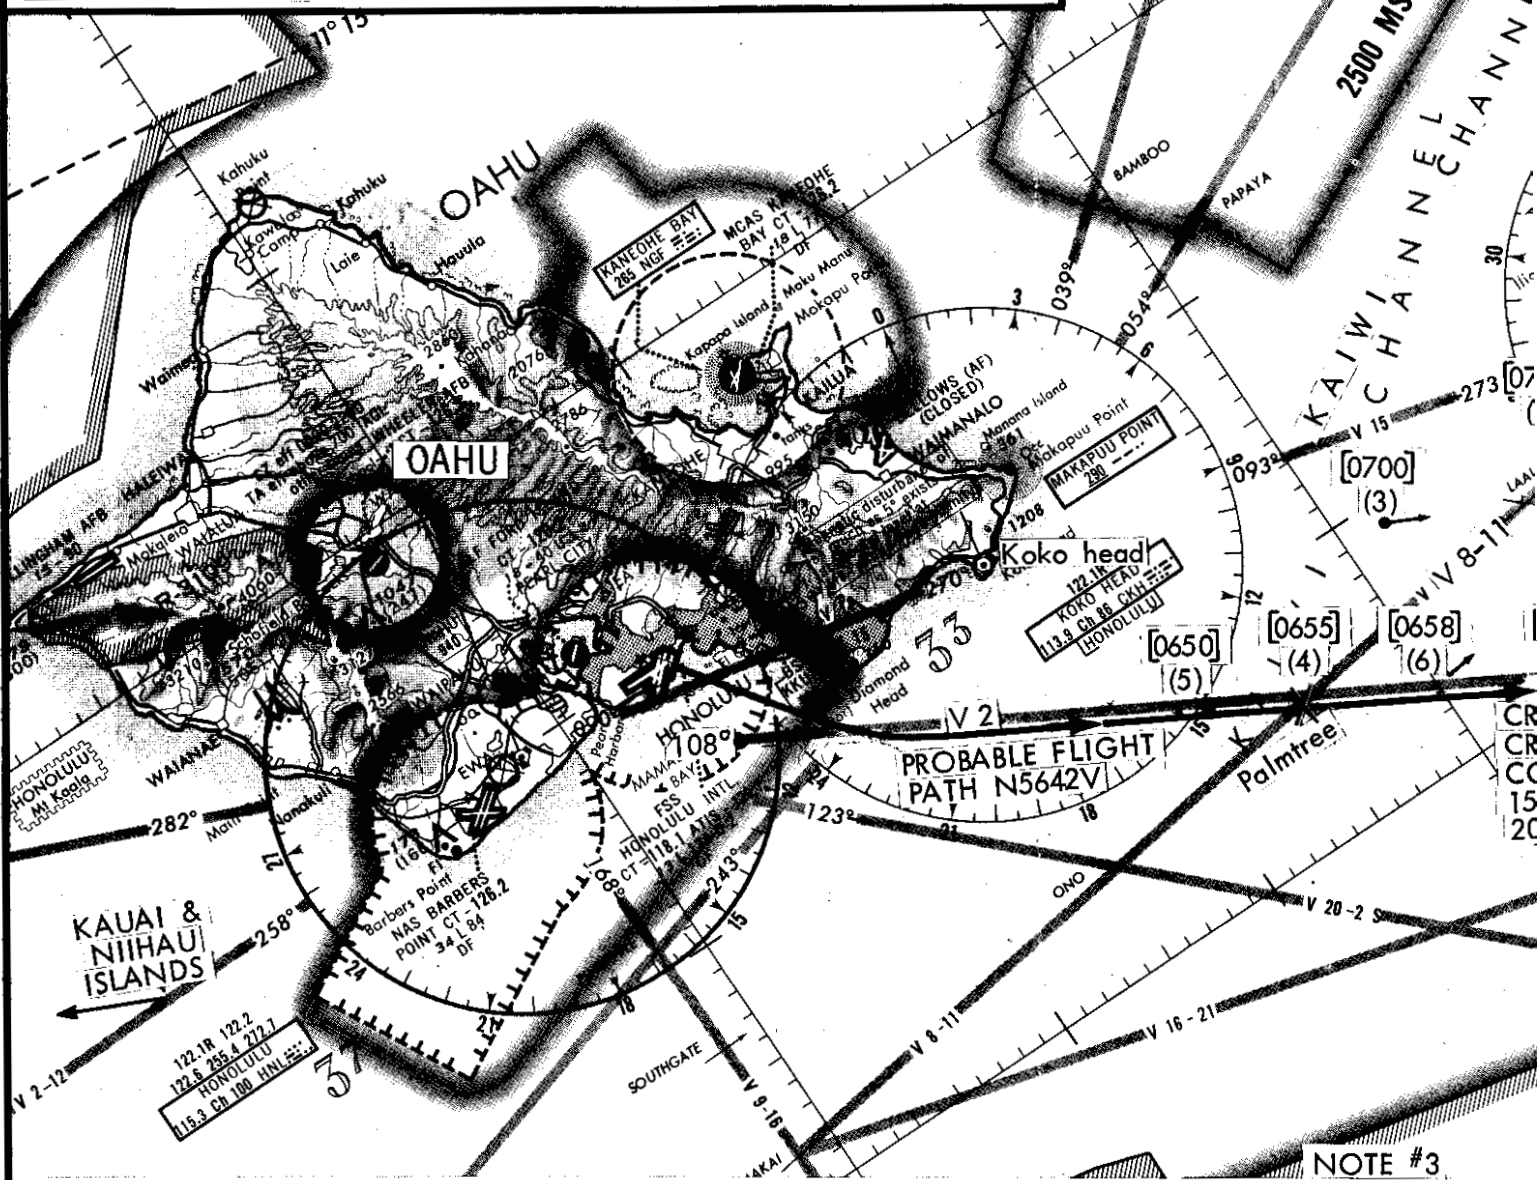
**WEATHER OBSERVATIONS
 IN AREA OF CRASH SITE
 ALII AIR HAWAII, INC.
 BEECH D18S, N5642V**

NO.	AIRLINE	FLIGHT	EXTRACTS FROM OBSERVATIONS	ALTITUDE IN FEET
(1)	ROYAL HAWAIIAN AIR SERVICE	1	LIGHT RAIN AND TURBULENCE	3,000
(2)	AIR MOLOKAI, LTO.		ENCOUNTERED RAIN AND SEVERE TURBULENCE, DARK CLOUDS SOUTH	500 TO 700

(3)	ALU AIR HAWAII, INC.	141	HEAVY RAIN AND DARK CLOUDS TO SOUTH	500 TO 700
(4)	HAWAIIAN AIRLINES	100	ENCOUNTERED RAIN WITH LIGHT TO MOOERATE TURBULENCE	7,000

(5)	ALOHA AIRLINES, INC.	304	FREEZING RAIN. HAIL, WINDSHIELD ICING, TURBULENCE	9,000
(6)	ALOHA AIRLINES, INC.	904	MODERATE TURBULENCE, HEAVY RAIN SHOWERS, LIGHTNING	14,000

(7)	ROYAL HAWAIIAN AIR SERVICE	206	THUNDERSTORM AND LIGHTNING IN LANAI - MOLOKAI CHANNEL	500 TO 1,000
(8)	ALOHA AIRLINES, INC.	380	ENCOUNTERED LIGHT TO MODERATE TURBULENCE, HEAVY RAIN	19,000

(9)	ROYAL HAWAIIAN AIR SERVICE	105	OBSERVED RAIN SHOWER APPROACHING MOLOKAI AIRPORT	500 TO 1000
(10)	HAWAIIAN AIRLINES	308	LARGE AREAS OF HEAVY RAIN TO LEFT	19,000

CRASH SITE
CRASH TIME-0705
COORDINATES:
 157°21'W
 20°58'N
