AIRCRAFT ACCIDENT REPORT

Sun Valley Airlines, Inc.

Beech 65B-80, N1027C

Fairfield, Idaho

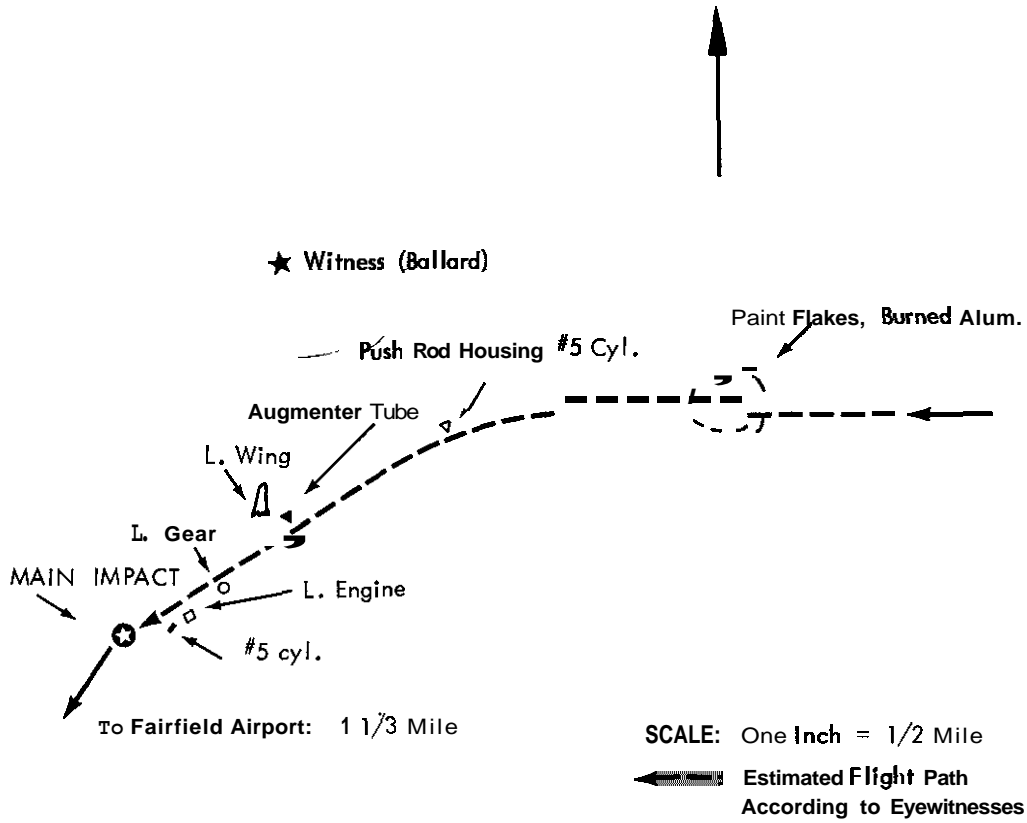
WRECKAGE DISTRIBUTION CHART
SUN VALLEY AIRLINES, INC.
BEECH AIRCRAFT MODEL 65B-80, N1027C

The centerline of the in-flight wreckage scatter was oriented along a heading of 210° magnetic. (See wreckage distribution diagram, Appendix D.) The estimated distance from the main crash site to the separated components was as follows: left wing - 750 yards, left landing gear - 500 yards, left engine - 250 yards. Farther back along the debris path, the undamaged pushrod housing of the No. 5 cylinder of the left engine was found. About 2 miles east-northeast of the main impact area, flakes of burned paint and aluminum were found in the snow.
