# AIRCRAFT ACCIDENT REPORT

Aero Taxi  
Beech E18S, N42A  
Cleveland, Ohio  
June 22, 1972

REPORT NUMBER: NTSB-AAR-72-33 c.1

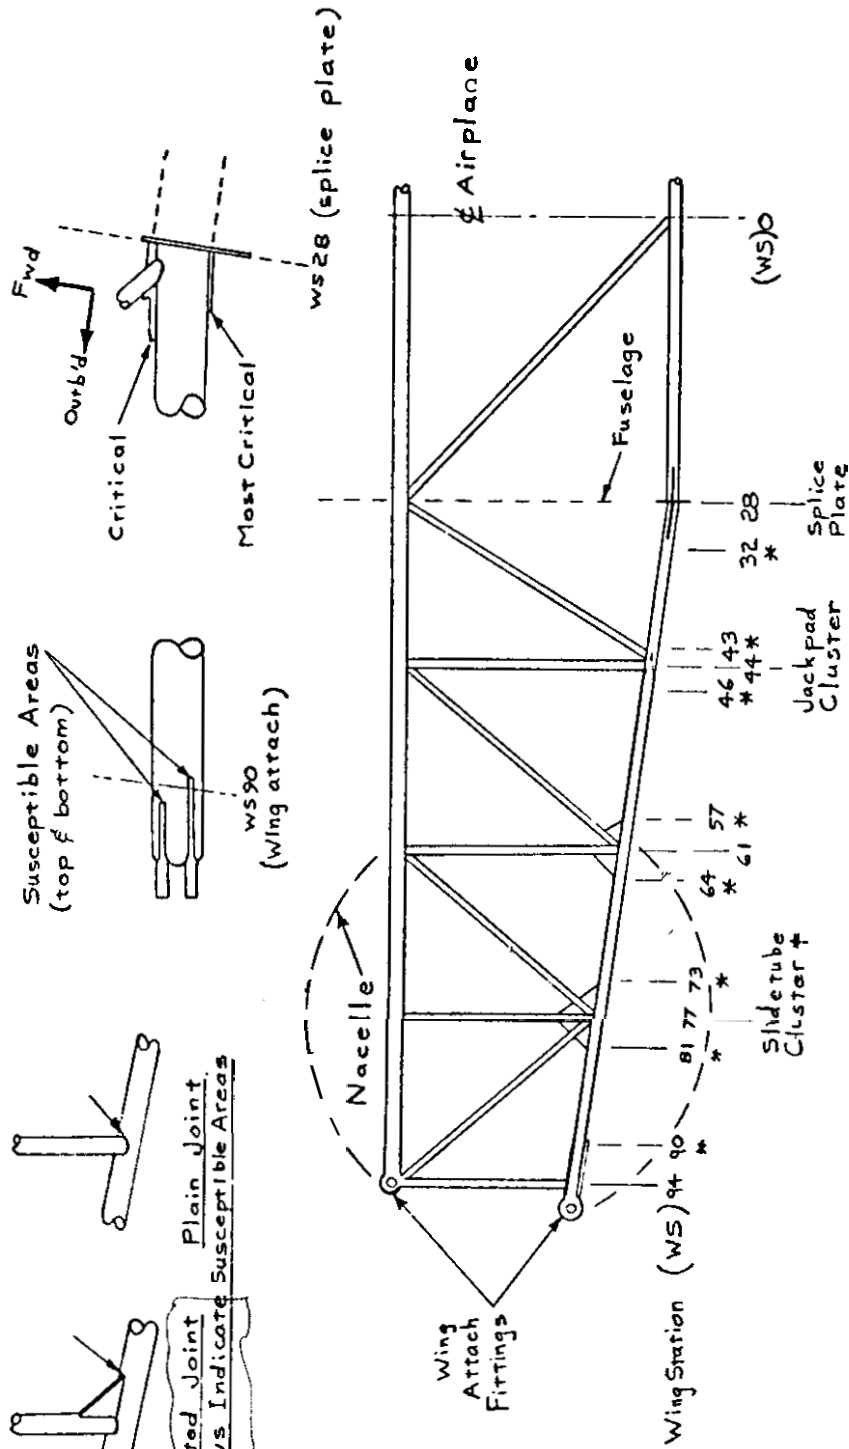
FIGURE 3

\* INDICATES AREAS TO BE INSPECTED PER THIS A.D.  
 † SEE AD 64-21-1, part (b) and AD 64-21-3, part (b).

B. (1) Inspect the front spar lower cap of the wing center section on each side of the airplane by methods specified below, except inspection sites reinforced by Beech Aircraft Corporation Kits 18-4024, **791** or **792** need not be inspected:

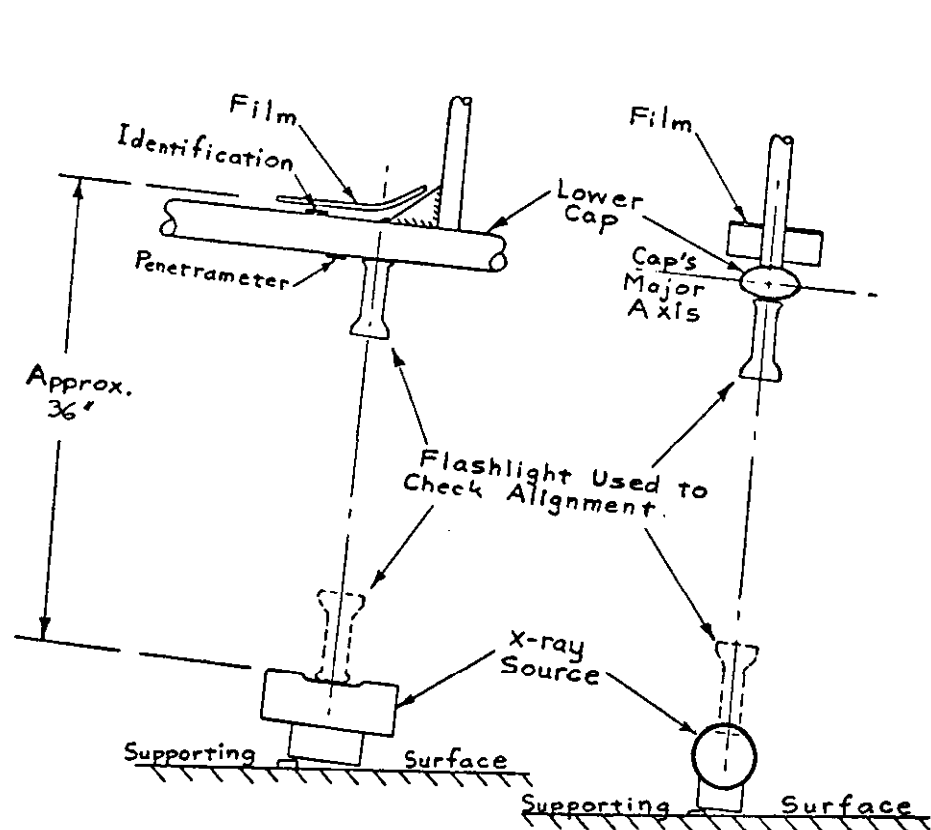
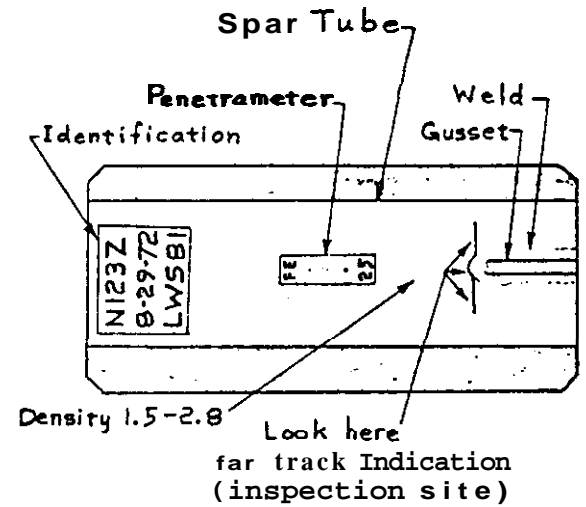
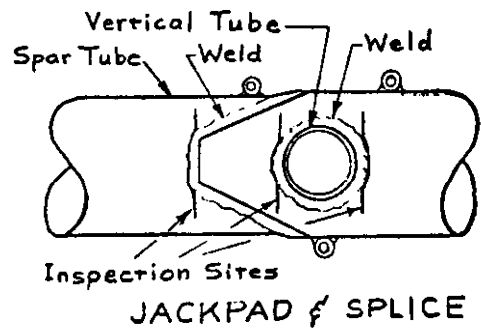
**FIGURE 4**

**EXAMPLE of RADIOGRAPH**  
**TYPICAL CRACK SHOWN**  
**GUSSETED JOINT**

(4) For each site where x-ray inspection is specified by Paragraph B, accomplish x-ray inspection while the wing is loaded. Figure 4 is an aid to the following instruction. Place fine grain film (such as **GAF 800**, **DuPont NDT-65** or **Kodak AA**) sandwiched between lead screens of **0.005**-inch thickness on the upper surface of the spar cap (over an inspection site) with identification symbols for at least the site (e.g. **LWS 81** etc.), date, and airplane registration number. Secure a steel penetrometer of **0.005**-inch thickness to the lower surface

of the spar cap at a location clear of the inspection site. Position the x-ray source approximately **36** inches from and generally below the film so that the center of the x-ray beam will be perpendicular to the major axis of the elliptical spar cap and perpendicular to the spanwise centerline of the spar cap at each inspection site. Use a flashlight and a protractor level as necessary to see that aiming of the x-ray beam compensates for wing dihedral and nose up attitude. At those areas covered by aluminum skin, a locally fabricated jig may be used to position the x-ray source. Expose film so that density of the radiograph of the spar cap material near the inspection site is **1.5 to 2.8** on the densitometer or National Bureau of Standards density scale. View film to see that the inspection site, the **0.010** inch diameter hole in the penetrometer, and its entire outline are plainly shown. Using a low power magnifying device, examine the inspection site portion of each radiograph for faint indications of cracks in spar cap material transverse to the spanwise centerline.
