# AIRCRAFT ACCIDENT REPORT

MACHINERY BUYERS CORPORATION

Learjet Model 24, N454RN

Atlanta, Georgia

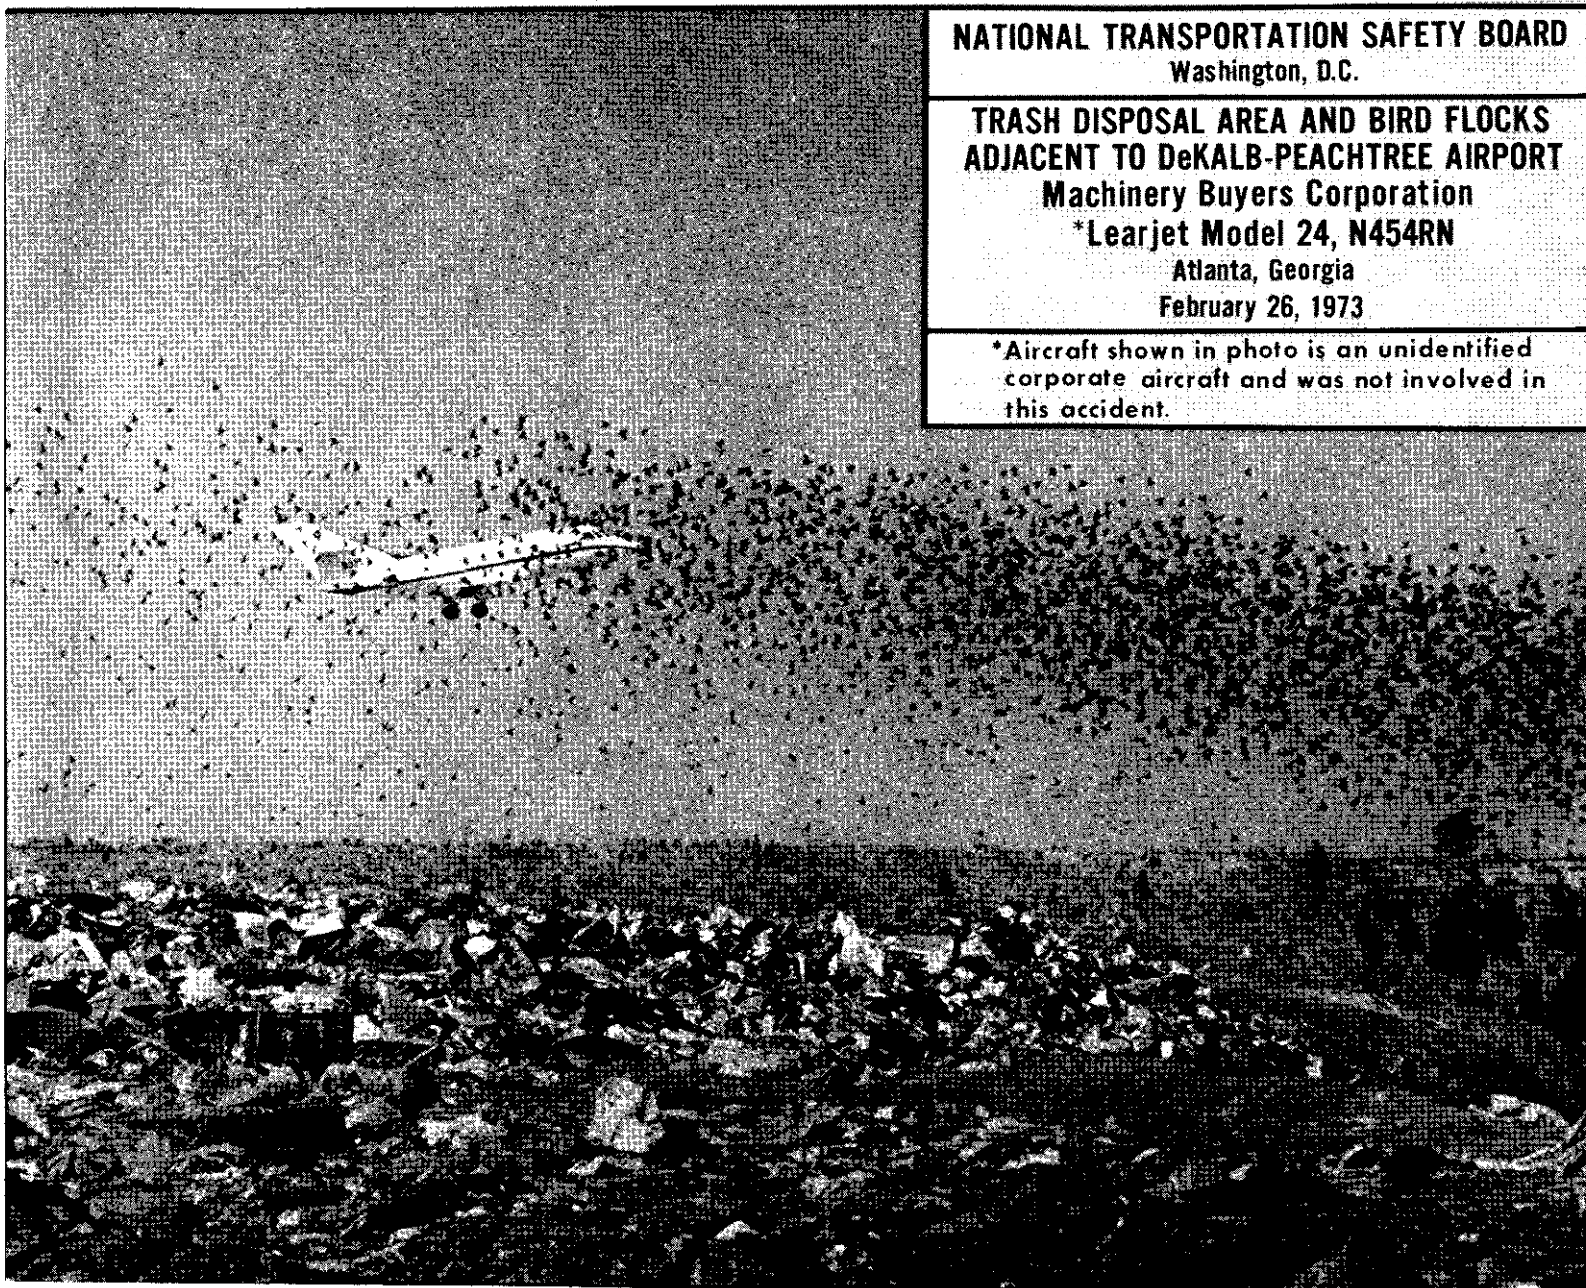
**TRASH DISPOSAL AREA AND BIRD FLOCKS  
ADJACENT TO DeKALB-PEACHTREE AIRPORT**  
**Machinery Buyers Corporation**  
**\*Learjet Model 24, N454RN**  
Atlanta, Georgia  
February 26, 1973

The area was used subsequently as a trash and garbage dump which attracted birds. (See Appendix C.) Under the provisions of FAA Order ASP5190.1, entitled "Compliance Requirements for Airports Developed or Improved with Federal Funds," the FAA advised the County in 1970 of the hazard to aviation presented by the dump. In the interim period, numerous communications were exchanged between the FAA and municipal authorities relative to this matter. In February 1971, the FAA was advised by the County that the dump would be closed by August 1972.

There is little doubt that the municipal dump located adjacent to the airport property attracts birds which are a serious hazard to aircraft. Local authorities did not close the dump by August 1972, as previously planned. The airport was returned to DeKalb County under Public Law 289 in 1960, and Federal funds were used for subsequent airport improvements in exchange for binding commitments designed to assure that the public interest would be served. In following-up on the compliance requirements for airports developed or improved with Federal funds, the FAA did not take adequate measures, in accordance with existing statutes, to assure that the hazard was removed from the vicinity of the airport.

\*Aircraft shown in photo is an unidentified corporate aircraft and was not involved in this accident.

1. Develop and implement a procedure for more stringent and continued surveillance of all facilities subject to the provisions of the "Airports & Airways Development Act" and impose timely sanctions against operators of facilities, which receive Federal aid and do not fully comply with the requirements imposed upon them by the provisions of this Act. (Recommendation No. A-73-36)

2. Disseminate by the widest possible distribution of FAA Advisory Circular 150/5200-3A dated March 2, 1972, subject "Bird Hazards to Aircraft," to ensure that all airport operators, air carriers, air taxi operators, flying schools, fixed-base operators, and airline transport, commercial, and private pilots, and flight instructors are fully aware of the hazards to aviation associated with bird strikes. (Recommendation No. A-73-37)
