NATIONAL  
TRANSPORTATION  
SAFETY  
BOARD

# AIRCRAFT ACCIDENT REPORT

AIR IOWA, INCORPORATED  
BEECH E18S, N310WA  
DAVENPORT, IOWA  
APRIL 19, 1973

REPORT NUMBER: NTSB-AAR-73-18

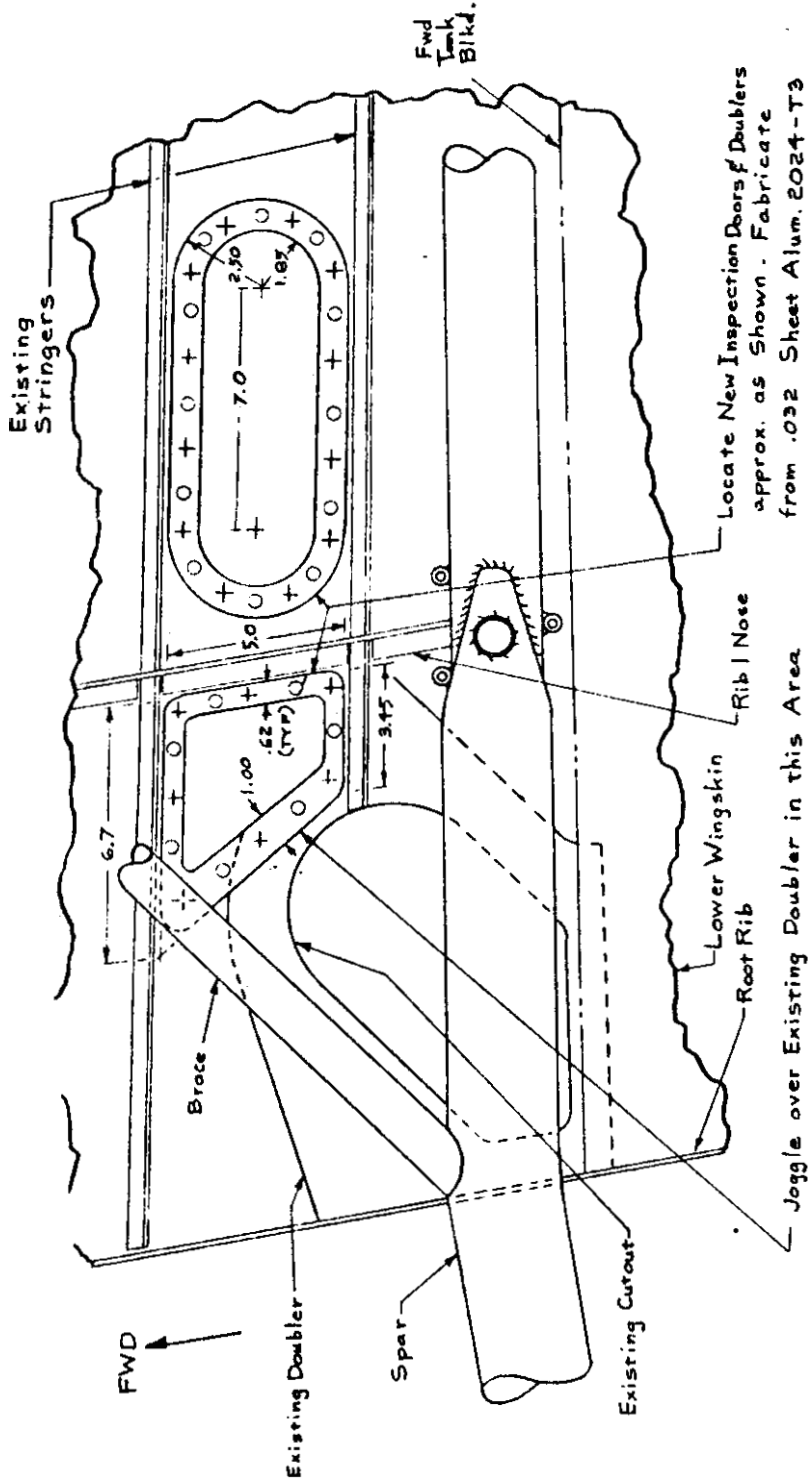
**FIGURE I**

R.H. WING SHOWN - VIEW LOOKING DOWN ON LOWER WINGSKIN & SPAR  
L.H. Opposite  
(Upper Wingskin Omitted for Clarity)

A) Modify the lower wing skin in accordance with Figure (1) or Figure (2) or an FAA-approved equivalent to facilitate the inspections specified in Paragraph B.

Drill #10(.200) hole thru new doors, wingskin & doublers as shown by (O) 19 places (approx. 2.4" spaces).  
 Attach (19) nutplates to doublers with countersunk AD3 rivets. (MK1000-3 Nutplates Recommended).  
 Attach doublers to skin with AD4 rivets shown by (+) 19 places (approx. 2.4" spaces).  
 Install doors on lower side with #10 screws 19 places.

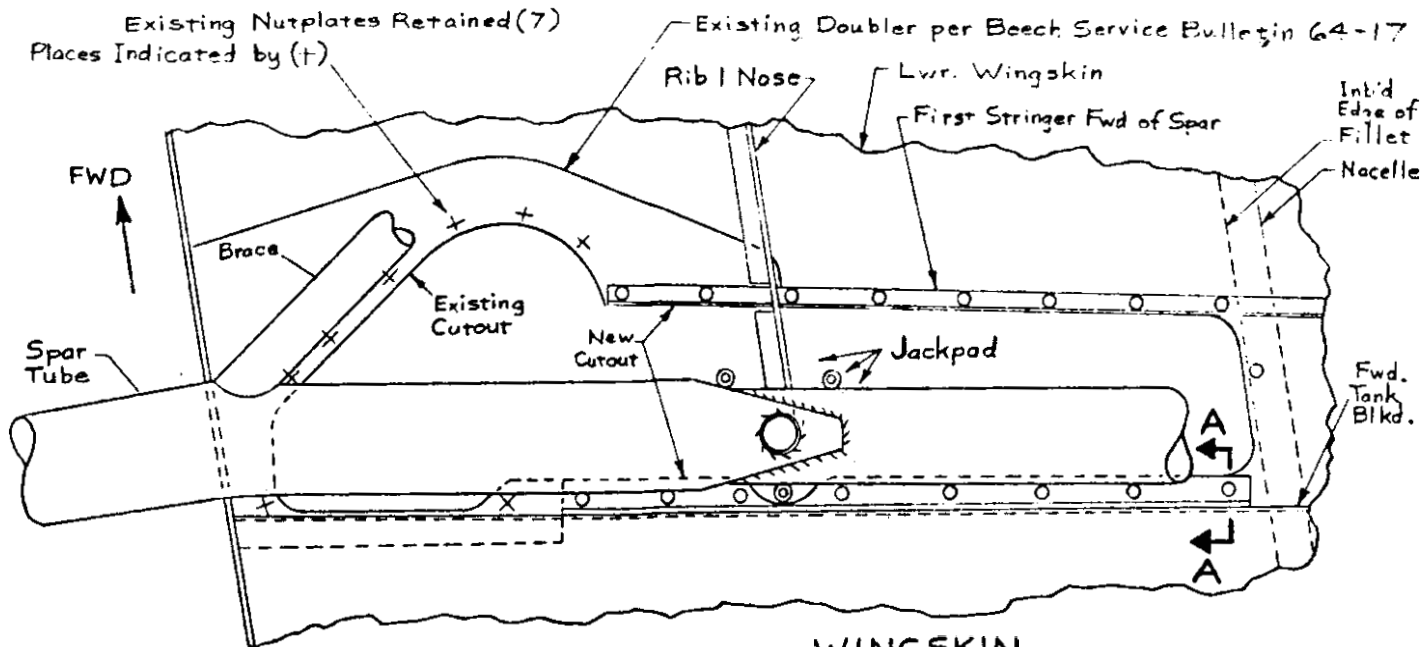
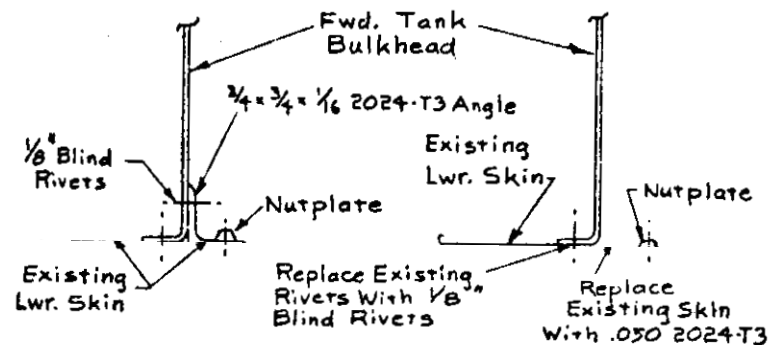
**FIGURE 2**

VIEW LOOKING DOWN ON LOWER WINGSKIN AND SPAR TUBE

VIEW A-A  
OPTIONAL MEANS OF ATTACHING  
INSPECTION PLATE AFT EDGE

Attach MK1000-3 Nutplates (or equiv.) (17 places) as shown by (O). Cut inspection door from .032 2024-T3 Alum. Allow 1/2" edge margin around all screws (min). Install door on lower side with #10 screws (25 places): cut three holes for jackpad access. Inspection door not shown.

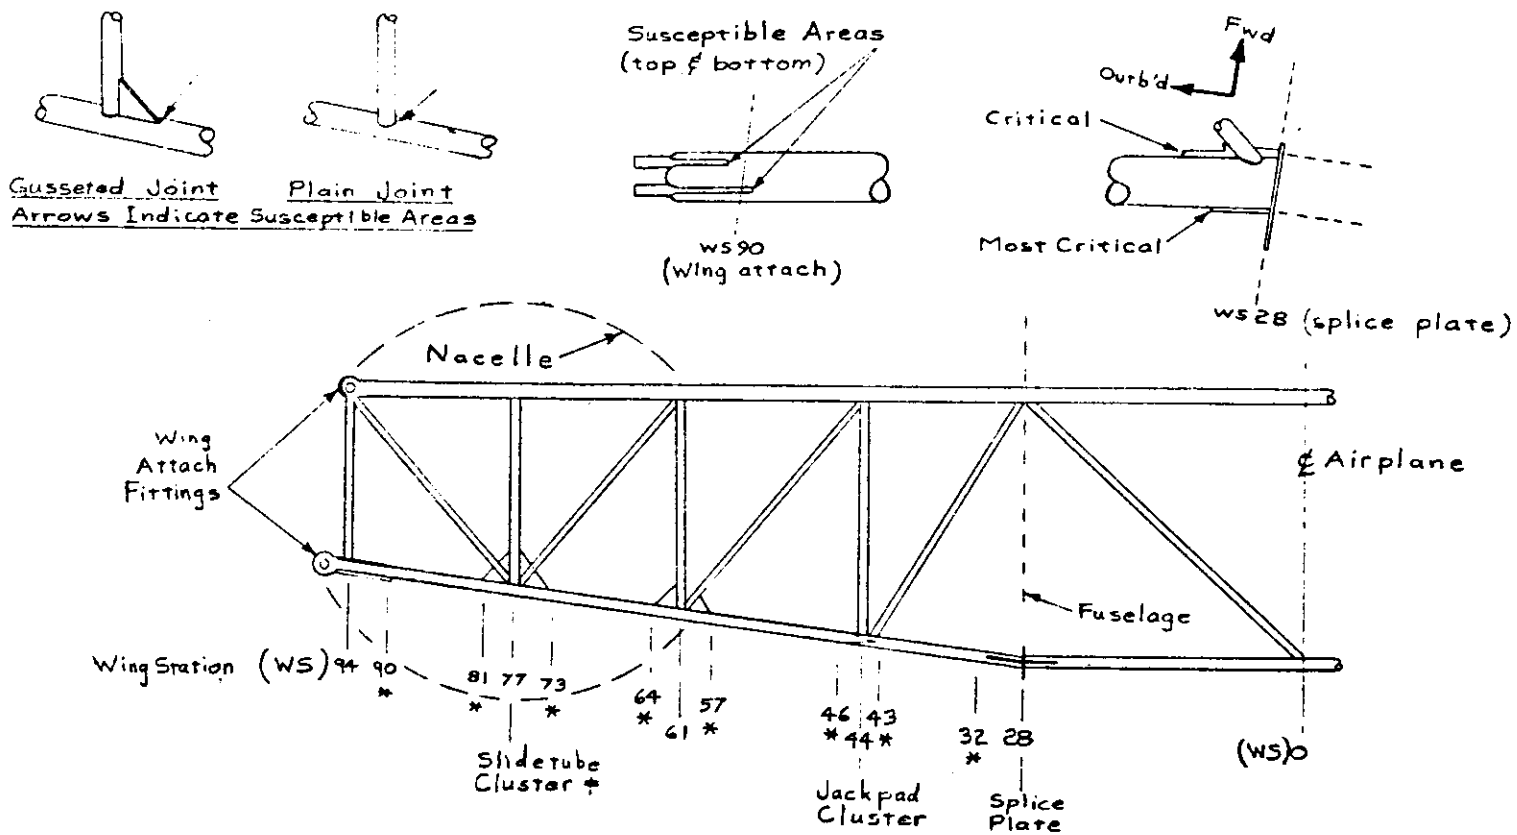
FIGURE 3

Half of Main Spar Center Section Truss

\* INDICATES AREAS TO BE INSPECTED PER THIS A.D.

B. (1) Inspect the front spar lower cap of the wing center section on each side of the airplane by methods specified below, except inspection sites reinforced by Beech Aircraft Corporation Kits 18-4024, 791 or 792 need not be inspected:

<u>Wing Station</u>	<u>Site (See Figure 3)</u>	<u>Method (See Para. C)</u>
90	Tips of welds at clevis tangs, upper and lower surfaces of cap	Visual, x-ray and either magnetic particle or penetrant
81, 73, 64 & 57	Tips of welds at gussets, upper surface of cap	" " "
46	Outboard ends of splice in cap, upper and lower surface of cap	" " "
32	Tips of welds at wing splice plate, fore and aft surfaces of cap	" " "
45 to 43	Tip of weld around cluster upper surface of cap	Visual and either magnetic particle or penetrant
61	Lower surface of spar cap below tube cluster, as seen from wheel well	" " "

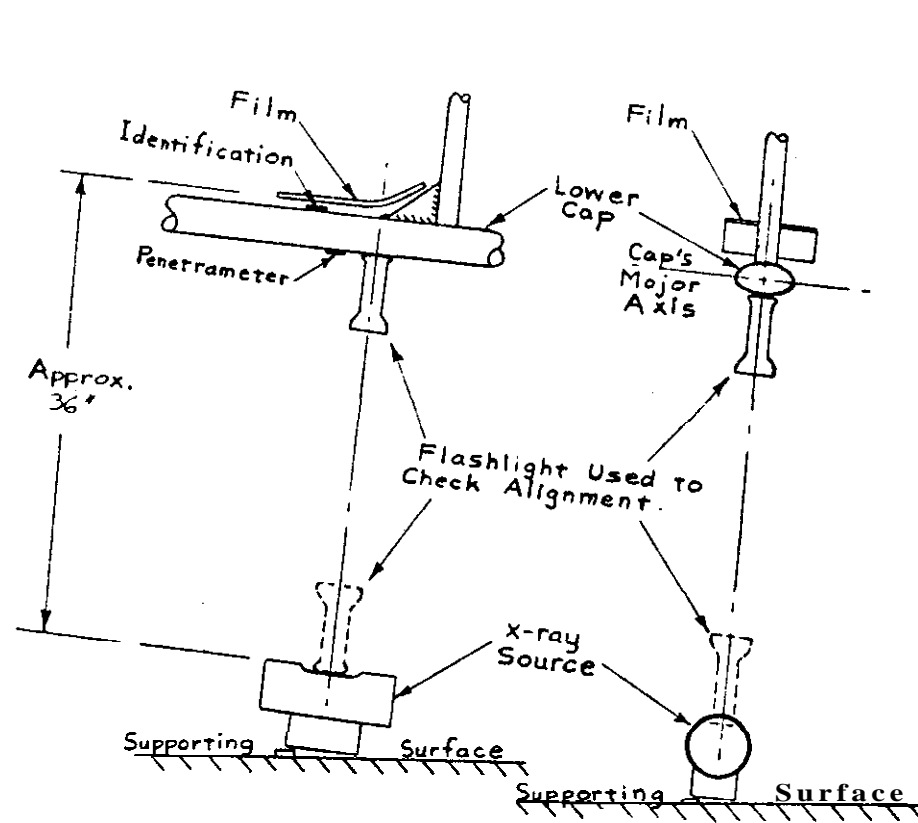
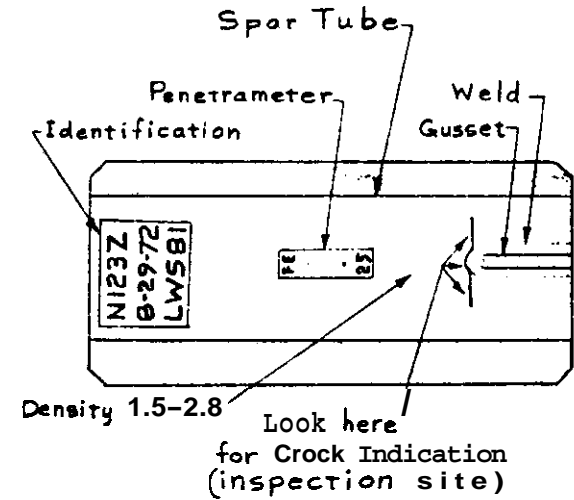
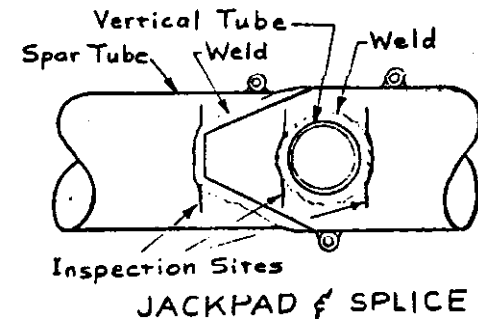
**FIGURE 4**

**FRONT VIEW**  
SHOWING SETUP FOR  
DIHEDRAL - TYPICAL  
GUSSETED JOINT

**SIDE VIEW**  
SHOWING SETUP FOR  
NOSE-UP ATTITUDE

**EXAMPLE of RADIOGRAPH**  
**TYPICAL CRACK SHOWN**  
**GUSSETED JOINT**

(4) For each site where x-ray inspection is specified by Paragraph B, accomplish x-ray inspection while the wing is loaded. Figure 4 is an aid to the following instruction. Place fine grain film (such as GAF 800, DuPont NDT-65 or Kodak AA) sandwiched between lead screens of 0.005-inch thickness on the upper surface of the spar cap (over an inspection site) with identification symbols for at least the site (e.g. LWS 81 etc.), date, and airplane registration number. Secure a steel penetrometer of 0.005-inch thickness to the lower surface

of the spar cap at a location clear of the inspection site. Position the x-ray source approximately 36 inches from and generally below the film so that the center of the x-ray beam will be perpendicular to the major axis of the elliptical spar cap and perpendicular to the spanwise centerline of the spar cap at each inspection site. Use a flashlight and a protractor level as necessary to see that aiming of the x-ray beam compensates for wing dihedral and nose up attitude. At those areas covered by aluminum skin, a locally fabricated jig may be used to position the x-ray source. Expose film so that density of the radiograph of the spar cap material near the inspection site is 1.5 to 2.8 on the densitometer or National Bureau of Standards density scale. View film to see that the inspection site, the 0.010 inch diameter hole in the penetrometer, and its entire outline are plainly shown. Using a low power magnifying device, examine the inspection site portion of each radiograph for faint indications of cracks in spar cap material transverse to the spanwise centerline.
