AIRCRAFT ACCIDENT REPORT

MCDONNELL-DOUGLAS DC-9-31, N8967E

**AKRON-CANTON REGIONAL AIRPORT,
NORTH CANTON, OHIO**

REPORT NUMBER: NTSB-AAR-74-12

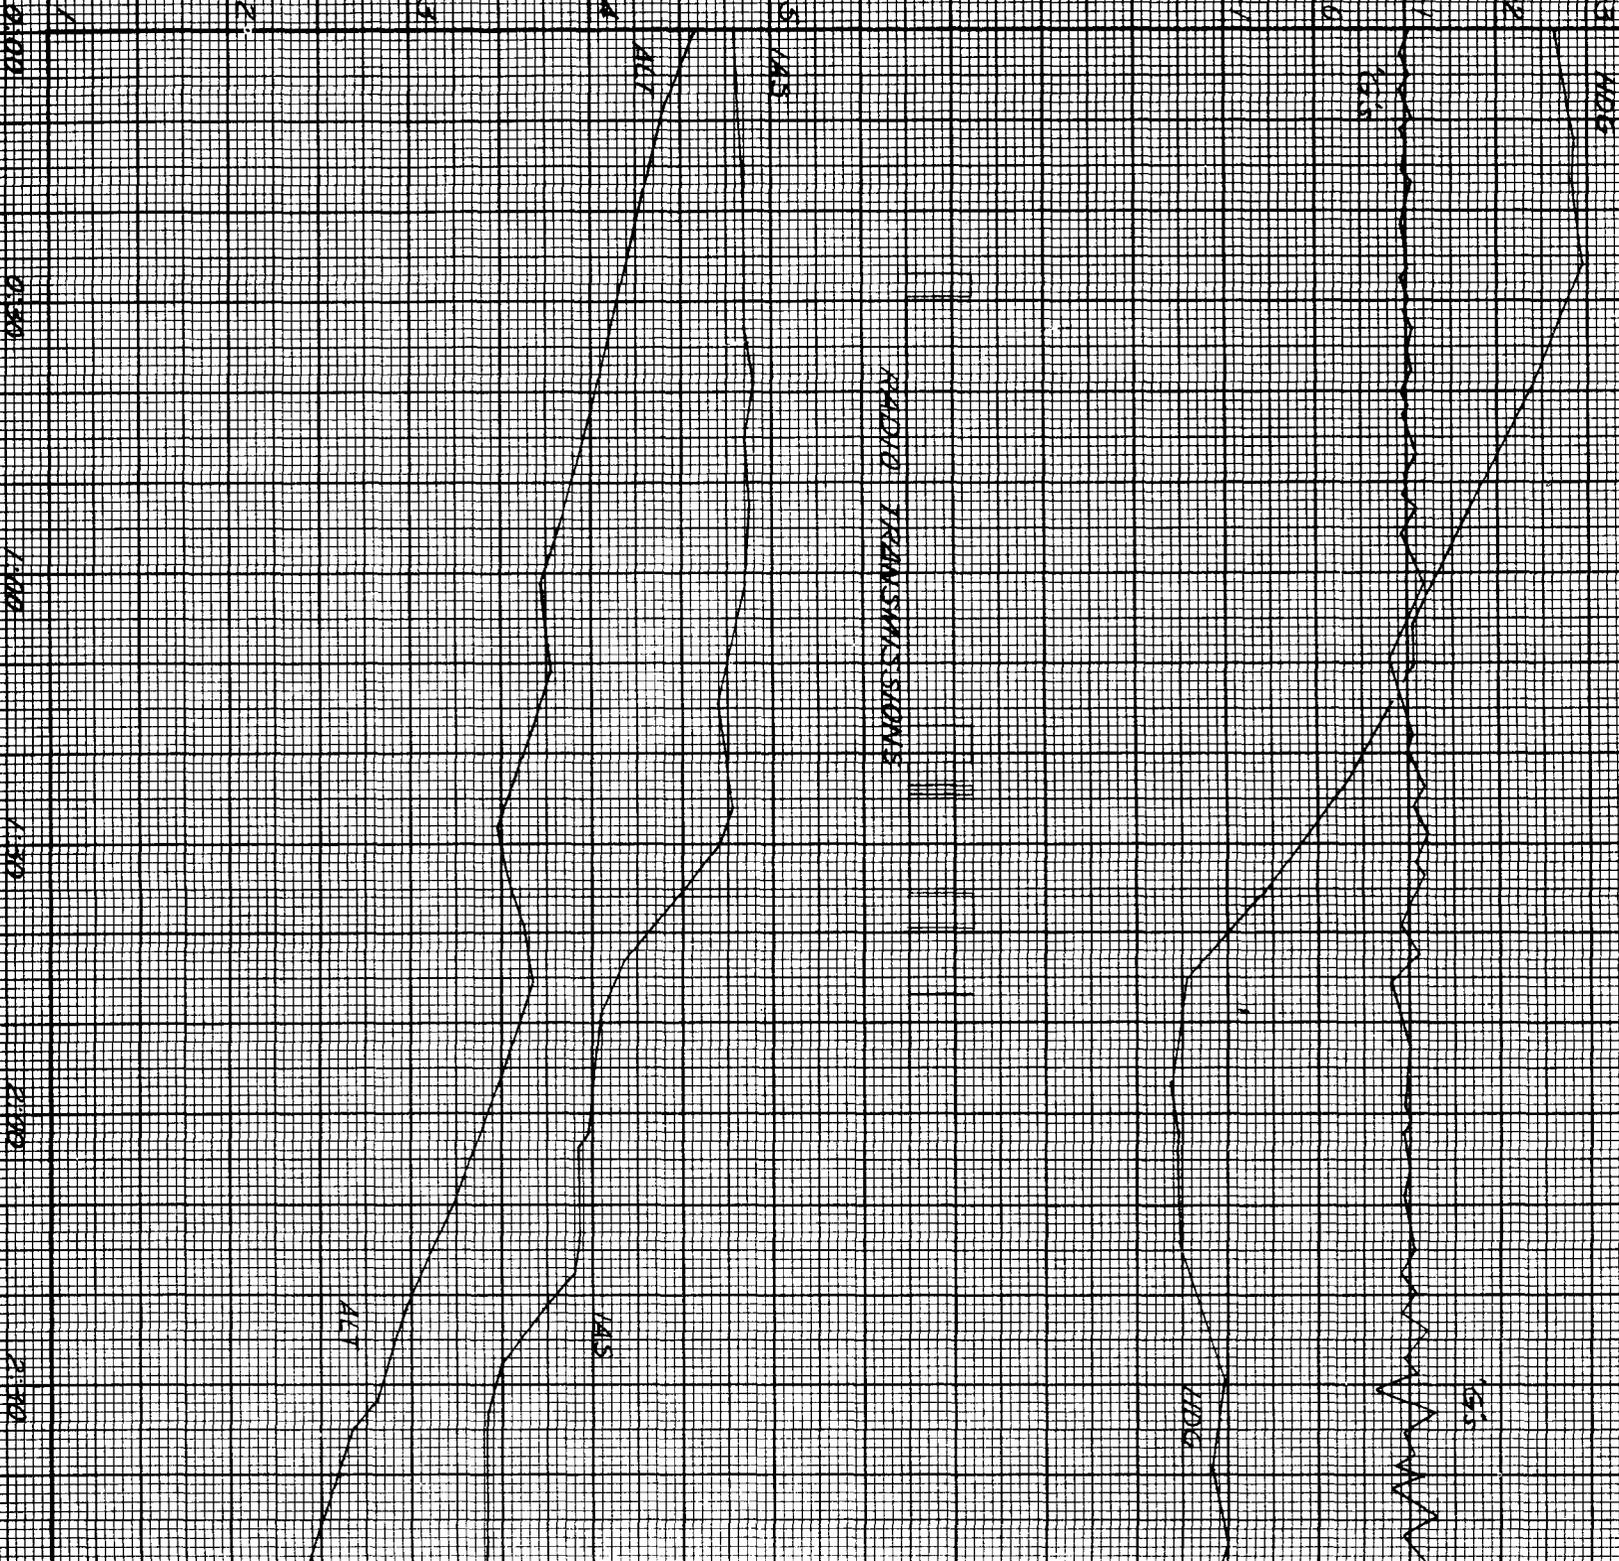
APPENDIX D

The flight data recorder airspeed trace disclosed that the indicated airspeed began increasing 35 seconds after the OM was passed. During the final minute of the approach, it increased steadily from 132 KIAS, and attained a maximum of 142 KIAS when the first officer called "Minimums." At touchdown, the airspeed trace was about 139 KIAS.

The average deceleration rate of EA 300 was about 6 feet/second². Over the last 400 feet of the runway, where evidence of viscous and reverted rubber hydroplaning was found, this rate decreased to 3 feet/second². This rate was achieved by applying brakes shortly after touchdown, using 80 percent N1 reverse thrust over the first portion of the landing roll, and full reverse thrust over the latter portion. Deceleration rates were computed from the manufacturer's wet runway stopping distances. The following table represents a comparison between these rates and EA 300's performance as noted above.
