AIRCRAFT ACCIDENT REPORT

PAN AMERICAN WORLD AIRWAYS, INC.

BOEING 707-321C, N458PA,

NOVEMBER 3, 1973

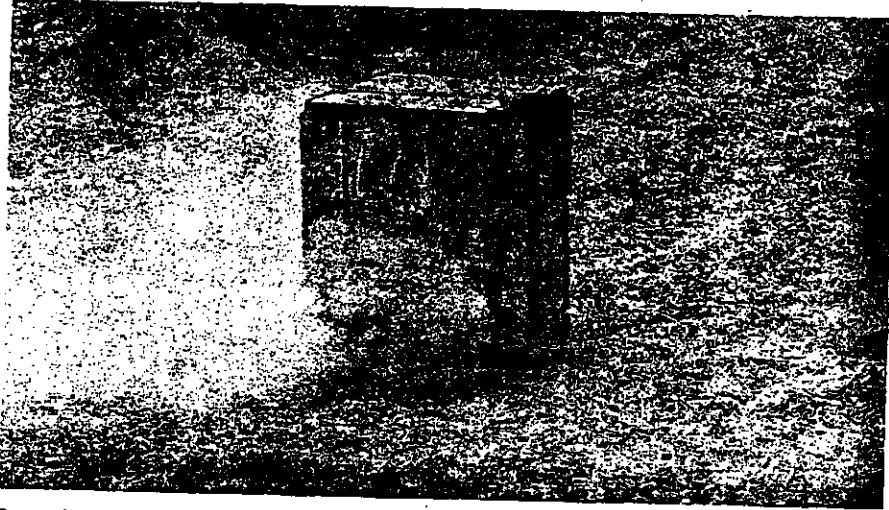
0 + 11 min.

<u>Time Lapse</u>	<u>Reaction</u>
7 min:	Bluish-white smoke was observed from around the lower surface on the container.
11 min:	The smoke downwind had an odor similar to that of burning wood.
13 min:	The white smoke flared profusely around the box and was orange momentarily.
15 min:	The quantity of smoke reduced.

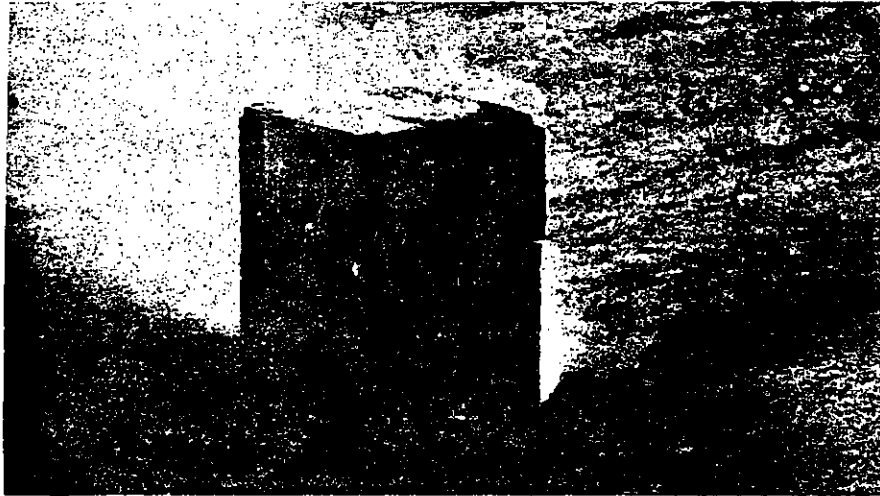
0 + 19 min.

<u>Time Lapse</u>	<u>Reaction</u>
17 min:	The odor of the smoke was similiar to that of burning wood.
19 1/2 min:	Flames were visible near the bottom of the box.
21 1/2 min:	Flames penetrated the top of the container.
