AIRCRAFT ACCIDENT REPORT

CONVAIR F106, 59-0044,

PIPER PA 24-250, N6876P,

MIDAIR COLLISION,

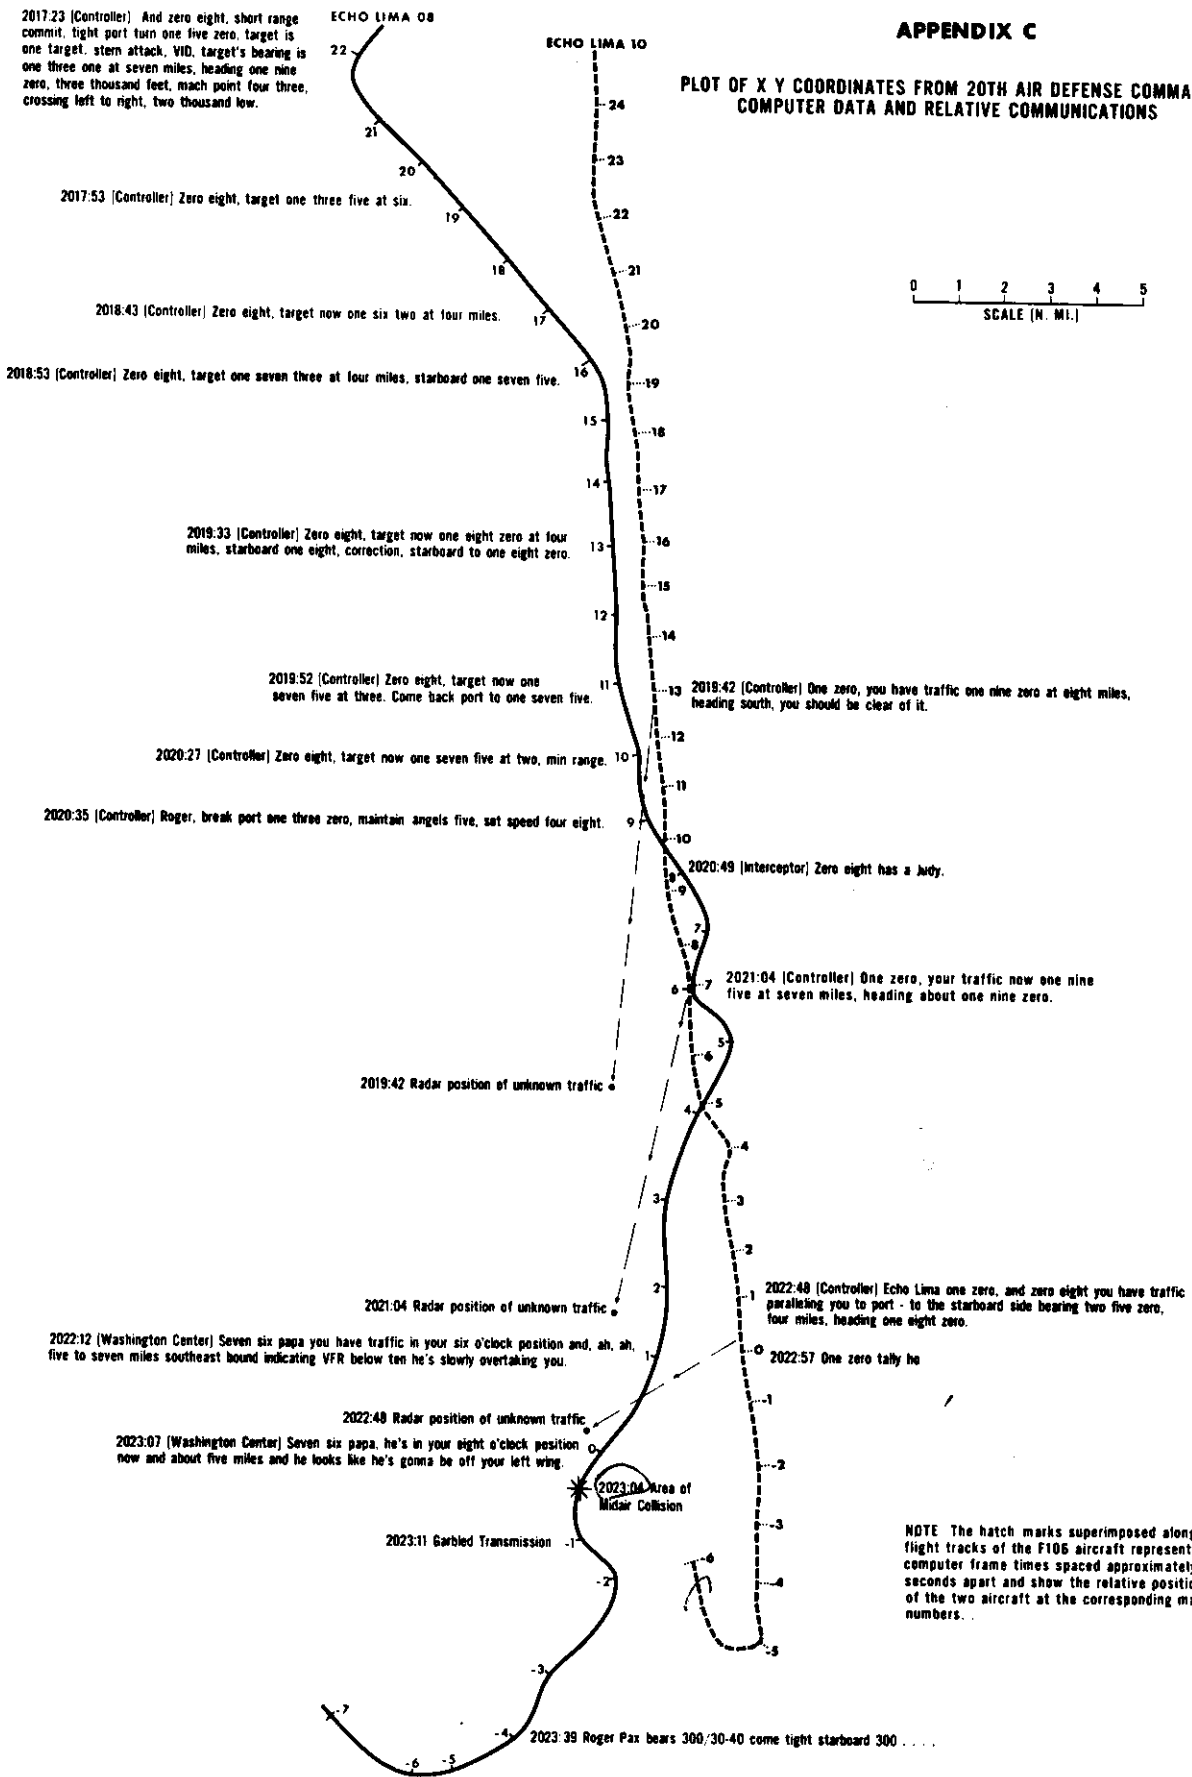
PLOT OF X Y COORDINATES FROM 20TH AIR DEFENSE COMMAND
COMPUTER DATA AND RELATIVE COMMUNICATIONS

The plot of X-Y coordinates generated by the NORAD computer radar, which was tracking EL08 and EL10, correlated with the pertinent communications, tends to confirm the probability that EL08 inadvertently intercepted N6876P instead of EL10.
