# AIRCRAFT ACCIDENT REPORT

USAF CONVAIR VT-29D (CV-340) AND

CESSNA 150H, N50430

REPORT NUMBER: NTSB-AAR-75-10

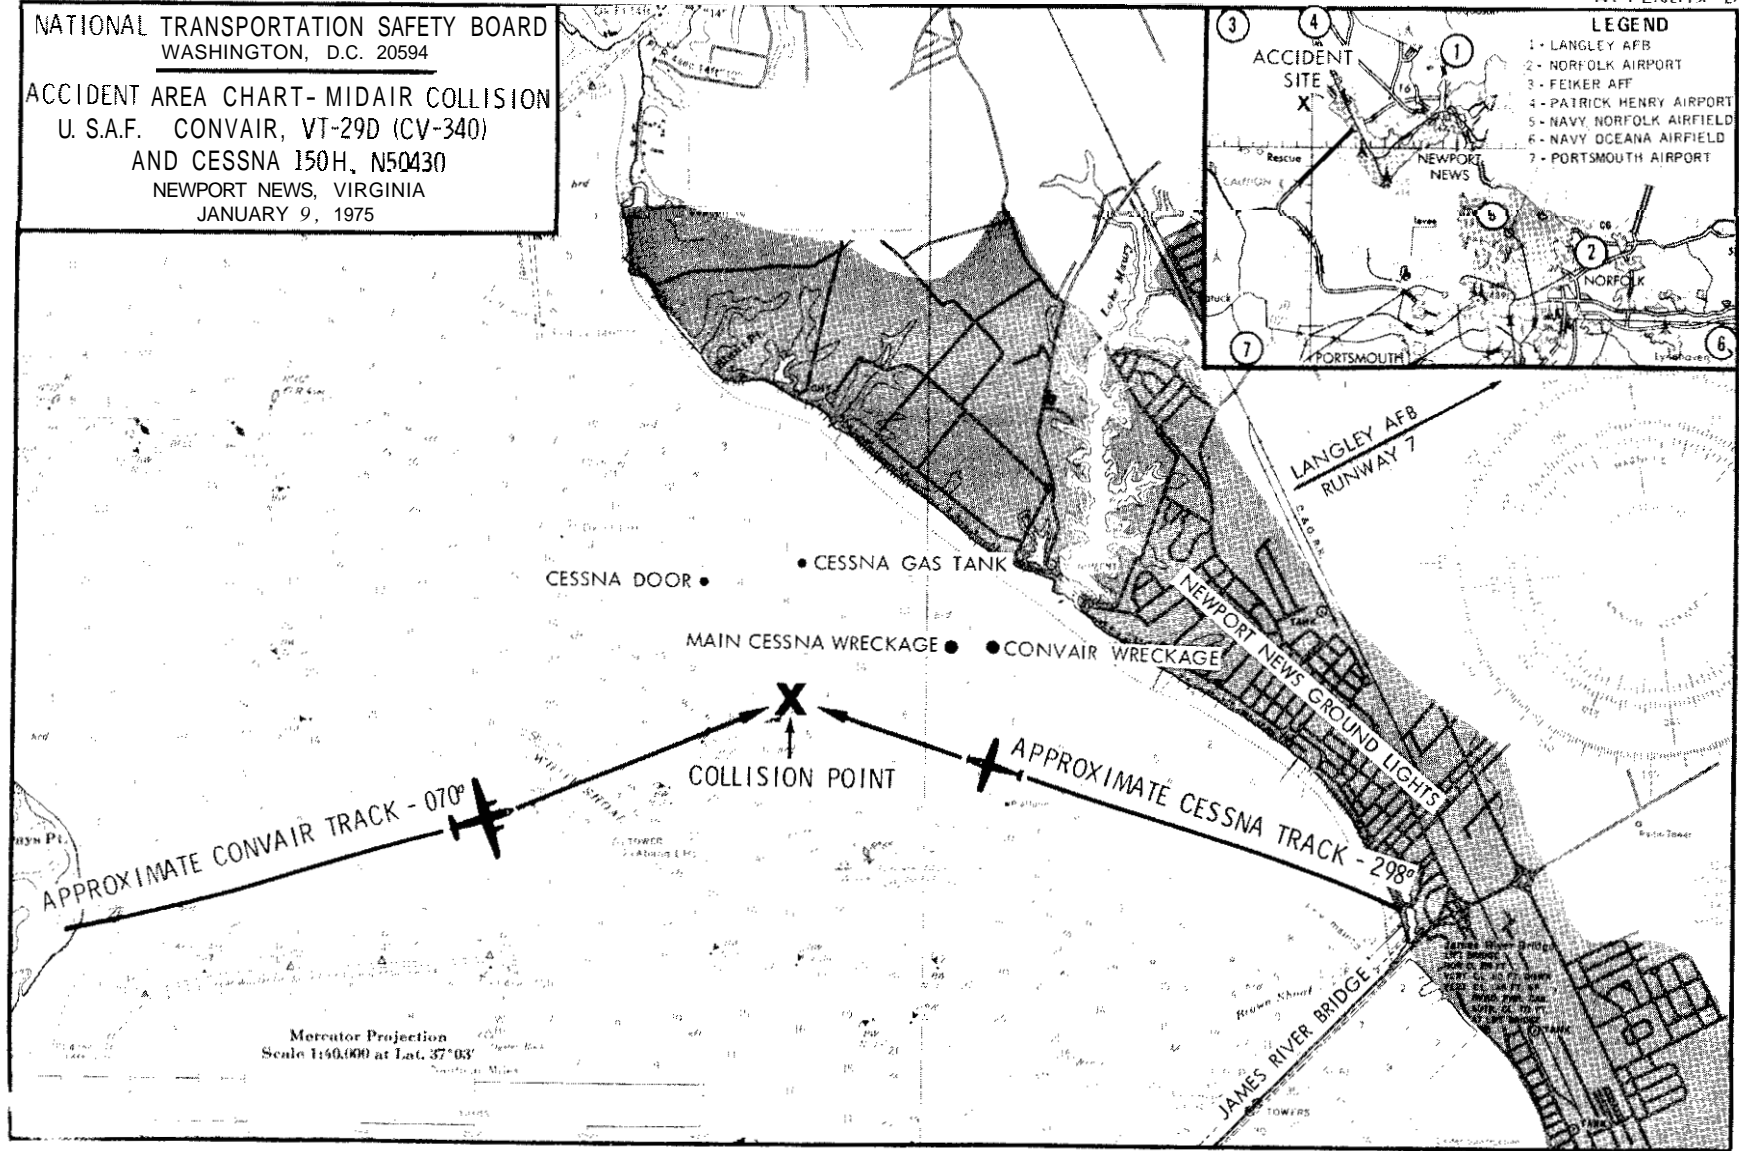
ACCIDENT AREA CHART-MIDAIR COLLISION  
U. S.A.F. CONVAIR, VT-29D (CV-340)  
AND CESSNA 150H, N50430  
NEWPORT NEWS, VIRGINIA  
JANUARY 9, 1975

The collision occurred at approximately 1836, during hours of darkness, at an altitude of 1,500 feet m.s.l., and at a point about 7 miles west of the threshold of runway 7 at Langley AFB. Both aircraft fell into the shallow waters of the James River tidal flat just west of Newport News, Virginia. The Convair wreckage was located at 37° 02' 15" latitude and 76° 29' 41" longitude. The main portion of the recovered Cessna wreckage was at 37° 02' 14" latitude and 76° 29' 54" longitude.

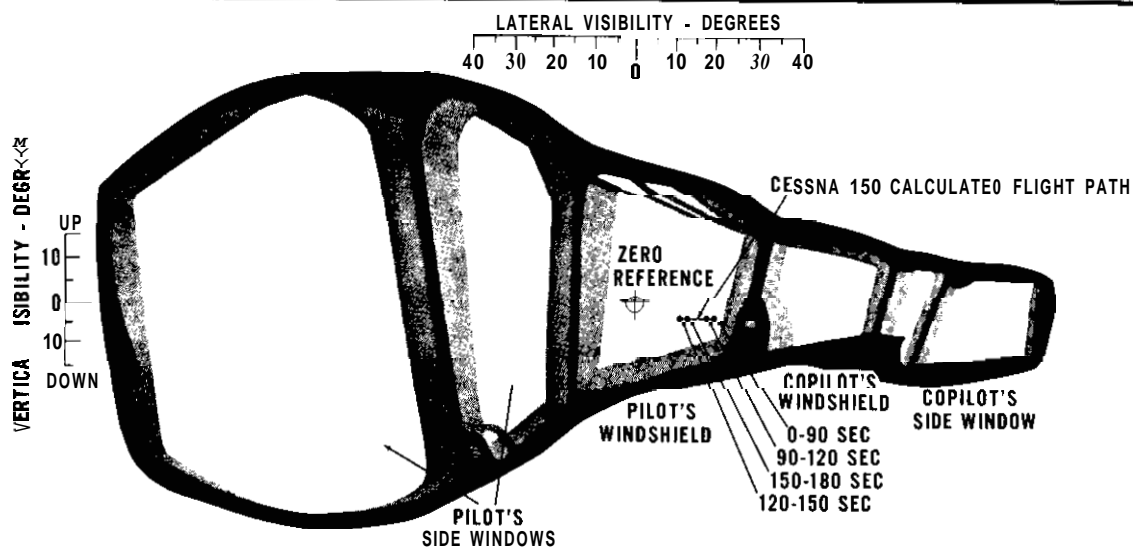
T-29 LEFT SEAT VISIBILITY FROM PILOT'S DESIGN EYE REFERENCE POINT

A visibility study was conducted to determine the field of vision from each cockpit. 5/ Cockpit visibility diagrams (Appendixes E and F) show the position of each aircraft in the field of vision of the occupants of the different cockpit seats. Any movement from the fixed eye position from where the photographs were taken would affect the location of the other aircraft in the viewer's field of vision.

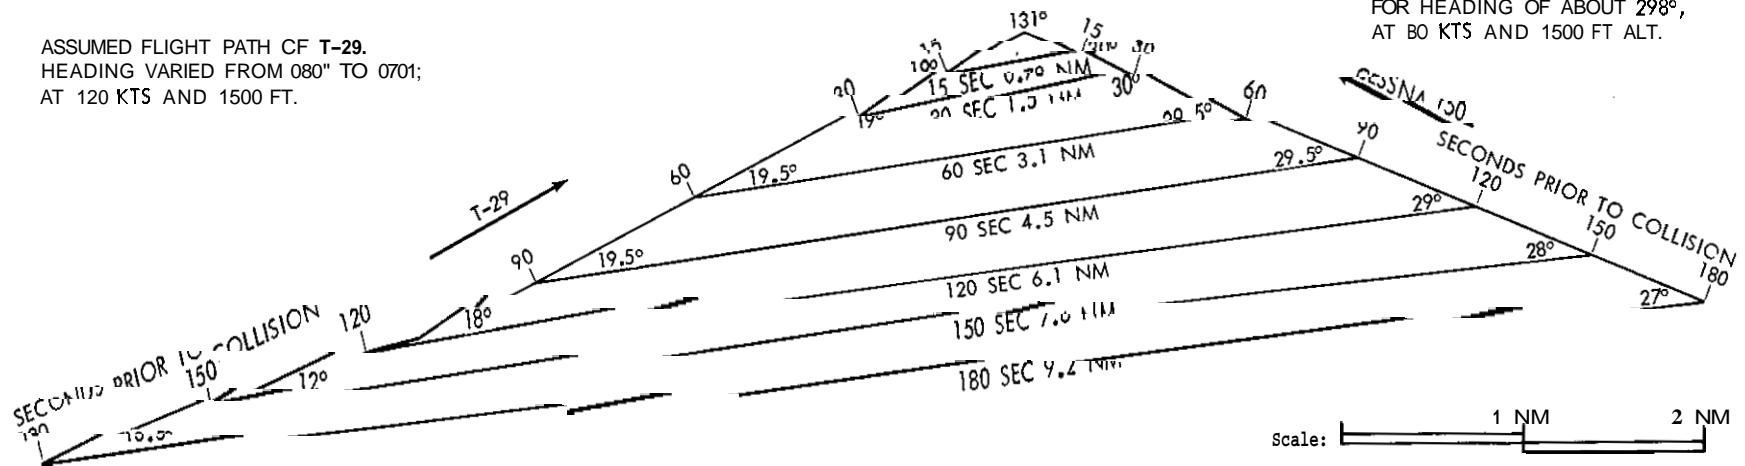
**RECONSTRUCTION OF PROBABLE FLIGHT PATHS IN FLIGHT COLLISION**  
**USAF T-29 AND CESSNA 150**  
NEWPORT NEWS, VIRGINIA  
JANUARY 9, 1975

At 1835:25, when the final controller informed the Convair crew that the traffic appeared slightly higher than the Convair on the precision radar, the time to collision was about 26 seconds and the closure distance was about 1.3 nmi. At this time the visual sight angle from the Convair to the Cessna was about 19°, and from the Cessna to the Convair about 30°. (See Appendix G for the reconstructed collision angle and visual sight lines from each aircraft.)

ASSUMED FLIGHT PATH OF T-29.  
HEADING VARIED FROM 080° TO 0701;  
AT 120 KTS AND 1500 FT.

ASSUMED FLIGHT PATH OF C-150  
FOR HEADING OF ABOUT 298°,  
AT 80 KTS AND 1500 FT.
