1. Report No. NTSB-AAR-76-2	2. Government Accession No.	3. Recipient's Catalog No.	
4. Title and Subtitle Aircraft Accident Report - Stribling-Puckett Inc., Beechcraft A100, N700SP, Hilton Head Island, South Carolina, April 26, 1975.		5. Report Date January 14, 1976	6. Performing Organization Code

AIRCRAFT ACCIDENT REPORT

STRIBLING-PUCKETT, INC.,  
BEEHCRAFT A100, N700SP  
HILTON HEAD ISLAND, SOUTH CAROLINA  
APRIL 26, 1975

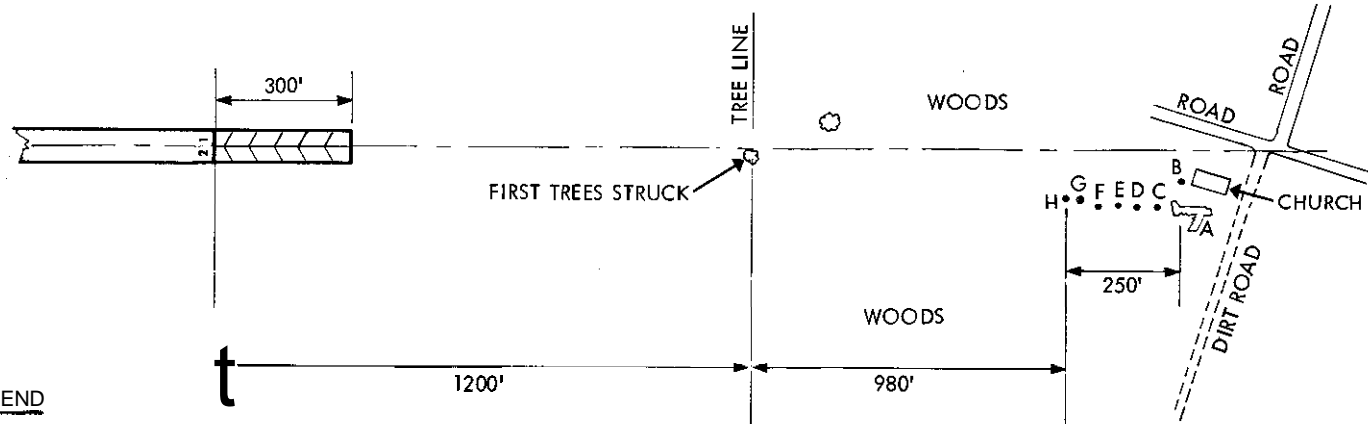
The fuselage came to rest upright on a magnetic heading of 035<sup>o</sup>; the top half was destroyed by fire and impact. The cockpit was damaged by impact and fire which destroyed most of its contents. (See Appendix D. )

- A. FUSELAGE, RT. WING & ENGINE
- B. LT. PROPELLER
- C. RT. PROPELLER
- D. HORIZONTAL TAIL SURFACES
- E. LT. ENGINE
- F. LT. MAIN GEAR
- G. 3FT. DIA. OAK TREE
- H. SECTION LT. WING & LT. FLAP IN TREE
