1. Report No. NTSR-AAR-76-3		2. Government Accession No.		3. Recipient's Catalog No.	
4. Title and Subtitle Aircraft Accident Report - Near Collision, American Airlines, Inc., Douglas DC-10, N124 and Trans World Airlines, Inc., Lockheed 1011, N11002, Near Carleton, Michigan, November 26, 1975		5. Report Date January 28, 1976		6. Performing Organization Code

AIRCRAFT ACCIDENT REPORT

NEAR MIDAIR COLLISION  
AMERICAN AIRLINES, INC., DOUGLAS DC10, N124  
AND  
TRANS WORLD AIRLINES, INC., LOCKHEED-1011, N11002  
NEAR CARLETON, MICHIGAN  
NOVEMBER 26, 1975

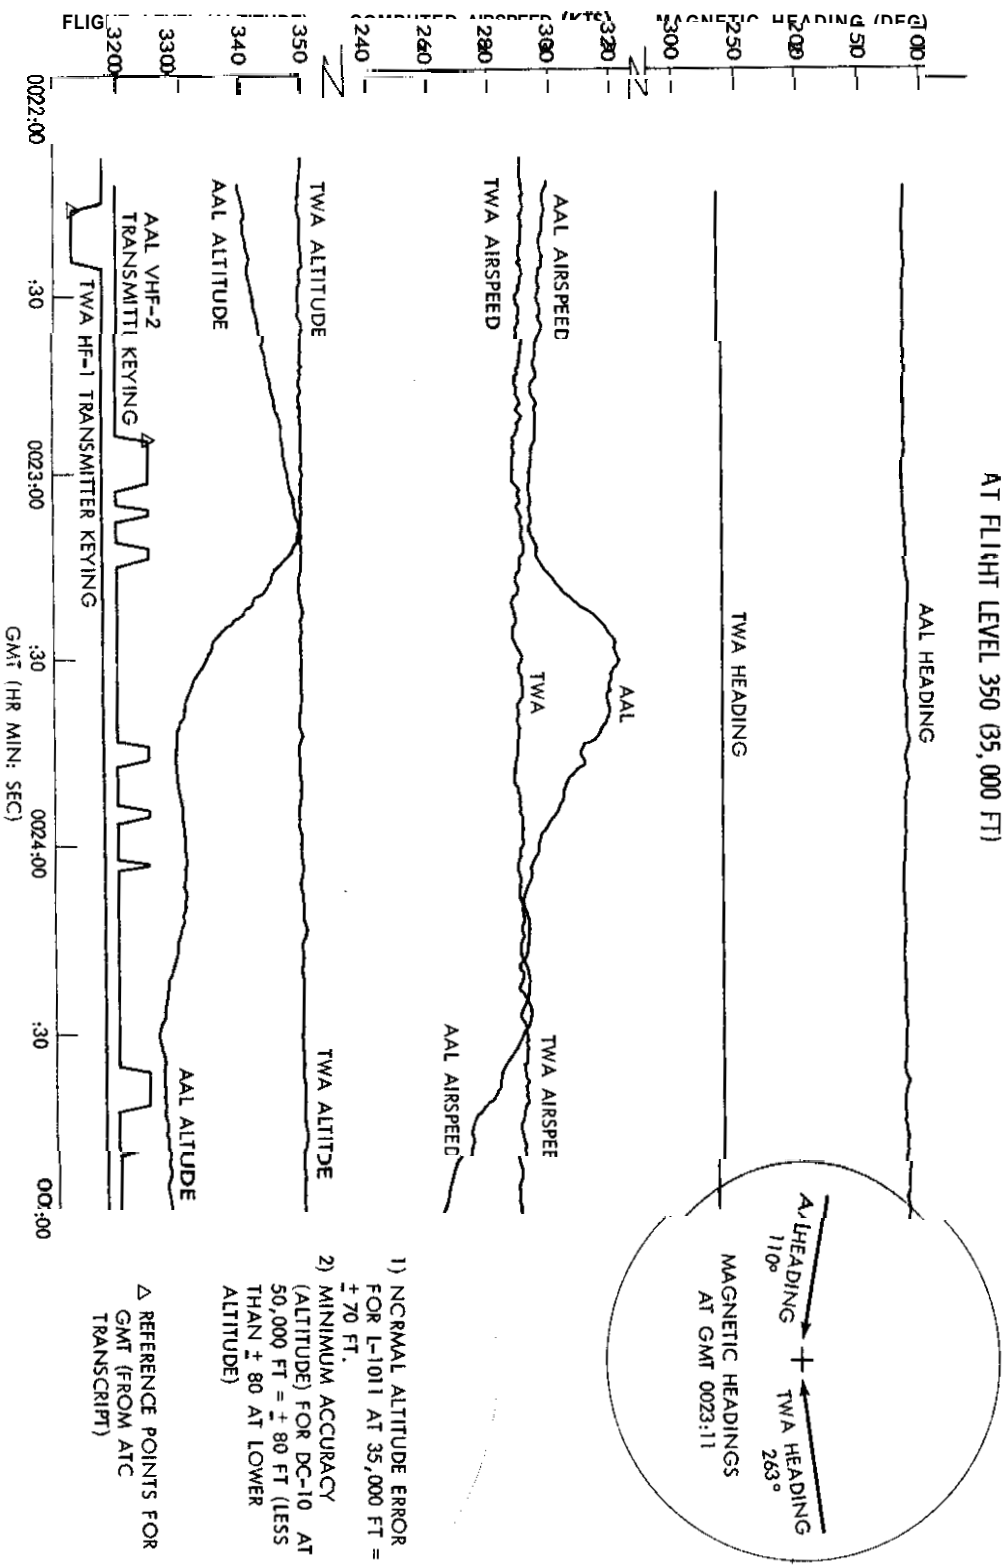
APPENDIX C

Thirty seconds after the evasive maneuver was started, the aircraft had reached **FL** 330. A maximum pressure altitude of 34,953 ft. was reached 4 seconds after the downward pitch movement began. At this time (1923:11) TWA 37's pressure altitude was 34,965 ft. (See Appendix C.)

The NAS Stage A radar positions for the two targets were interpolated to 1/2-second intervals for the 20 seconds from 1923:00 to 1923:20. The interpolation showed that at 1923:16.5 the targets of TWA 37 and American 182 converged to within 0.108 nmi. This figure is within the range of the resolution of the radar equipment which is specified to be accurate to 1/8 nmi. in range and about  $1/10^\circ$  in azimuth. TWA 37 was reporting a constant flight level of 350 and American 182 reported **FL** 349 at 1923:08.0. At 1923:20.0 American 182's beacon reported **FL** 345.

AMERICAN AIRLINES DC-10, N124, FLIGHT 182  
 TRANS WORLD AIRLINES L-1011, N11002, FLIGHT 37  
 NOVEMBER 26, 1975  
 23 NMI W OF CARLETON VORTAC, MICHIGAN  
 AT FLIGHT LEVEL 350 (35,000 FT)
