1. Report No. NTSB-AAR-76-9		2. Government Accession No.		3. Recipient's Catalog No.	
4. Title and Subtitle Aircraft Accident Report - Aerotransportes Entre Rios S.R.L. Canadair CL-44-6, LV-JSY, Miami International Airport, Miami, Florida, September 27, 1975				5. Report Date March 10, 1976

AIRCRAFT ACCIDENT REPORT

AEROTRANSPORTES ENTRE RIOS S.R.L.  
CANADAIR CL-44-6, LV-JSY  
MIAMI INTERNATIONAL AIRPORT  
MIAMI, FLORIDA  
SEPTEMBER 27, 1975

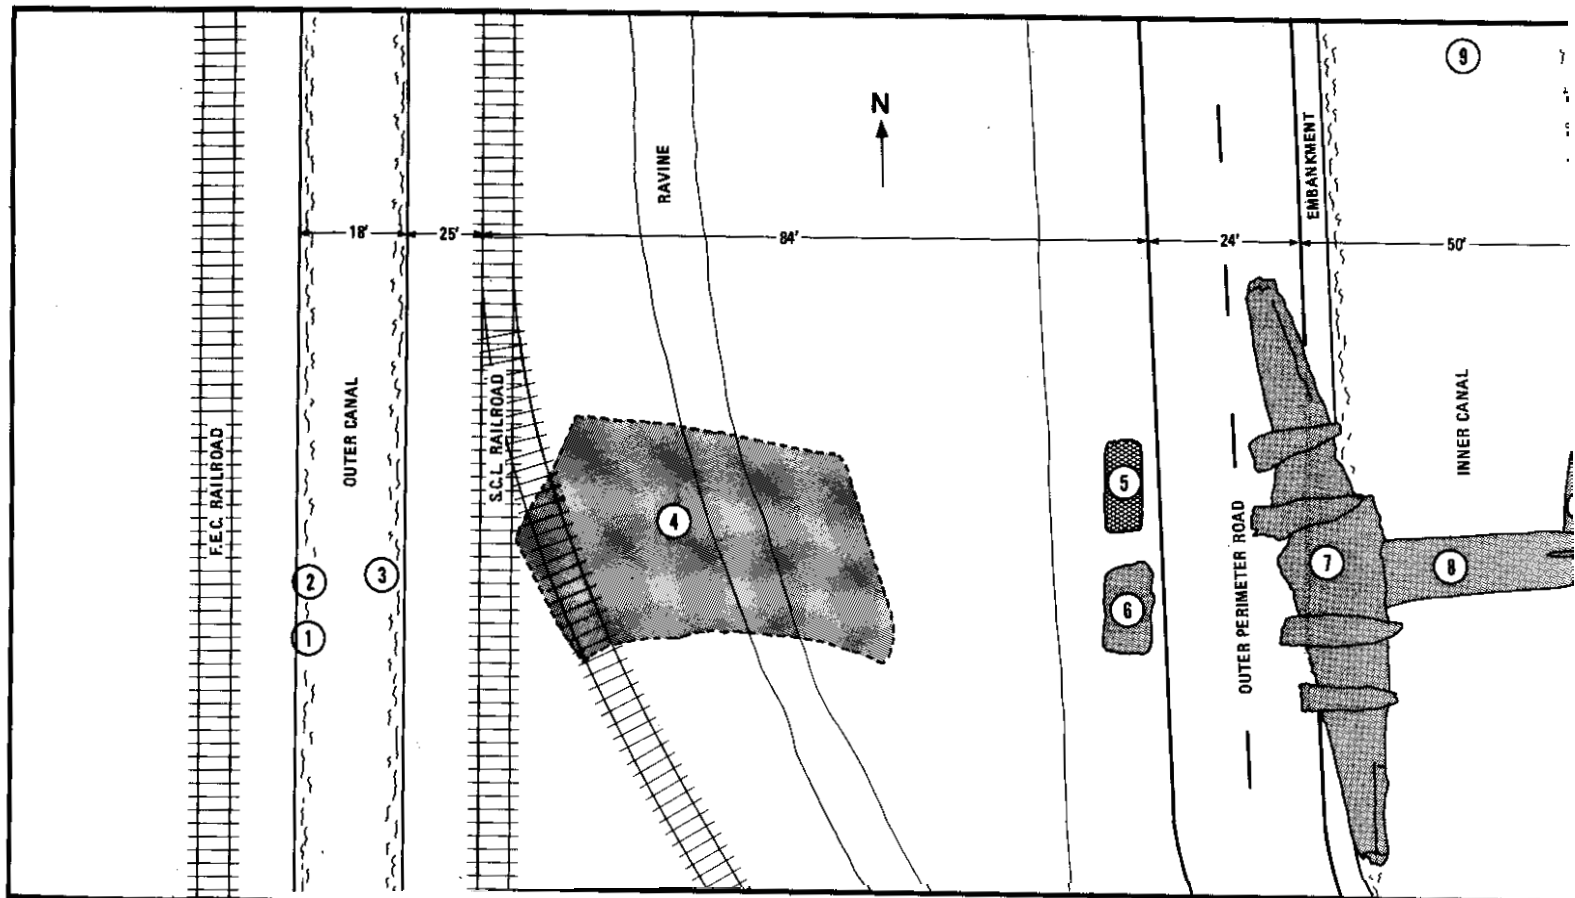
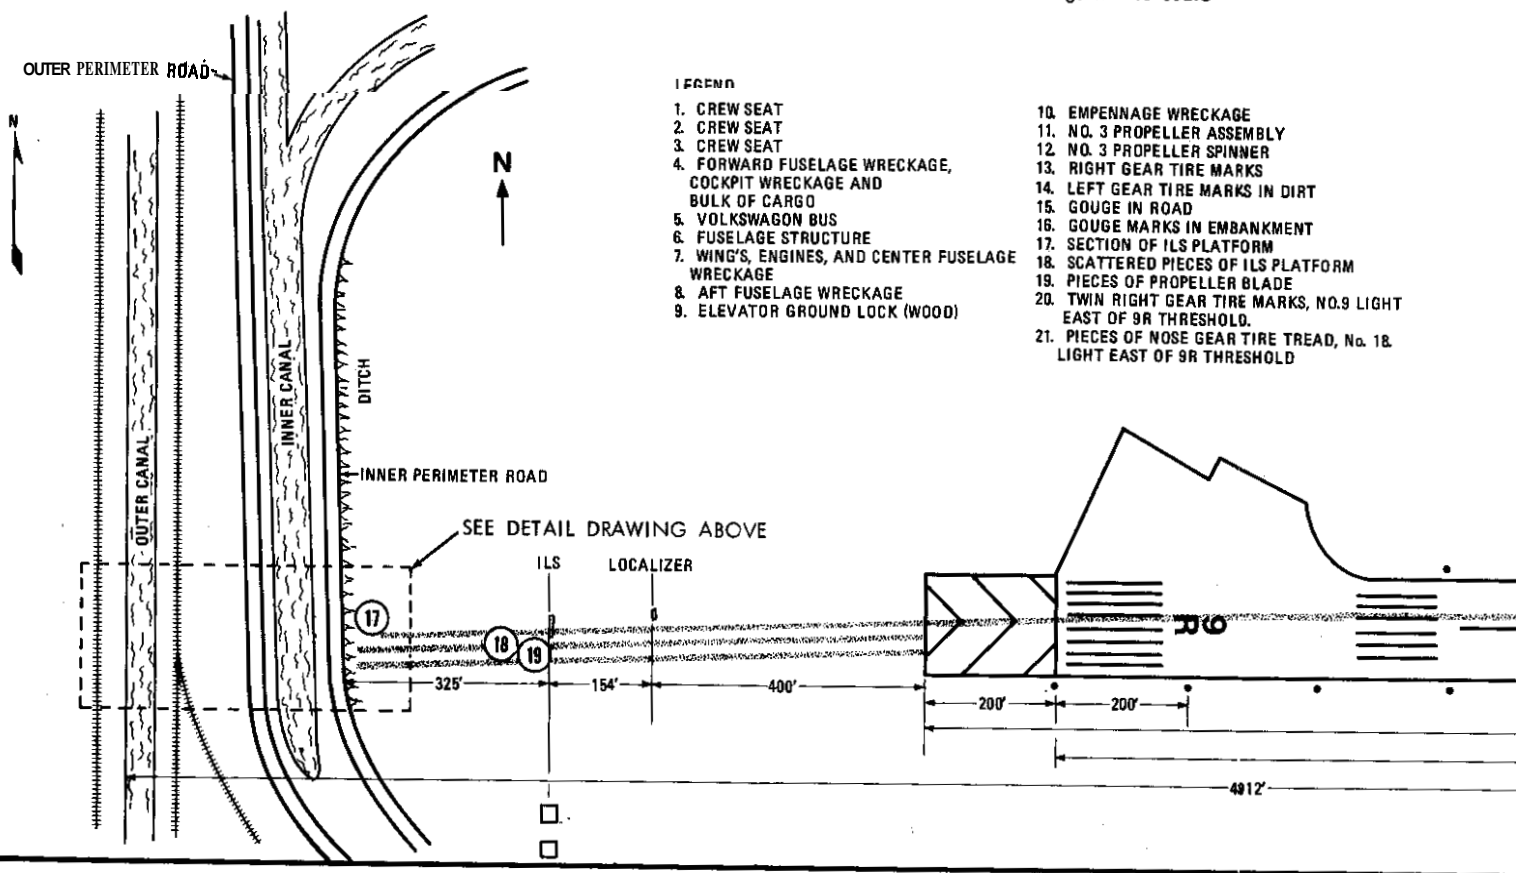
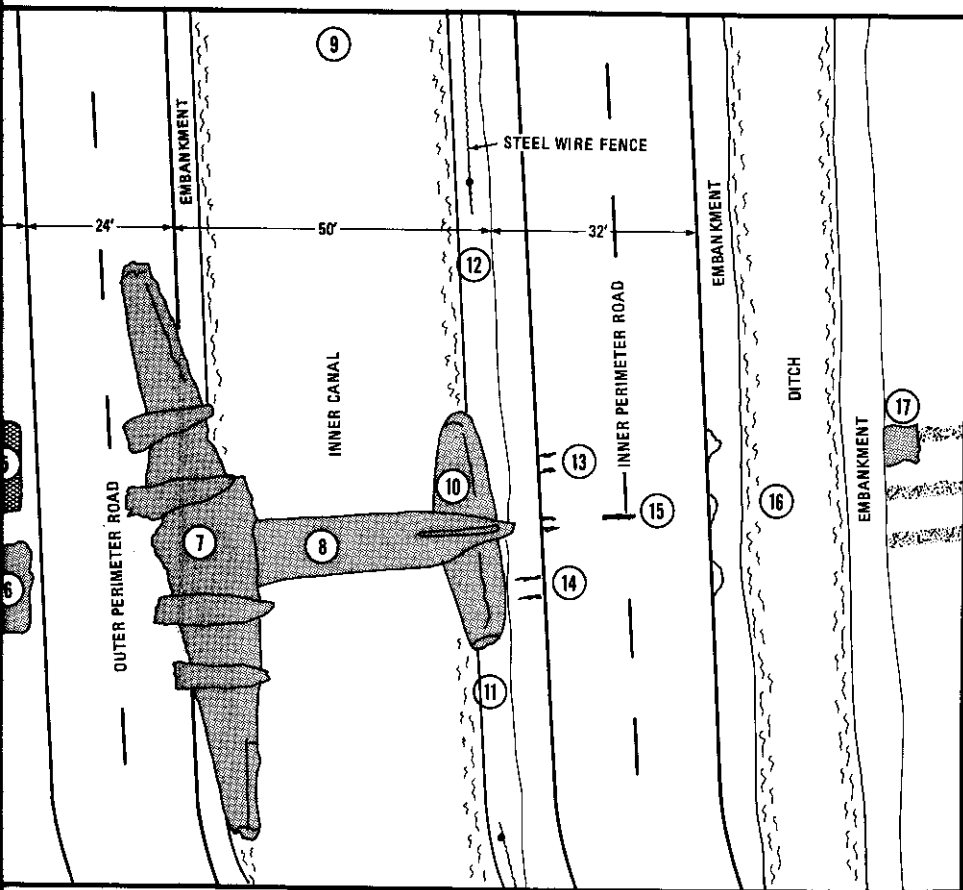
**WRECKAGE DISTRIBUTION CHART**  
**AEROTRANSPORTES ENTRE RIOS**  
**CANADAIR CL-44-6, LV-JSY, S/N106925**  
**MIAMI INTERNATIONAL AIRPORT**  
**MIAMI, FLORIDA**  
**SEPTEMBER 27, 1975**  
**DCA 76-Ai!-005**

The empennage came to rest on the east bank of a canal 961 ft. from the departure end of the runway. The fuselage was across the canal and the center section, wings and engines were on its west bank. The fuselage forward of the wing, the cargo in the cabin, and the occupants were found west of the canal. (See Appendix D.)

- EMPELLAGE WRECKAGE
- N. 3 PROPELLER ASSEMBLY
- N. 3 PROPELLER SPINNER
- RIGHT GEAR TIRE MARKS
- LEFT GEAR TIRE MARKS IN DIRT
- GOUGE IN ROAD
- GOUGE MARKS IN EMBANKMENT
- SECTION OF ILS PLATFORM
- SCATTERED PIECES OF ILS PLATFORM
- PIECES OF PROPELLER BLADE
- TWIN RIGHT GEAR TIRE MARKS, N. 9 LIGHT
- EAST OF 9R THRESHOLD.
- PIECES OF NOSE GEAR TIRE TREAD. N. 18
- LIGHT EAST OF 9R THRESHOLD
