1. Report No. NTSB-AAR-76-11	2. Government Accession No.	3. Recipient's Catalog No.	
4. Title and Subtitle Aircraft Accident Report - Airlift International, Inc., McDonnell-Douglas DC-8-63F, N6161A, John F. Kennedy International Airport, Jamaica, New York, Sept. 20, 1975		5. Report Date March 24, 1976

AIRCRAFT ACCIDENT REPORT

AIRLIFT INTERNATIONAL, INC.
McDONNELL-DOUGLAS DC-8-63F, N6161A
JOHN F. KENNEDY INTERNATIONAL AIRPORT
JAMAICA, NEW YORK
SEPTEMBER 20, 1975

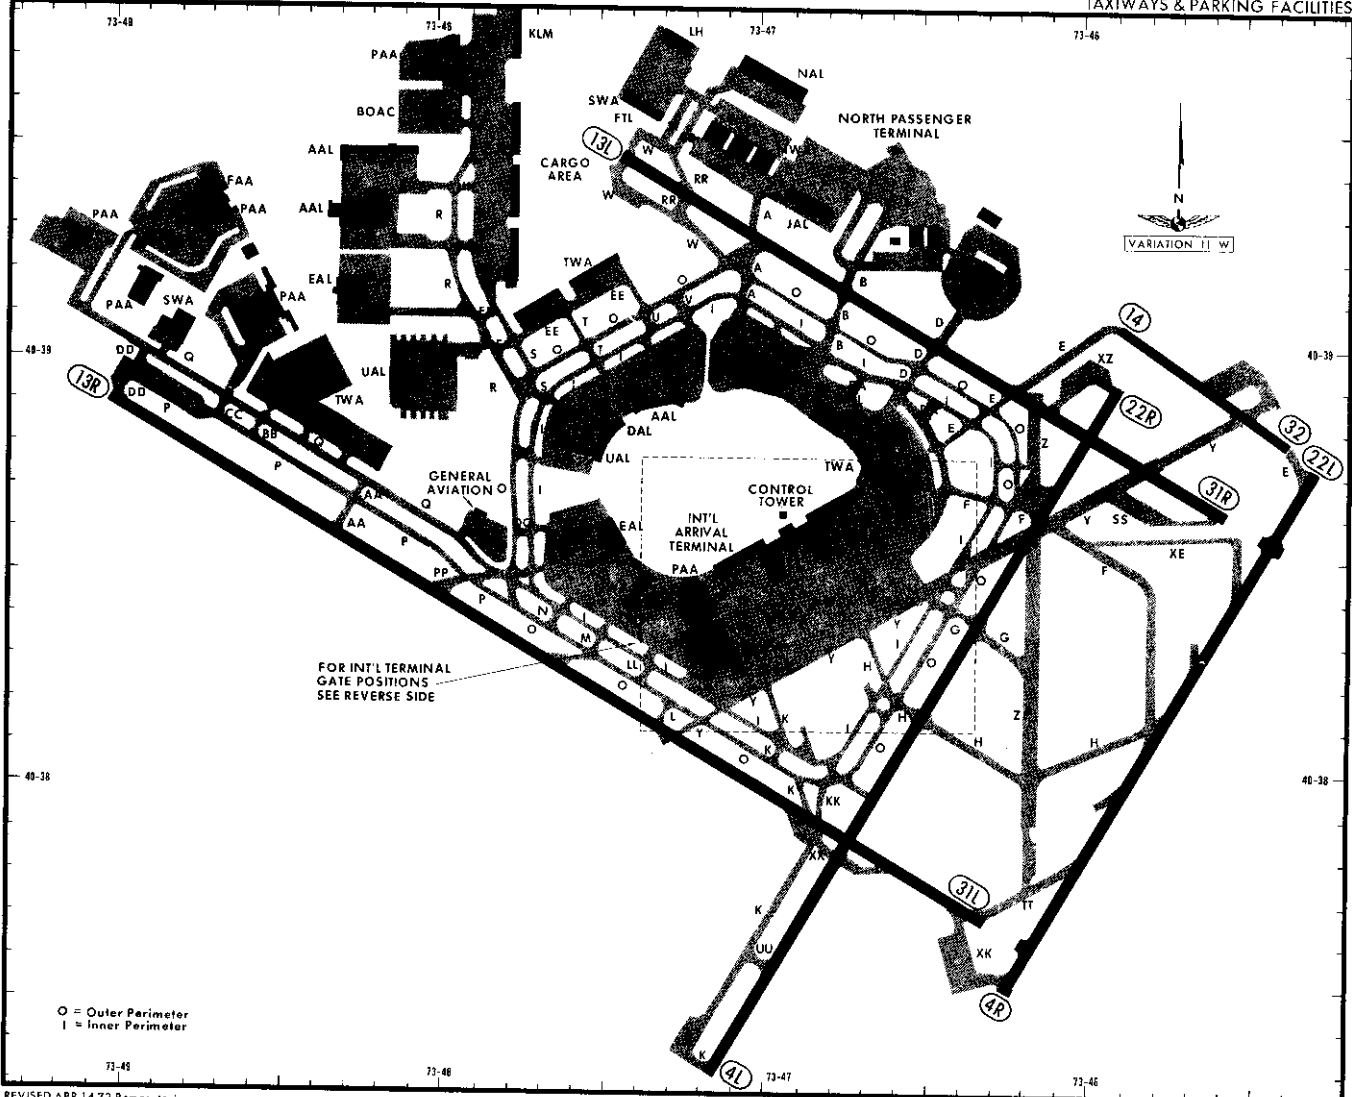
APPENDIX D

The captain stated that while he was occupied in taxiing the aircraft toward runway 22L in low-visibility conditions, he requested that the first officer "check" and see if the runway was adequate for takeoff. The first officer then looked at the Jeppesen taxiway and parking facilities chart (see Appendix D) and advised the captain that runway 22L was acceptable. This chart does not contain runway limitations data. However, the applicable chart in the Runway Analysis Manual (see Appendix E), which is carried in the aircraft and which was available to the flightcrew, stated that the maximum allowable takeoff weight **on** runway 22L for the DC-8-63F airplane with JT3D-7 engines and configured with flaps of 23°, when computed at 68°F and 0 wind, was 314,800 lbs. The crewmembers did not refer to the Runway Analysis Manual.

Because the captain was occupied with taxiing in restricted visibility conditions, the responsibility for determining whether runway 22L was adequate for takeoff was assigned to the first officer. Instead of checking the appropriate data contained in the Runway Analysis Manual, the first officer looked at a taxiway and parking facilities chart which did not contain sufficient information from which to make this determination.
