1. Report No. NTSB-AAR-76-12	2. Government Accession No.	3. Recipient's Catalog No.	
4. Title and Subtitle Aircraft Accident Report - Japan Air Lines, Co., Ltd. Boeing 747-246, JA8122, Anchorage, Alaska, December 16, 1975		5. Report Date March 31, 1976	6. Performing Organization Code

AIRCRAFT ACCIDENT REPORT

JAPAN AIR LINES CO., LTD.
BOEING 747-246, JA8122
ANCHORAGE, ALASKA
DECEMBER 16, 1975

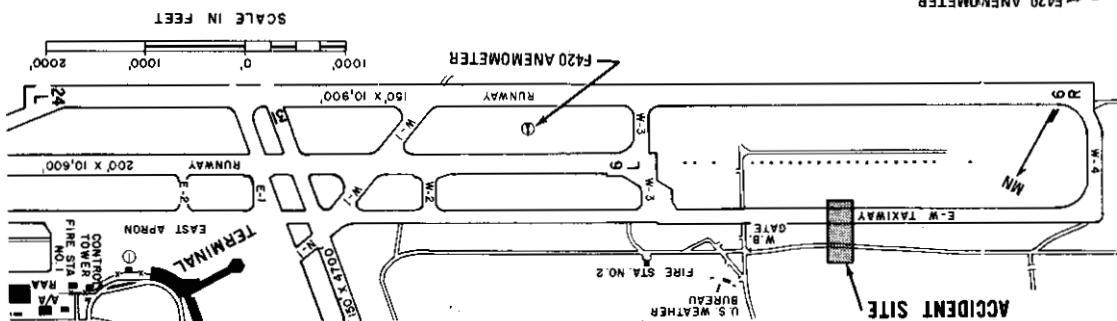
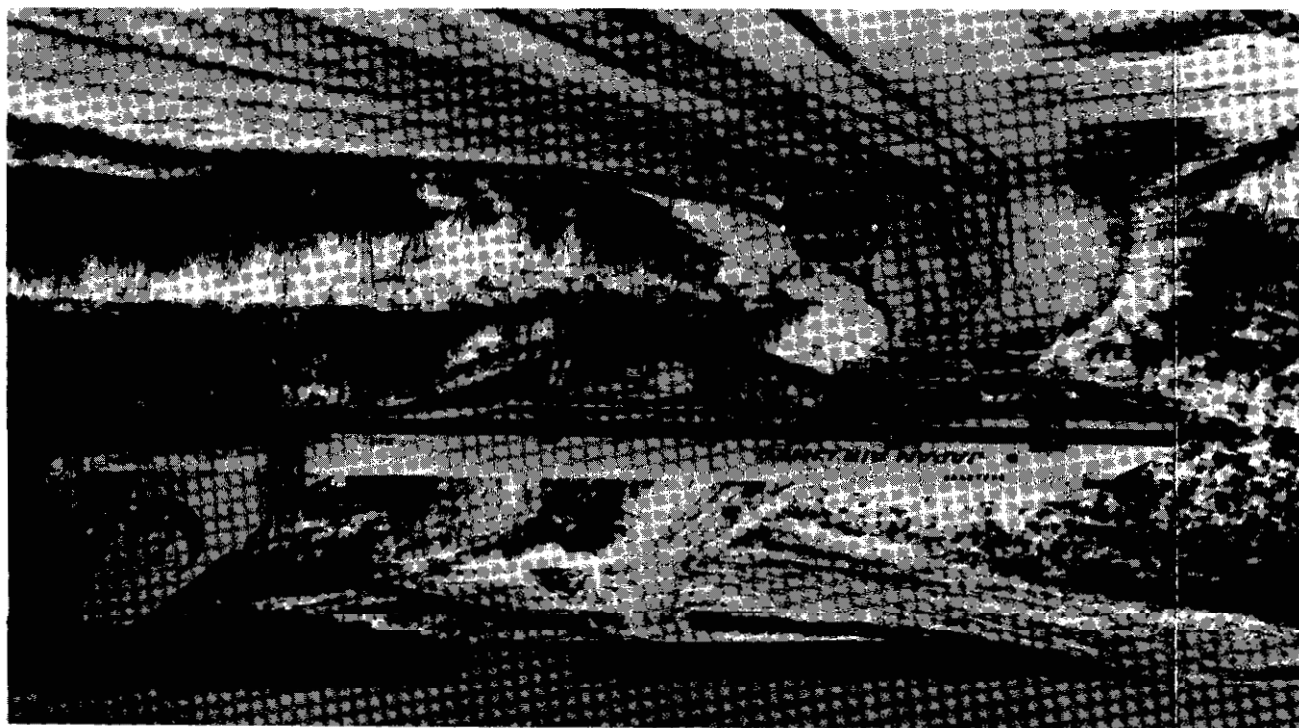
PLAN VIEW - RUNWAY 6R & E-W TAXIWAY

The aircraft then canted to the right and slowly changed its heading (counterclockwise) to about 70° to the taxiway, slid backward **down** the embankment, and came to rest 90° to the taxiway. The statements by the first officer and flight engineer essentially confirm the captain's account of the accident.

Runways 6L and 6R are served by the east-west taxiway which is 75 feet wide and about 15,400 feet long. The taxi lights are 99.4 feet apart, and the distance between the top edges of the embankments is 119 feet. The taxiway has a grade from its center to each side of 1" to 1-1/2° and its surface is asphalt. The terrain adjacent to both sides of the east-west taxiway from the entry to runway 6R (W-3) to the entry to runway 6L (W-4) is inclined; the incline on the north side of the taxiway where the accident occurred was about -13°.

ACCIDENT SITE

BROKEN TAXIWAY LIGHTS
