1. Report No. NTSB-AAR-76-14		2. Government Accession No.		3. Recipient's Catalog No.	
4. Title and Subtitle Aircraft Accident Report - Continental Air Lines, Inc., Boeing 727-224, N88777, Stapleton International Airport, Denver, Colorado, August 7, 1975				5. Report Date May 5, 1976

CONTINENTAL AIR LINES, INC.
BOEING 727-224, N88777
STAPLETON INTERNATIONAL AIRPORT
DENVER, COLORADO
AUGUST 7, 1975

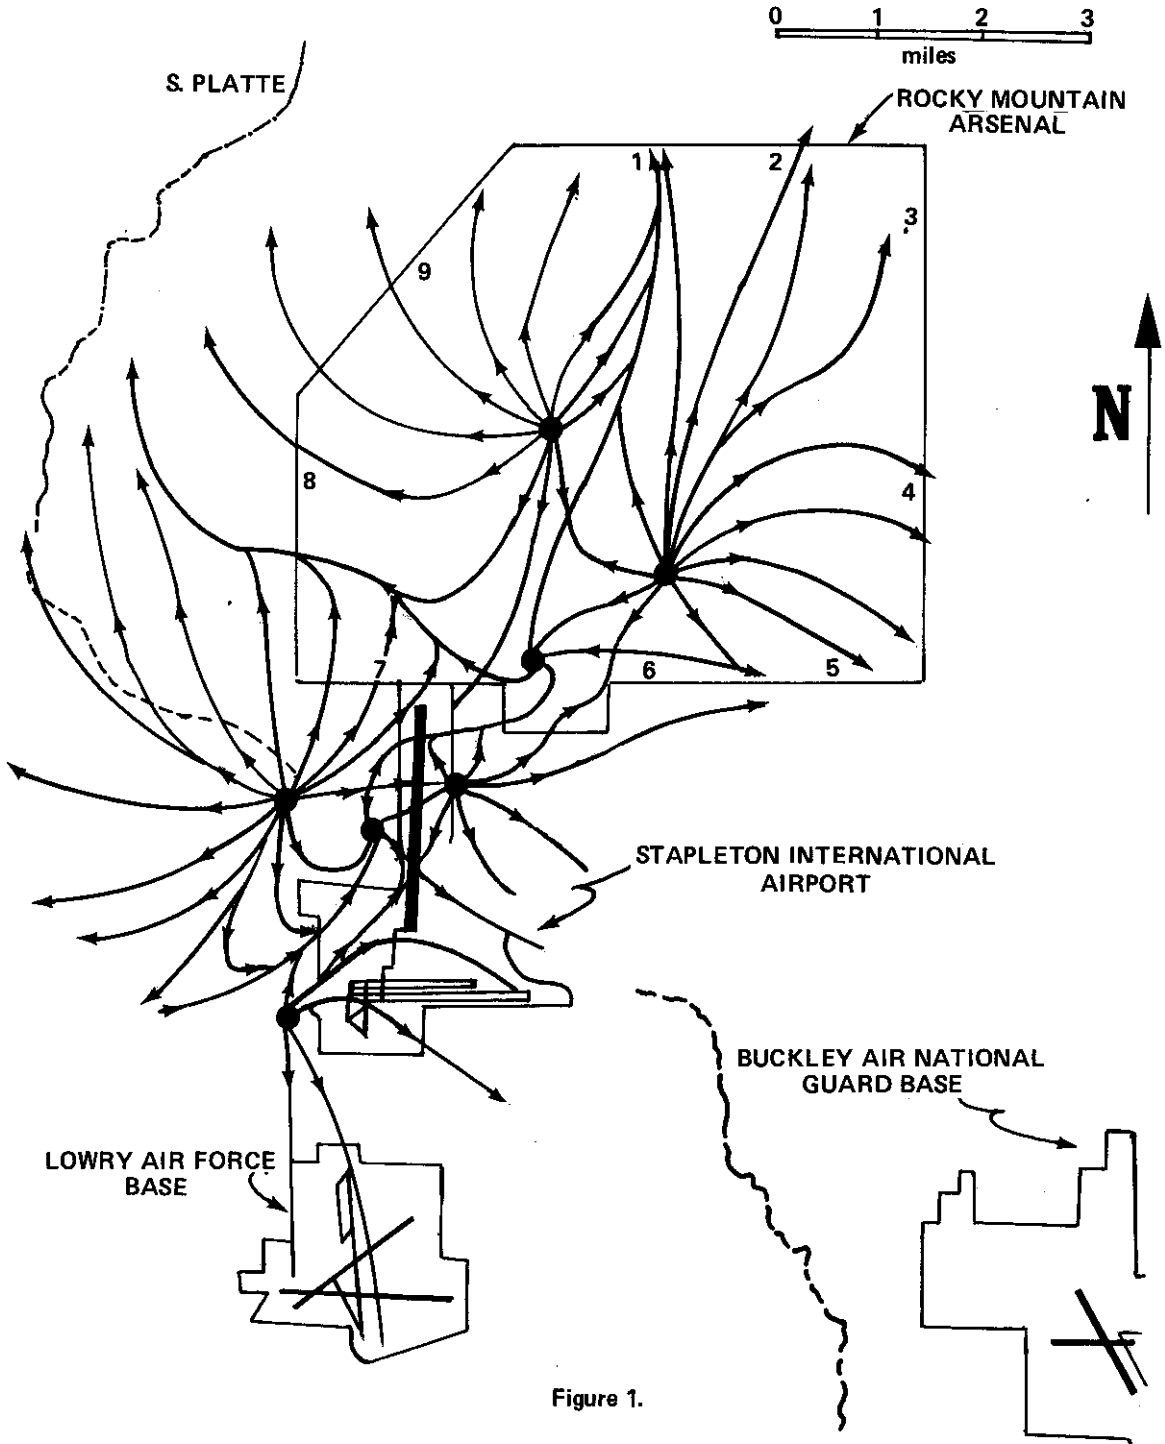
Figure 1.

Streamlines drawn from time-space conversion/isogon analysis superimposed on runway 35L at Stapleton Airport showing the probable runway and surface wind relationship at 1605:30 m.d.t.

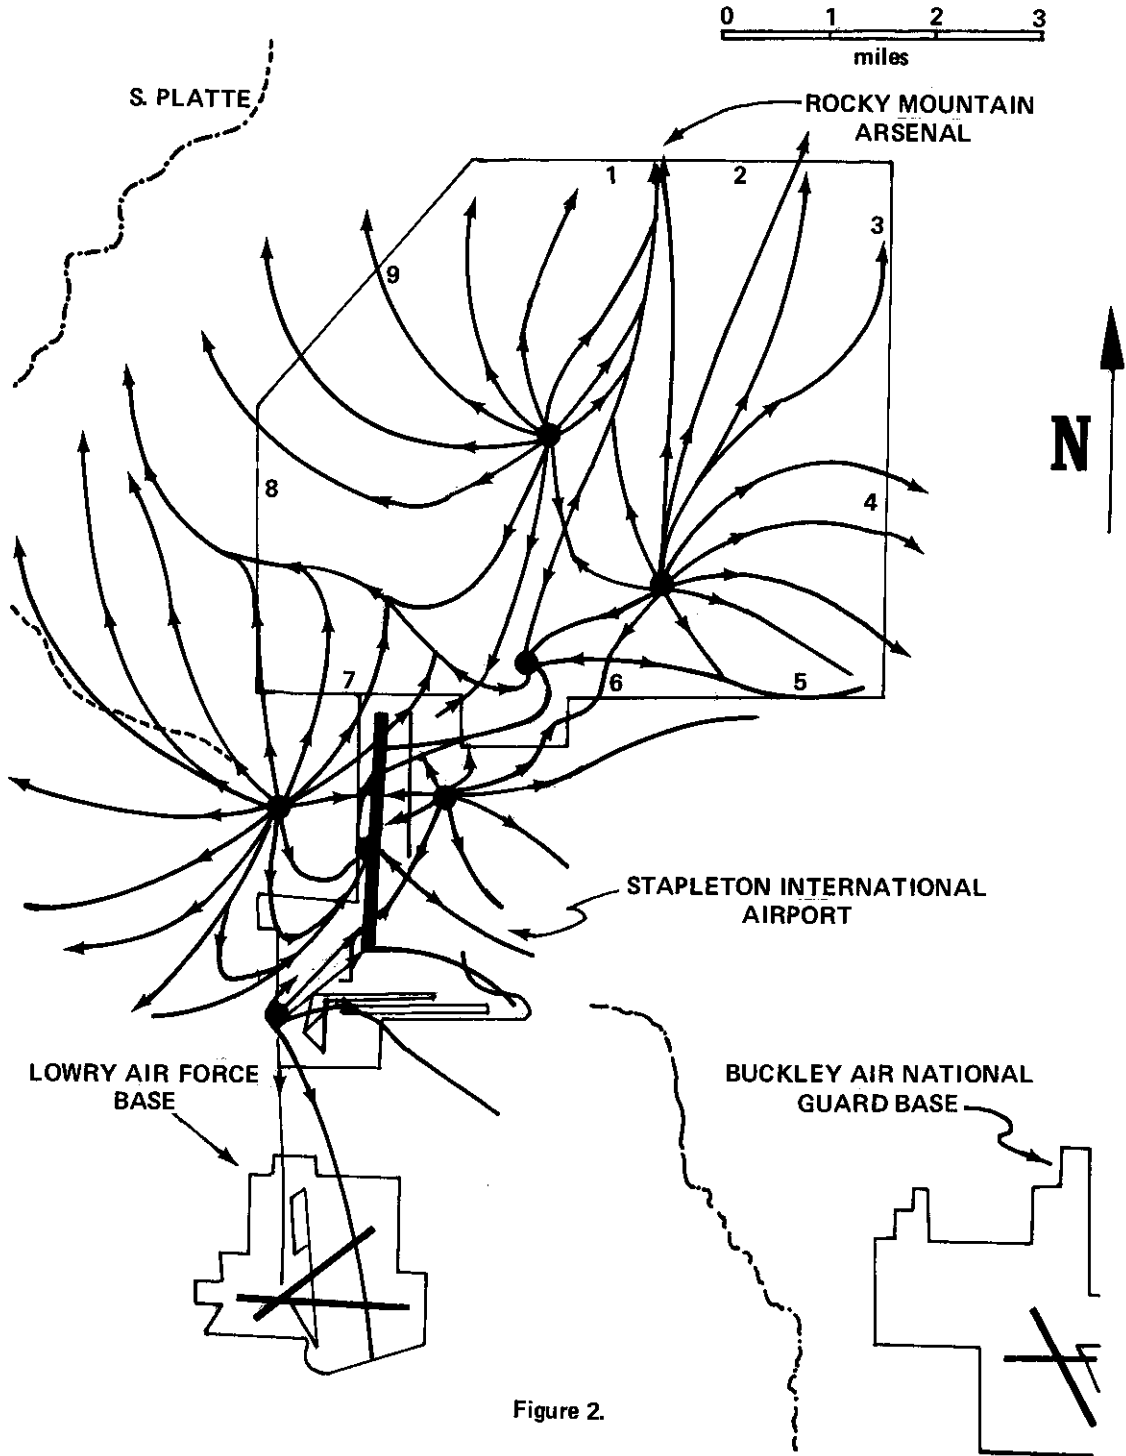
Figure 2.

Streamlines drawn from time-space conversion/isogon analysis superimposed on runway 35L at Stapleton Airport showing the probable runway and surface wind relationship at 1607 m.d.t.

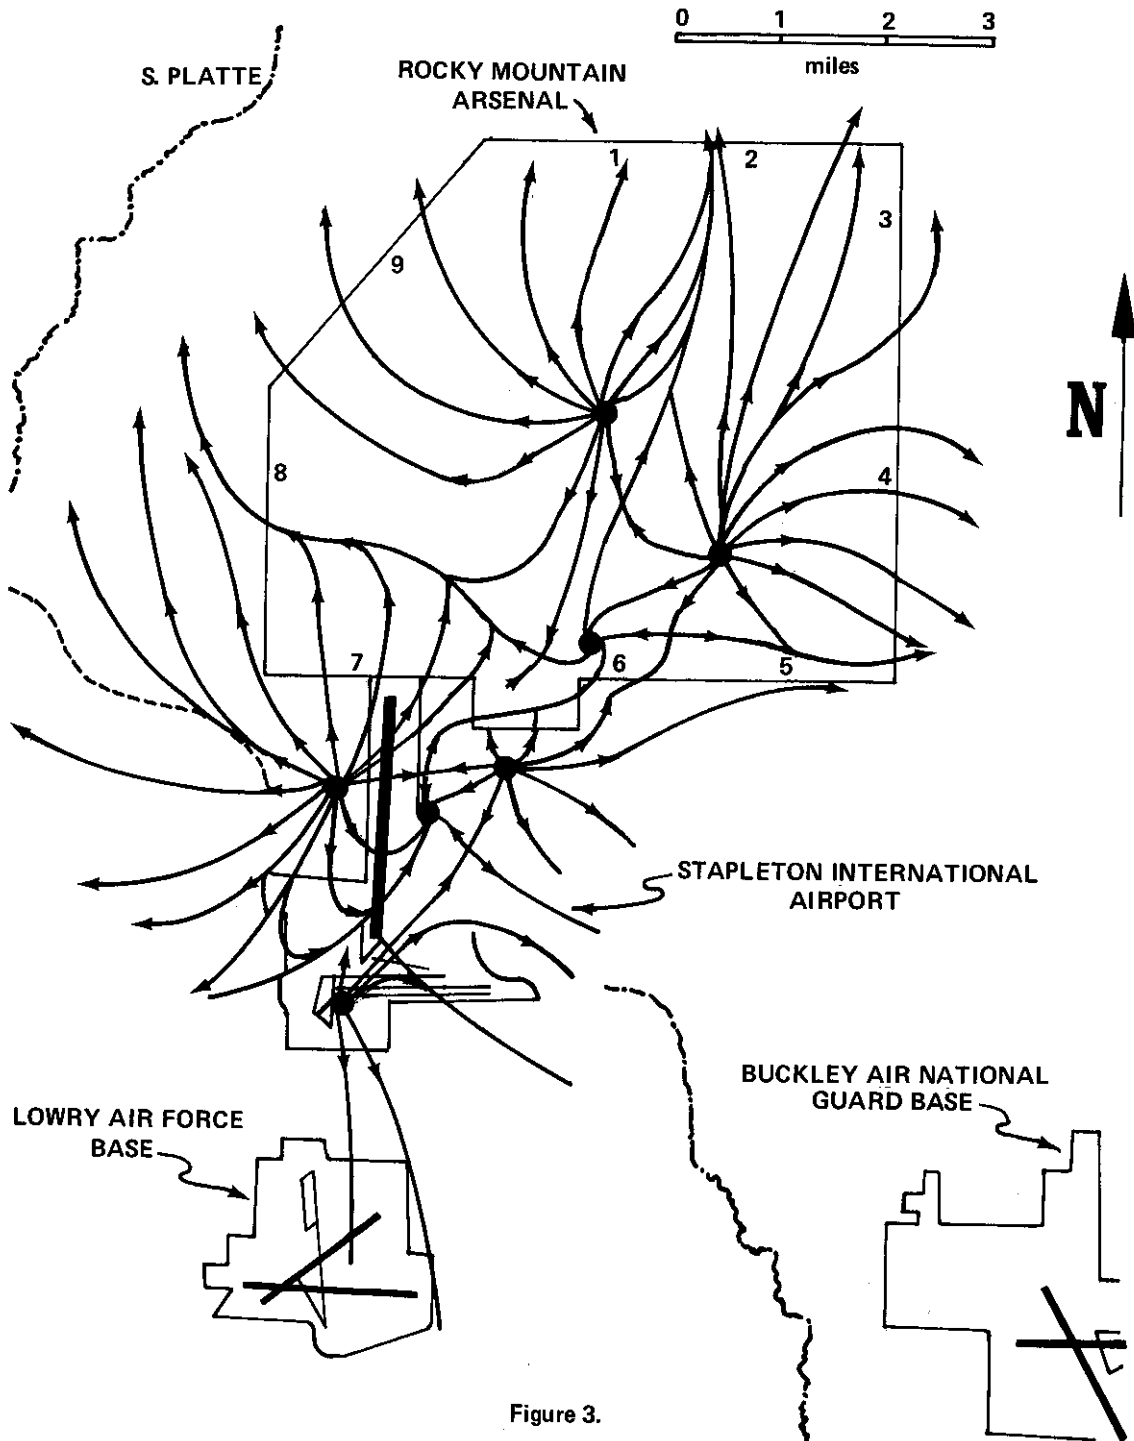
Figure 3.

Streamlines drawn from time-space conversion/isogon analysis superimposed on runway 35L at Stapleton Airport showing the probable runway and surface wind relationship at 1610 m.d.t.

About 1600, the most influential center of divergence was probably located west of the center of runway 35L; and it was moving east-northeast at about 9 kn. As the thunderstorm expanded and moved east-northeastward, this center of divergence began to strongly affect the wind conditions on Stapleton Airport because of its strong horizontal outflow.

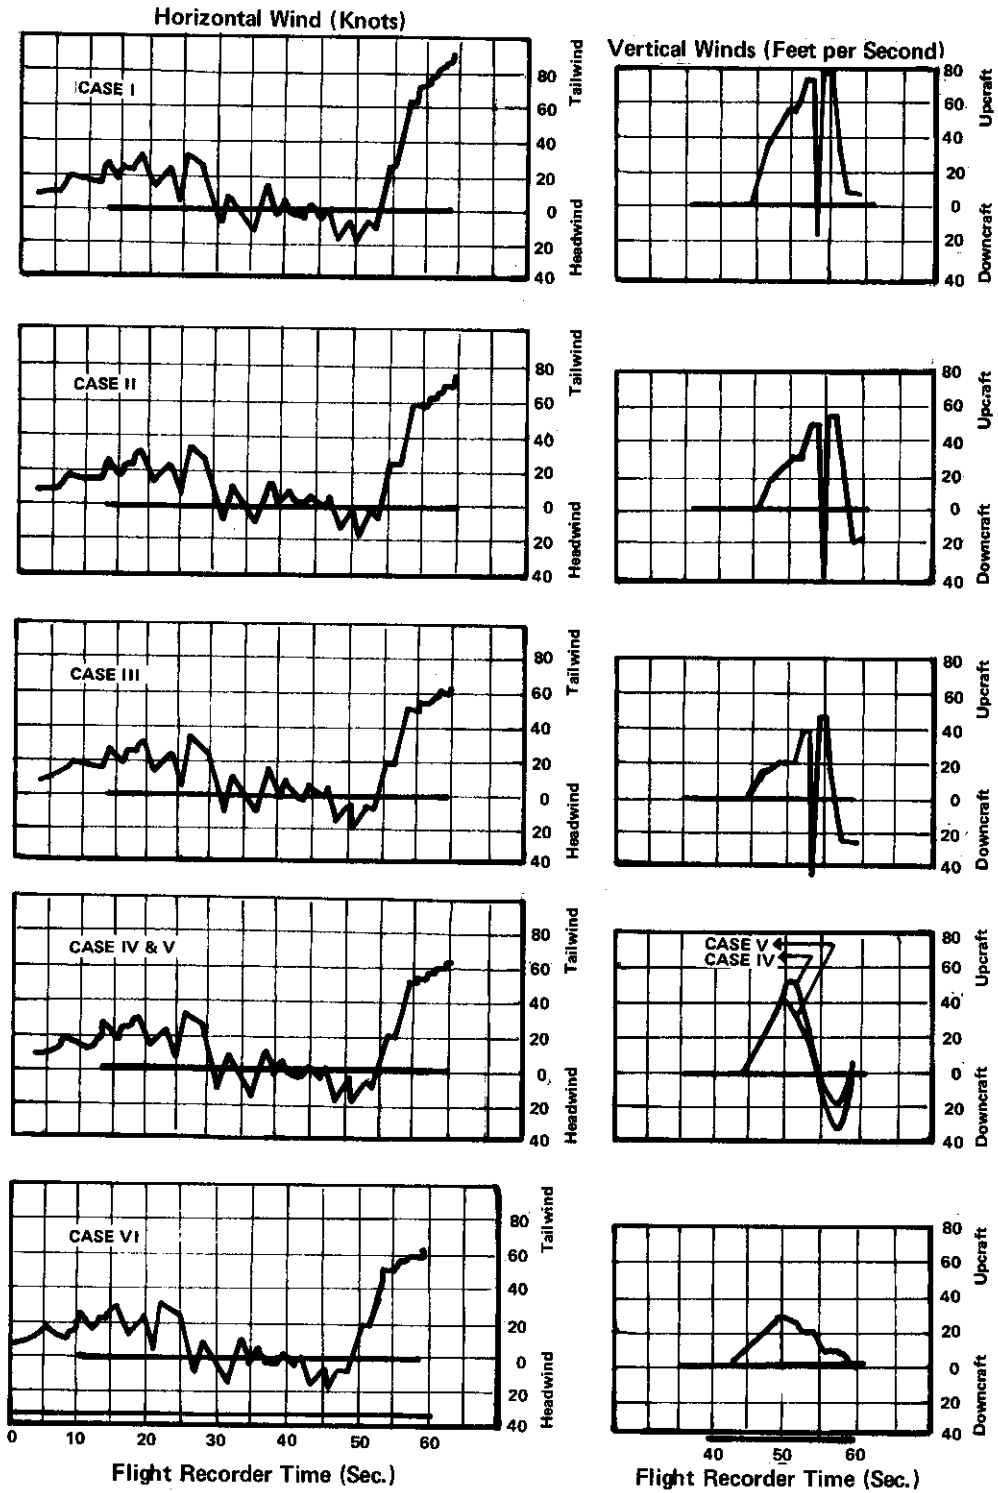
Figure 4.

HORIZONTAL AND VERTICAL WINDS DERIVED FROM AIRCRAFT PERFORMANCE ANALYSIS
