AIRCRAFT ACCIDENT REPORT

OVERSEAS NATIONAL AIRWAYS, INC
DOUGLAS DC-10-30, N10325

JOHN F. KENNEDY INTERNATIONAL
AIRPORT

1. Report No. NTSB-AAR-76-19		2. Government Accession No.		3. Recipient's Catalog No.	
4. Title and Subtitle Aircraft Accident Report -- Overseas National Airways, Inc., Douglas DC-10-30, N1032F, John F. Kennedy International Airport, Jamaica, New York, November 12, 1975				5. Report Date December 16, 1976

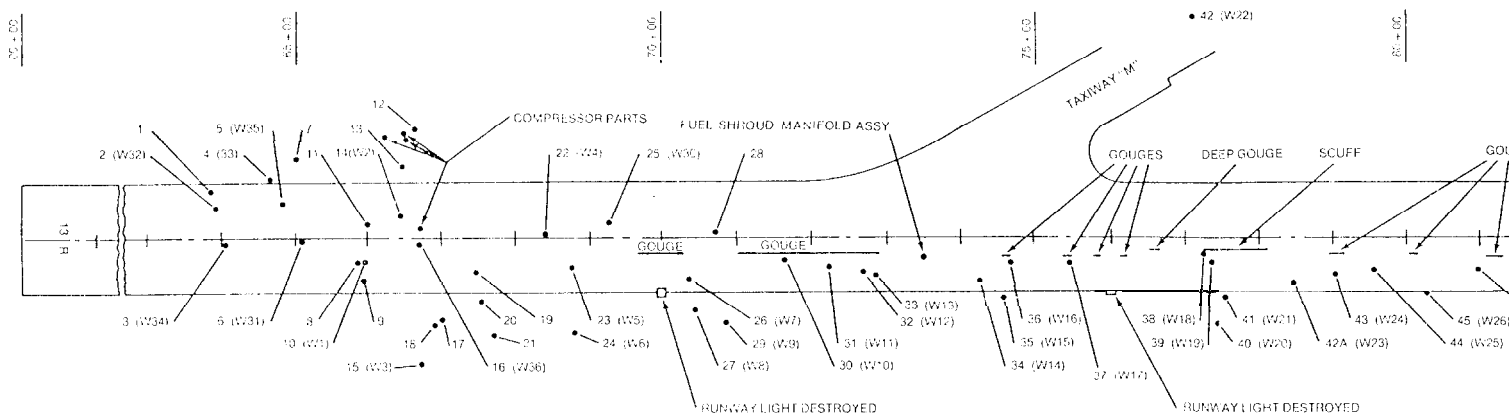
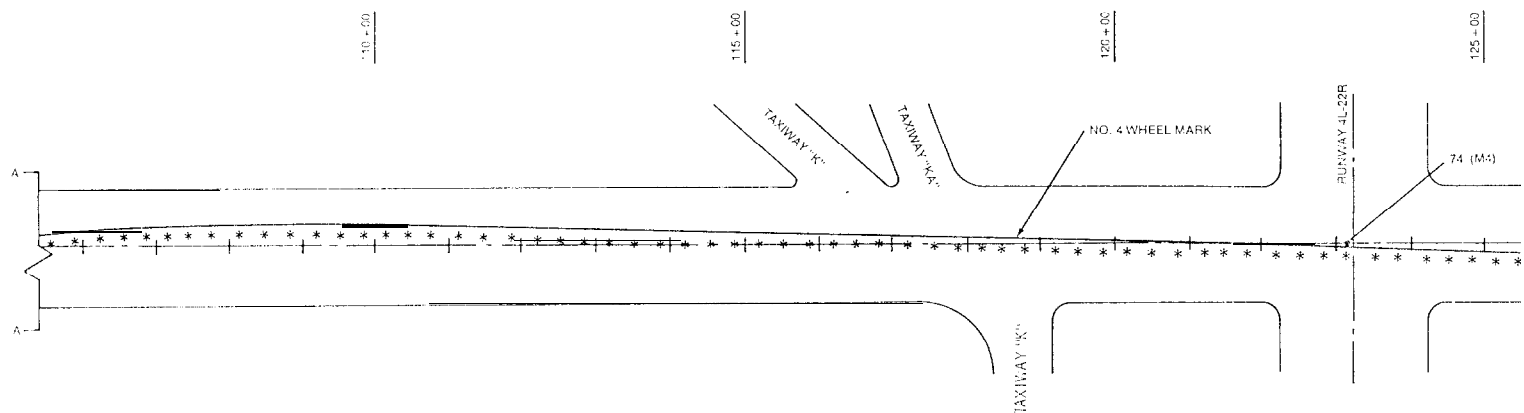
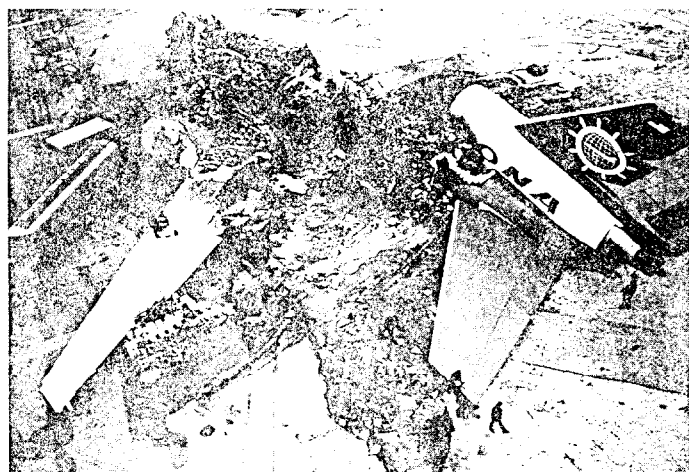
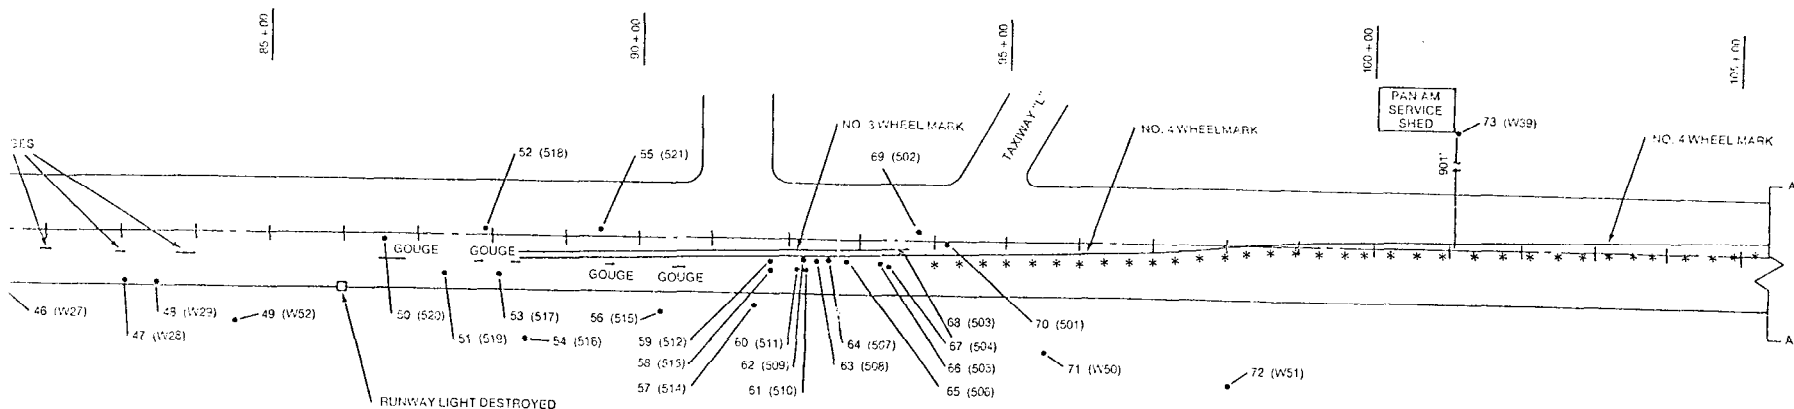
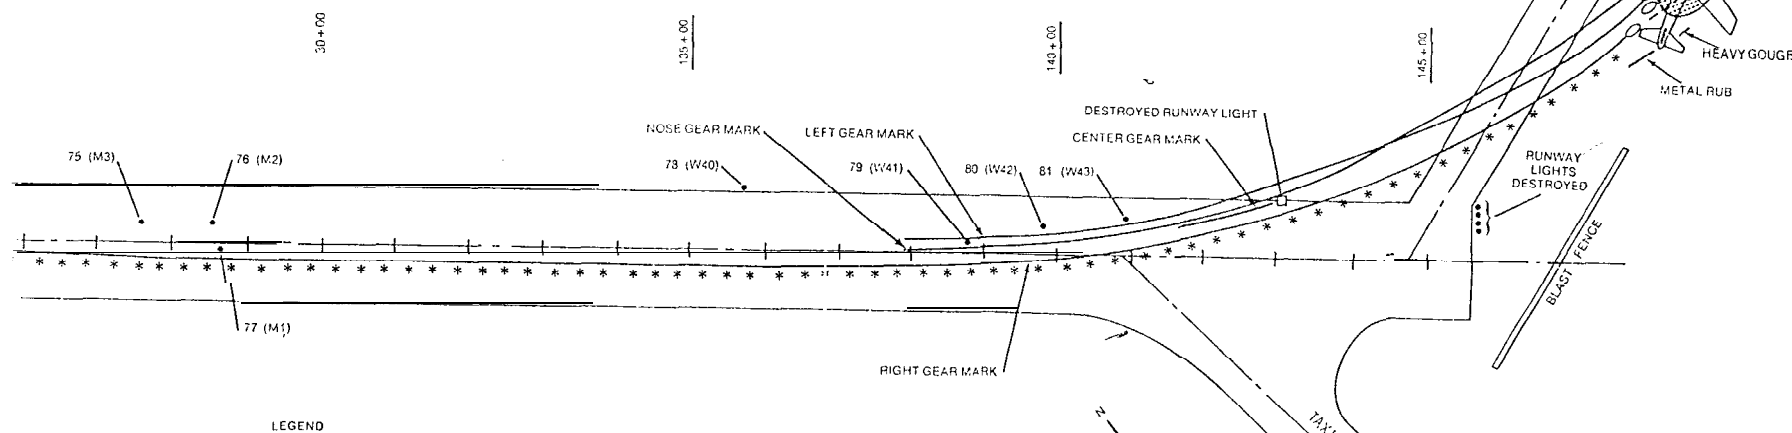
1. SEA GULL
2. (W32) COMPRESSOR PART
3. (W34) COVERED BLEED FITTING ON LH REVERSER
4. (W32) ENGINE FIRE SEAL BLOWOUT DOOR
5. (W35) NO. 1 SENSOR SHIM
6. (W31) COMPRESSOR PART
7. SEA GULL
8. SEA GULL
9. SEA GULL
10. (W1) REVERSER TO PYLON STRIP
11. SEA GULL
12. SEA GULL
13. SEA GULL
14. (W2) PIECE OF COWLING
15. (W3) FH CORE COWL
16. (W36) COMPRESSOR PART IMBEDDED IN ACOUSTIC MAT
17. SEA GULL
18. SEA GULL
19. SEA GULL
20. SEA GULL
21. SEA GULL
22. (W4) PIECE OF LH CORE COWLING
23. (W5) ACCESS BLOWOUT DOOR/FAN REVERSER
24. (W6) LH FAN COWLING
25. (W30) INNER COMPRESSOR BLEED DOOR
26. (W7) PIECE OF TIRE
27. (W8) PIECE OF TIRE
28. SEA GULL
29. (W9) RH REVERSER FAN AIR BLEED DUCT
30. (W10) FH CENTERLINE CLEAR DOOR

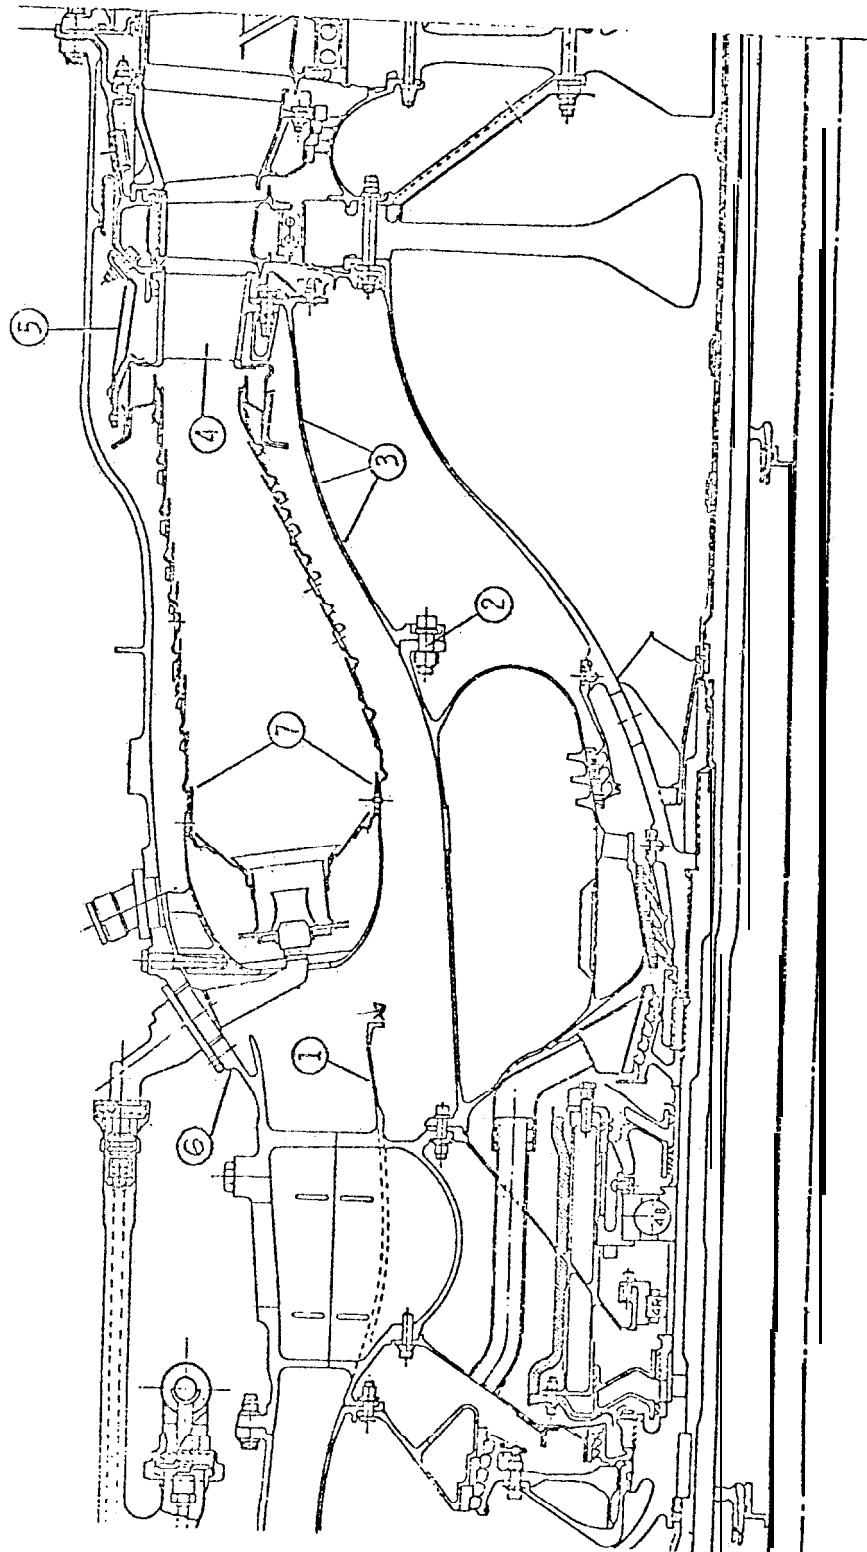
DEFORMATION LOCATION

7. Combustor Liner
Inward and aft buckling of shell
Normal differential pressure is 15 PSI
Pressure required for buckling is 192 PSI differential pressure
