1. Report No. NTSB-AAR-77-5		2. Government Accession No.		3. Recipient's Catalog No.	
4. Title and Subtitle Aircraft Accident Report - Ruel Insurance Corporation Cessna 414, N8PR, and U.S. Air Force F-4E, 67-0255, Near Brighton, Florida September 13, 1976		5. Report Date September 16, 1977		6. Performing Organization Code

AIRCRAFT ACCIDENT REPORT

RUEL INSURANCE CORPORATION  
CESSNA 414, N8PR,  
and  
U.S. AIR FORCE  
F-4E, 67-0255,  
NEAR BRIGHTON, FLORIDA  
SEPTEMBER 13, 1976

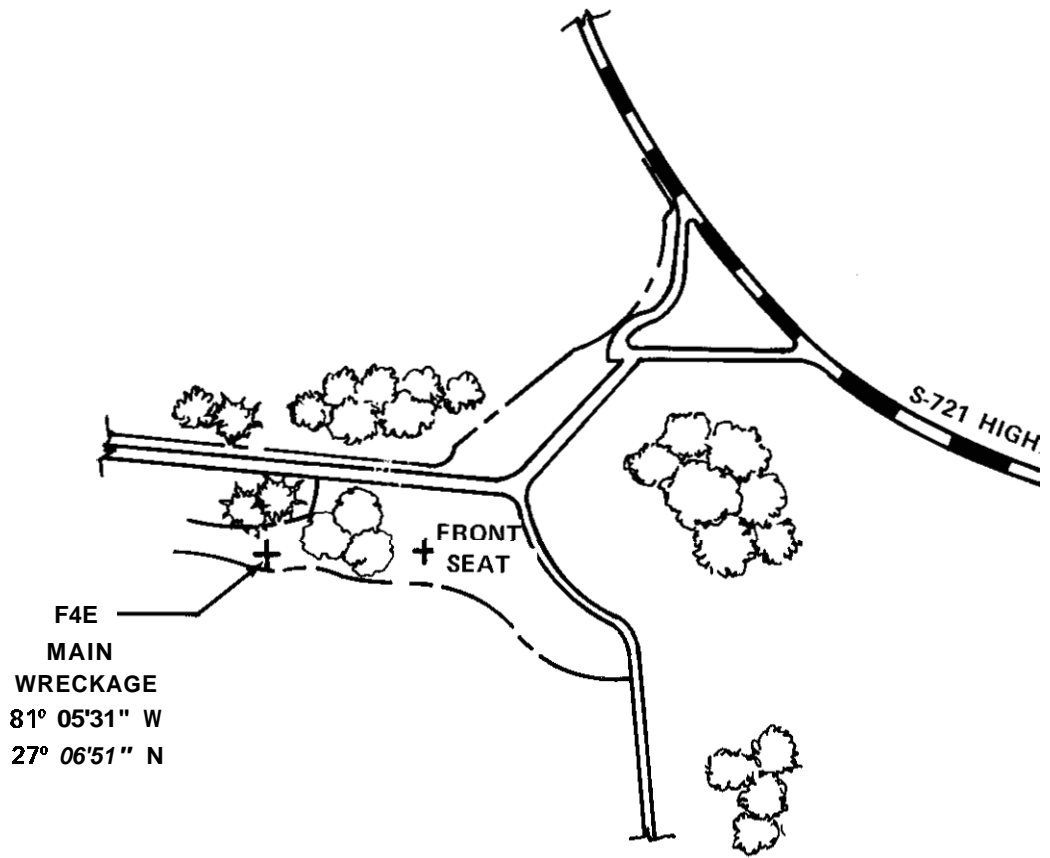
The main wreckage of the F-4E was found in a swampy area in a **small** pond about 1.5 miles west of the NSPR site. All of the aircraft was in this area except those miscellaneous parts found with the NSPR parts. The only parts from NSPR found in the F-4E main wreckage area were pieces from the left engine cowl. (See Appendix D.)

F4E  
 MAIN  
 WRECKAGE  
 81° 05'31" W  
 27° 06'51" N

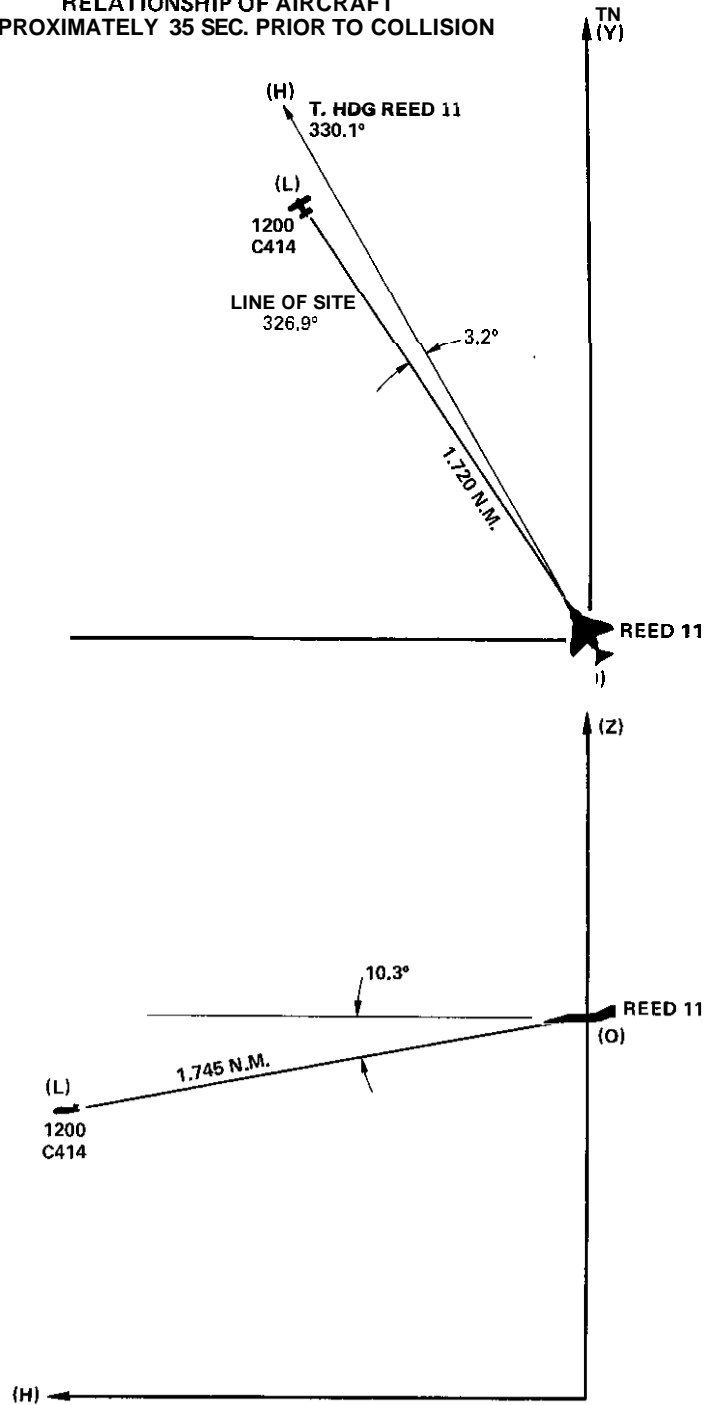
RELATIONSHIP OF AIRCRAFT  
APPROXIMATELY 35 SEC. PRIOR TO COLLISION

The computed data also showed that 55 seconds before the collision, the distance between the lead F-4E and NSPR was 2.8 nmi; 35 seconds before the collision, the distance of separation was 1.7 nmi; and 15 seconds the same distance was .7 nmi. (See Appendix E.)
