1. Report No. NTSB-AAR-77-10	2. Government Accession No.	3. Recipient's Catalog No.	
4. Title and Subtitle Aircraft Accident Report Texas International Airlines, Inc., Douglas DC-9-14, N9104, Stapleton International Airport, Denver, Colorado, November 16, 1976		5. Report Date October 27, 1977	6. Performing Organization Code

AIRCRAFT ACCIDENT REPORT

TEXAS INTERNATIONAL AIRLINES, INC.  
DOUGLAS DC-9-14, N9104  
STAPLETON INTERNATIONAL AIRPORT  
DENVER, COLORADO  
NOVEMBER 16, 1976

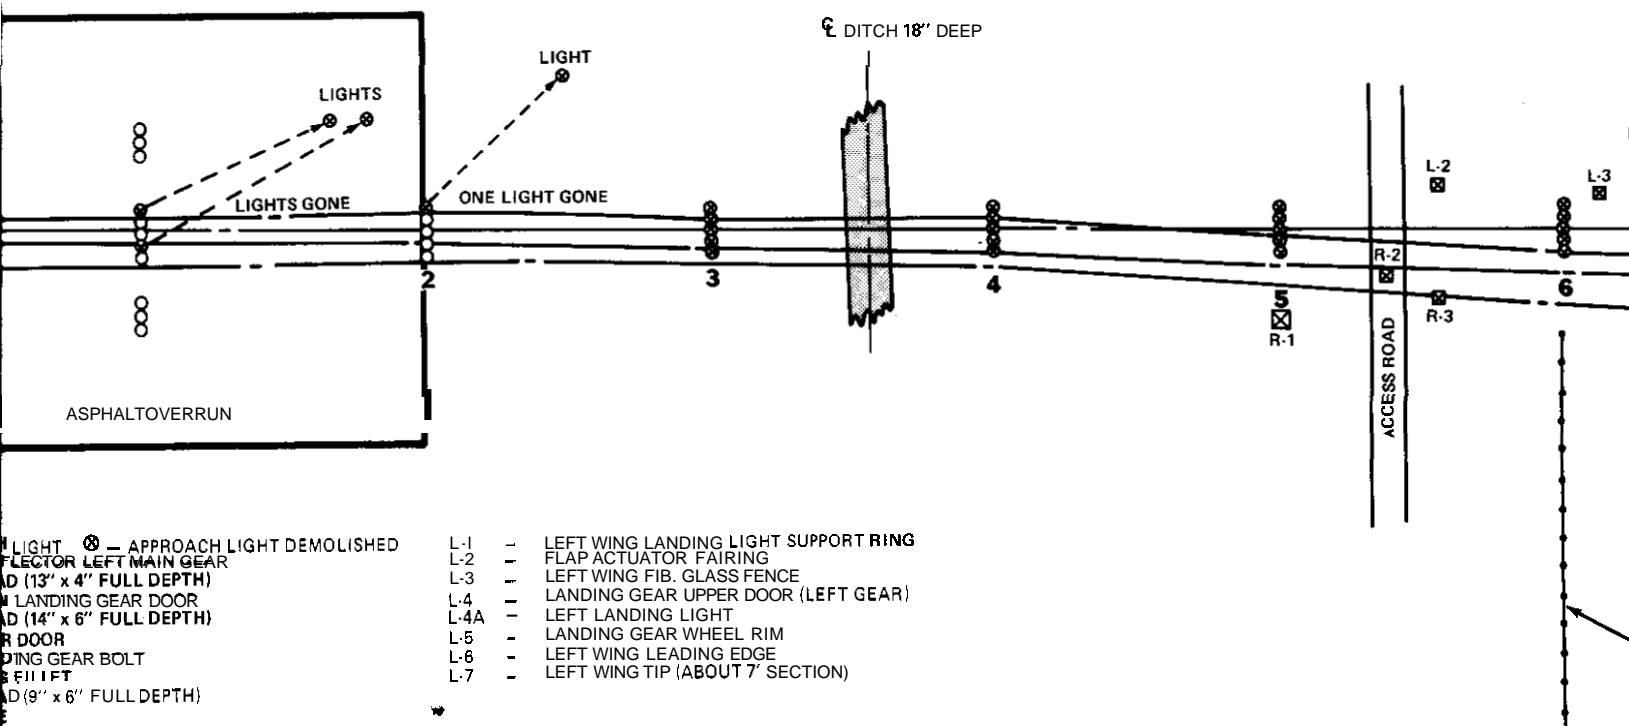
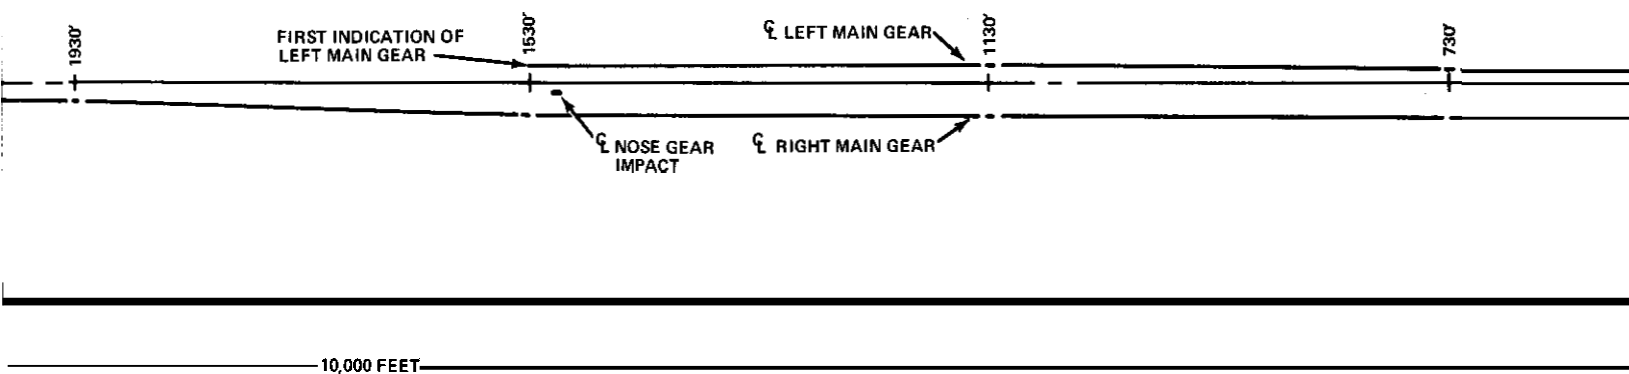
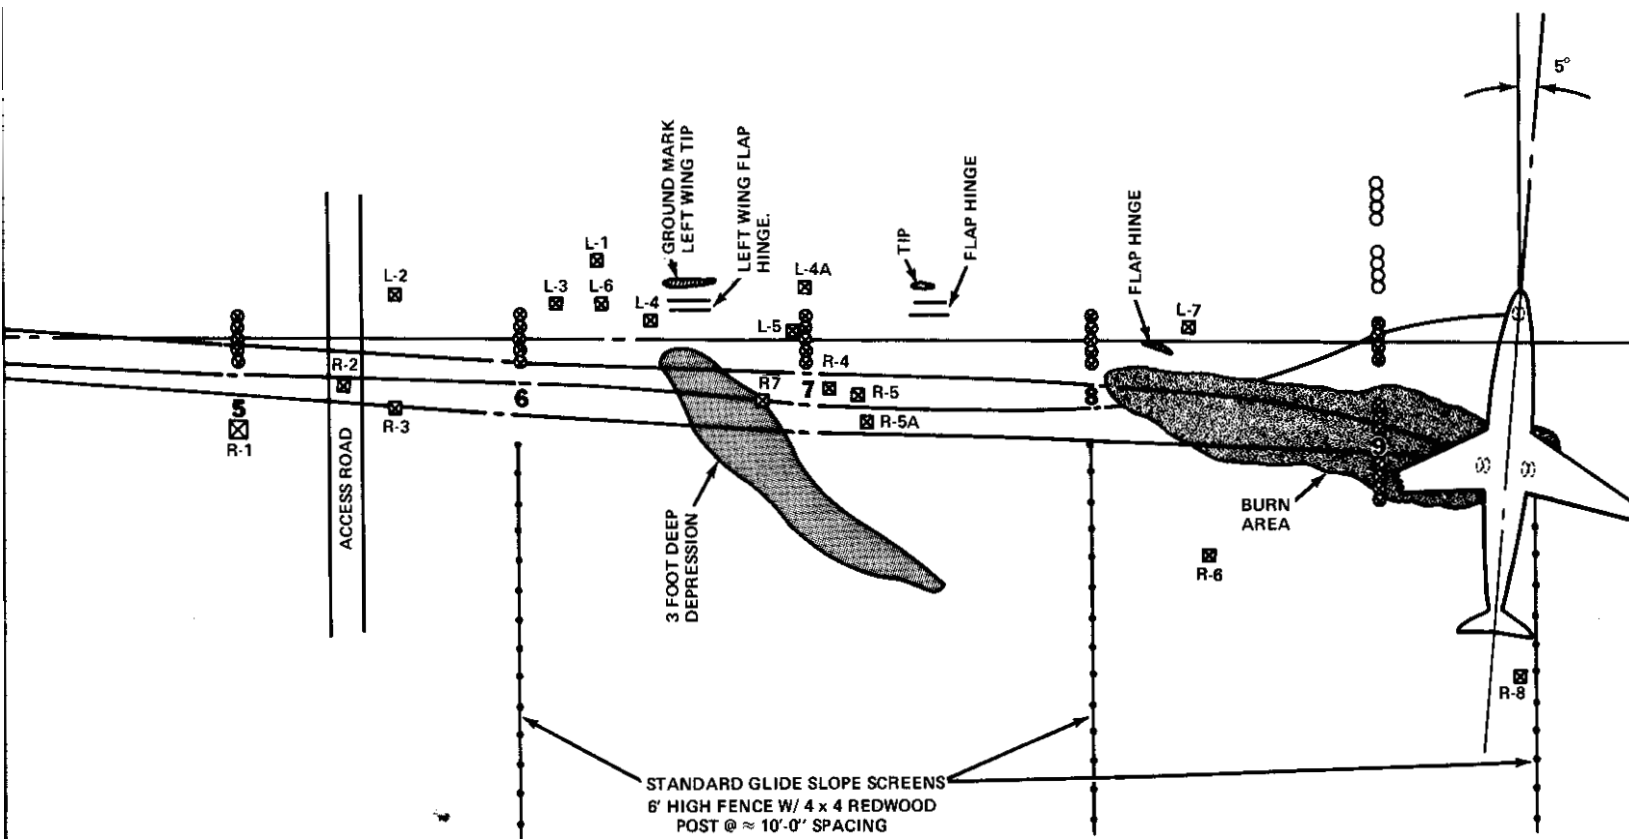
WRECHAGE DISTRIBUTION CHART  
TEXAS INTERNATIONAL AIRLINES, INC.  
MCDONNELL - DOUGLAS DC-9-14, N 9104  
STAPLETON INTERNATIONAL AIRPORT  
DENVER, COLORADO  
NOVEMBER 16, 1976

- - APPROACH LIGHT    ⊗ - APPROACH LIGHT DI
- R-1 - SPRAY DEFLECTOR LEFT MAIN GEAR
- R-2 - TIRE TREAD (13" x 4" FULL DEPTH)
- R-3 - LEFT MAIN LANDING GEAR DOOR
- R-4 - TIRE TREAD (14" x 6" FULL DEPTH)
- R-5 - NOSE GEAR DOOR
- R-5A - LEFT LANDING GEAR BOLT
- R-6 - LEFT WING FILLET
- R-7 - TIRE TREAD (9" x 6" FULL DEPTH)
- R-8 - TAIL CONE
