1. Report No. NTSB-AAR-78-1		2. Government Accession No.		3. Recipient's Catalog No.	
4. Title and Subtitle Aircraft Accident Report -- Commonwealth of Pennsylvania, Piper PA-31T, N631PT, Bressler, Pennsylvania, February 24, 1977				5. Report Date January 5, 1978

AIRCRAFT ACCIDENT REPORT

COMMONWEALTH OF PENNSYLVANIA
PIPER PA-31T, N631PT
BRESSLER, PENNSYLVANIA
FEBRUARY 24, 1977

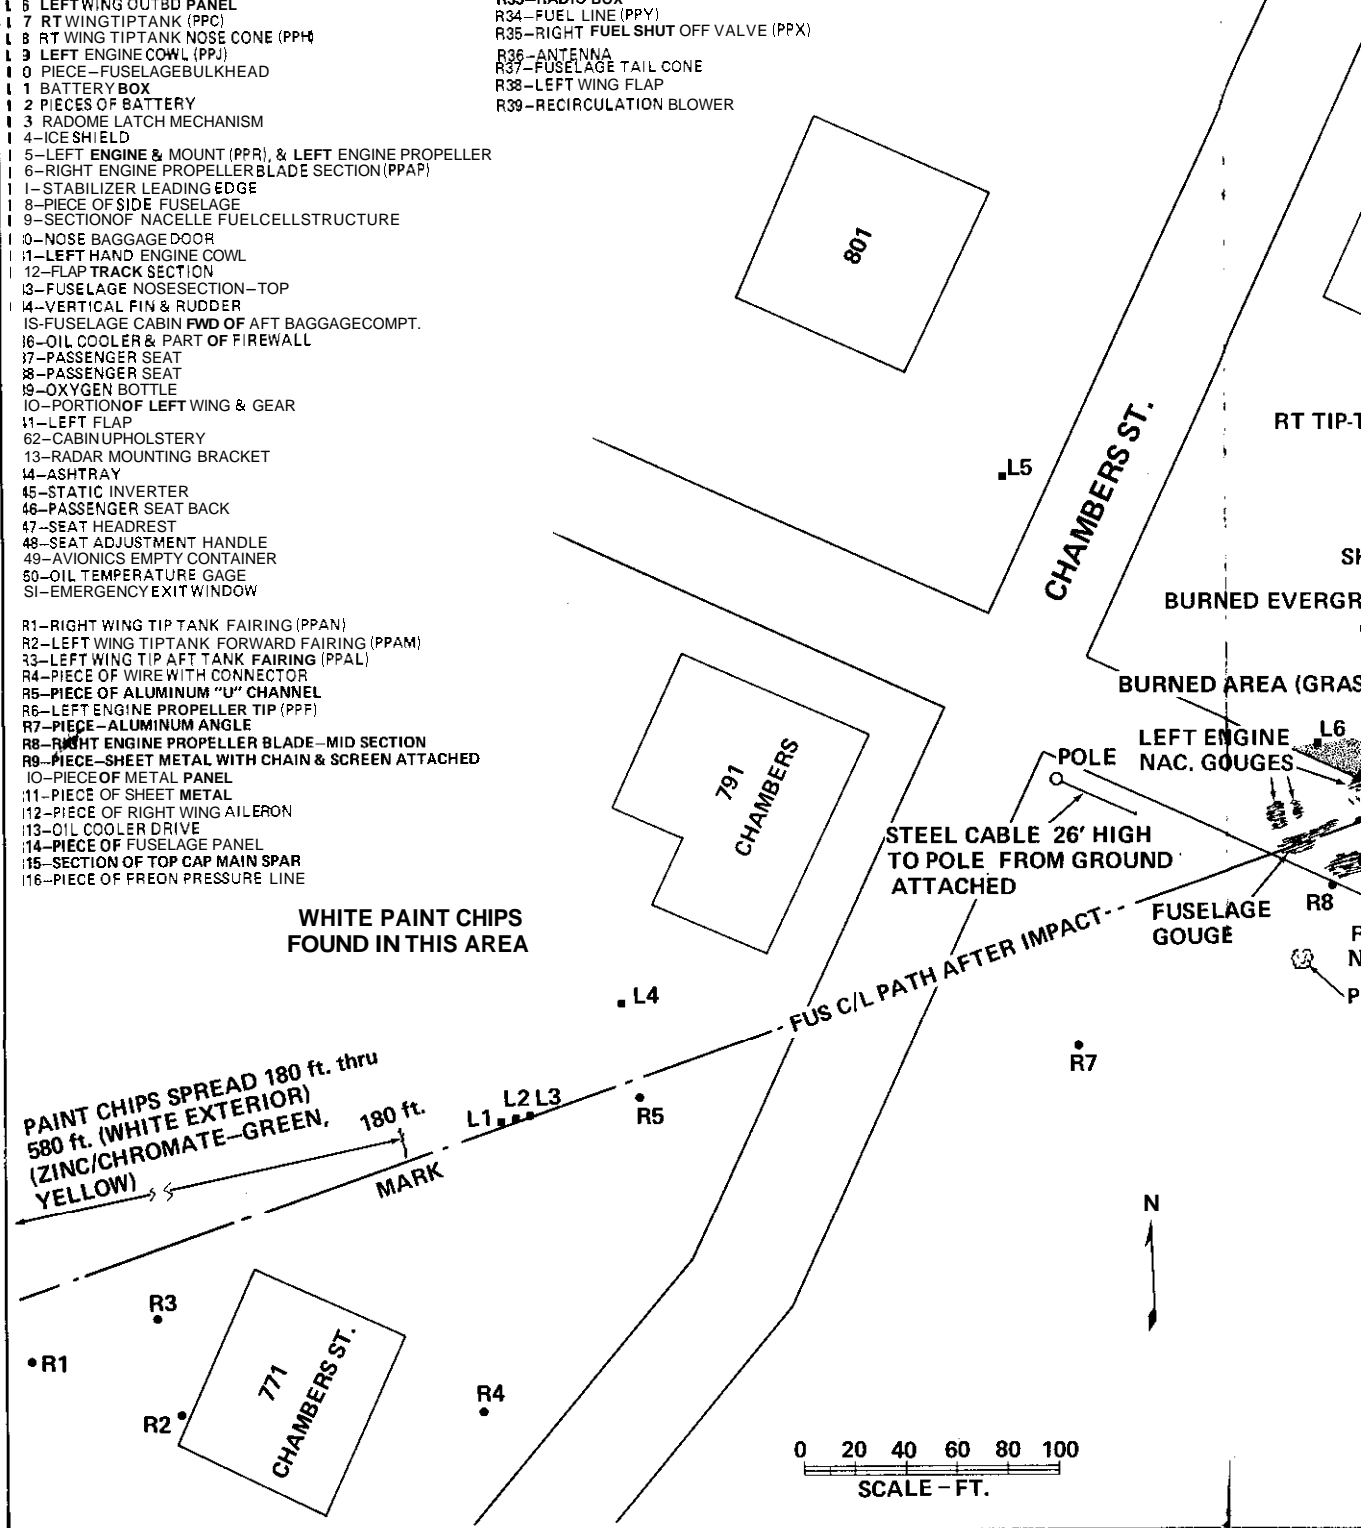
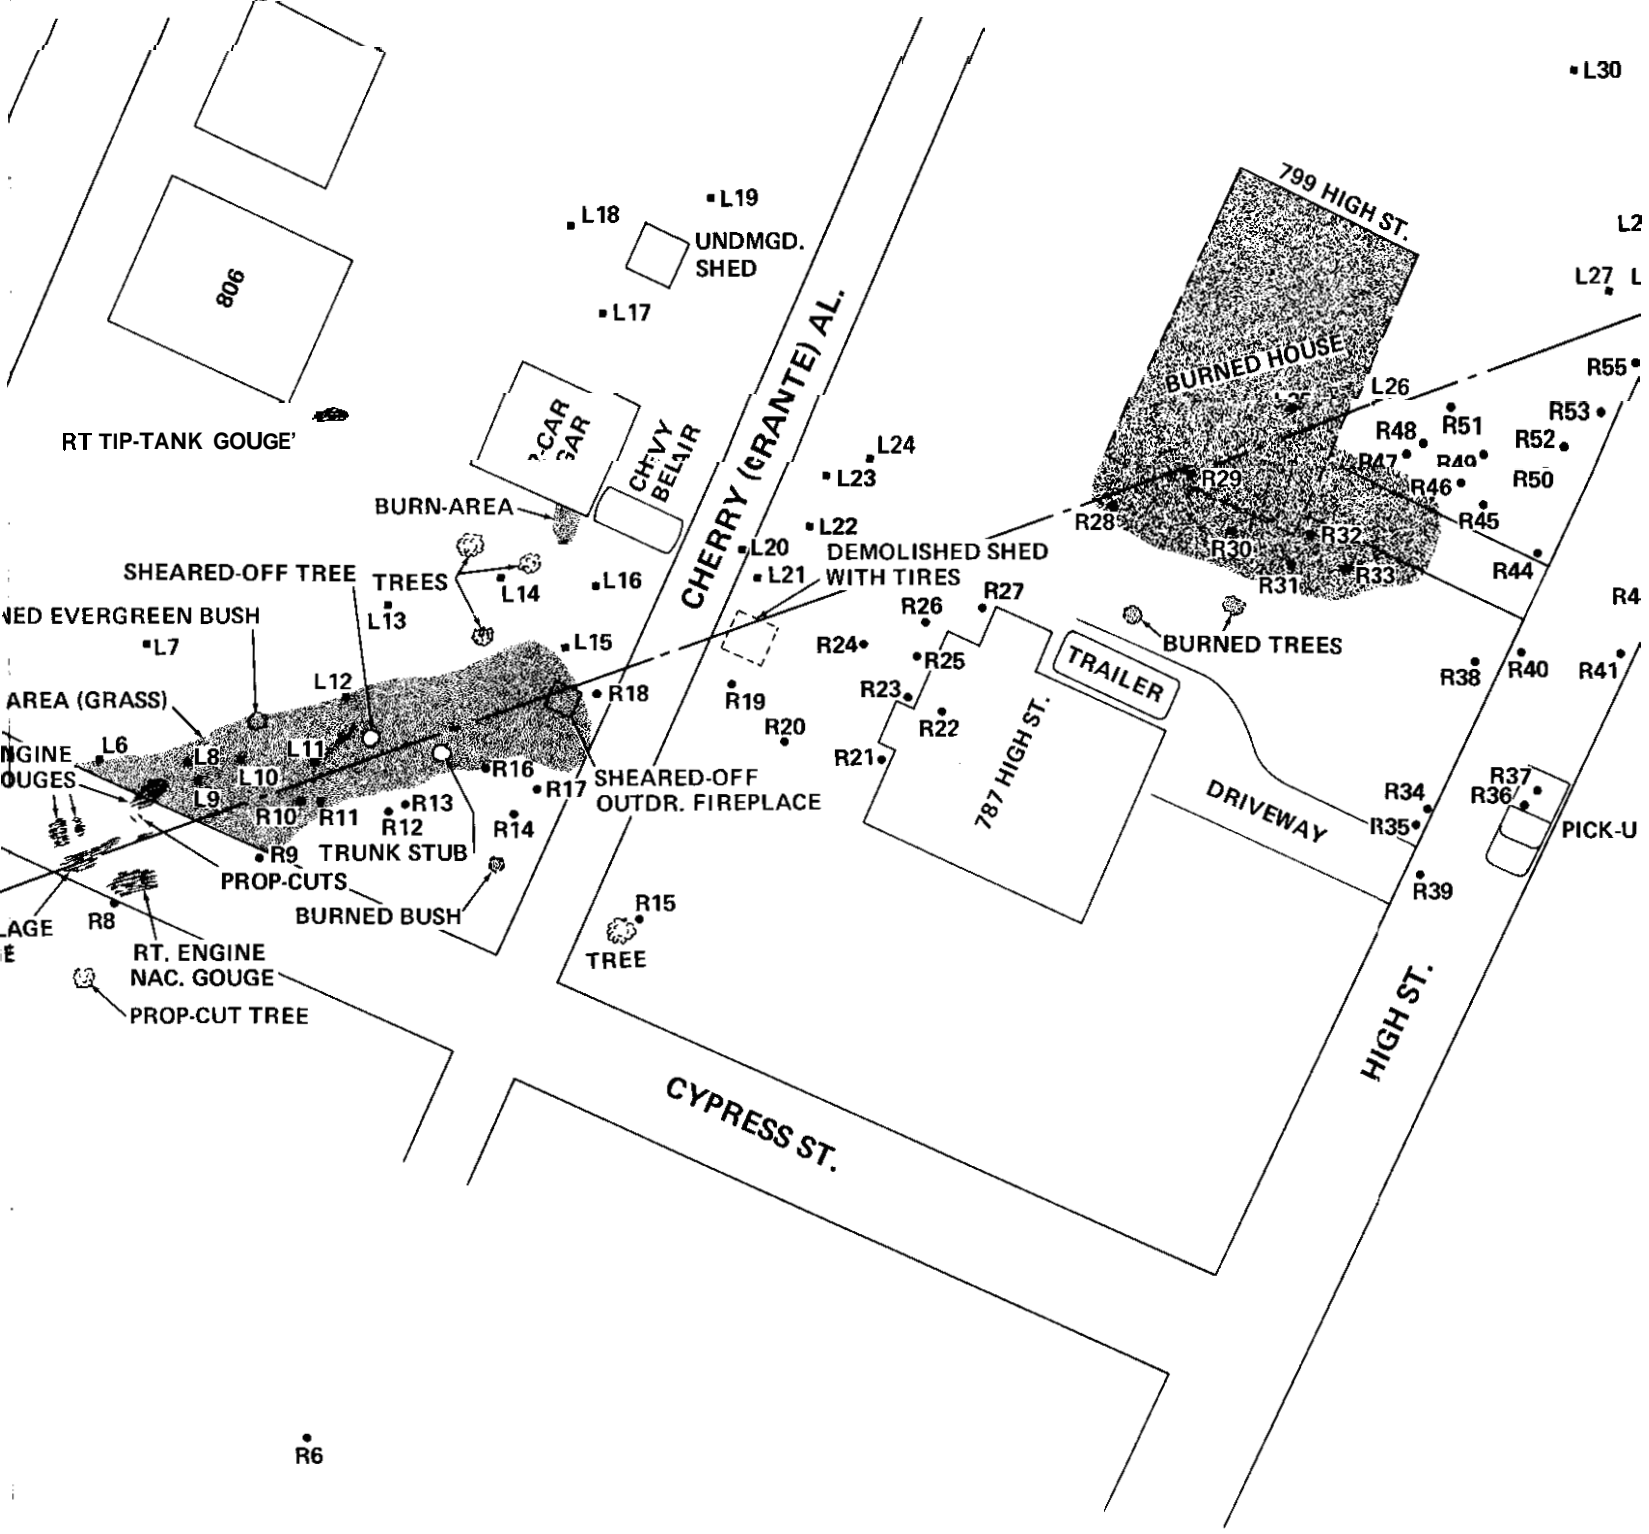
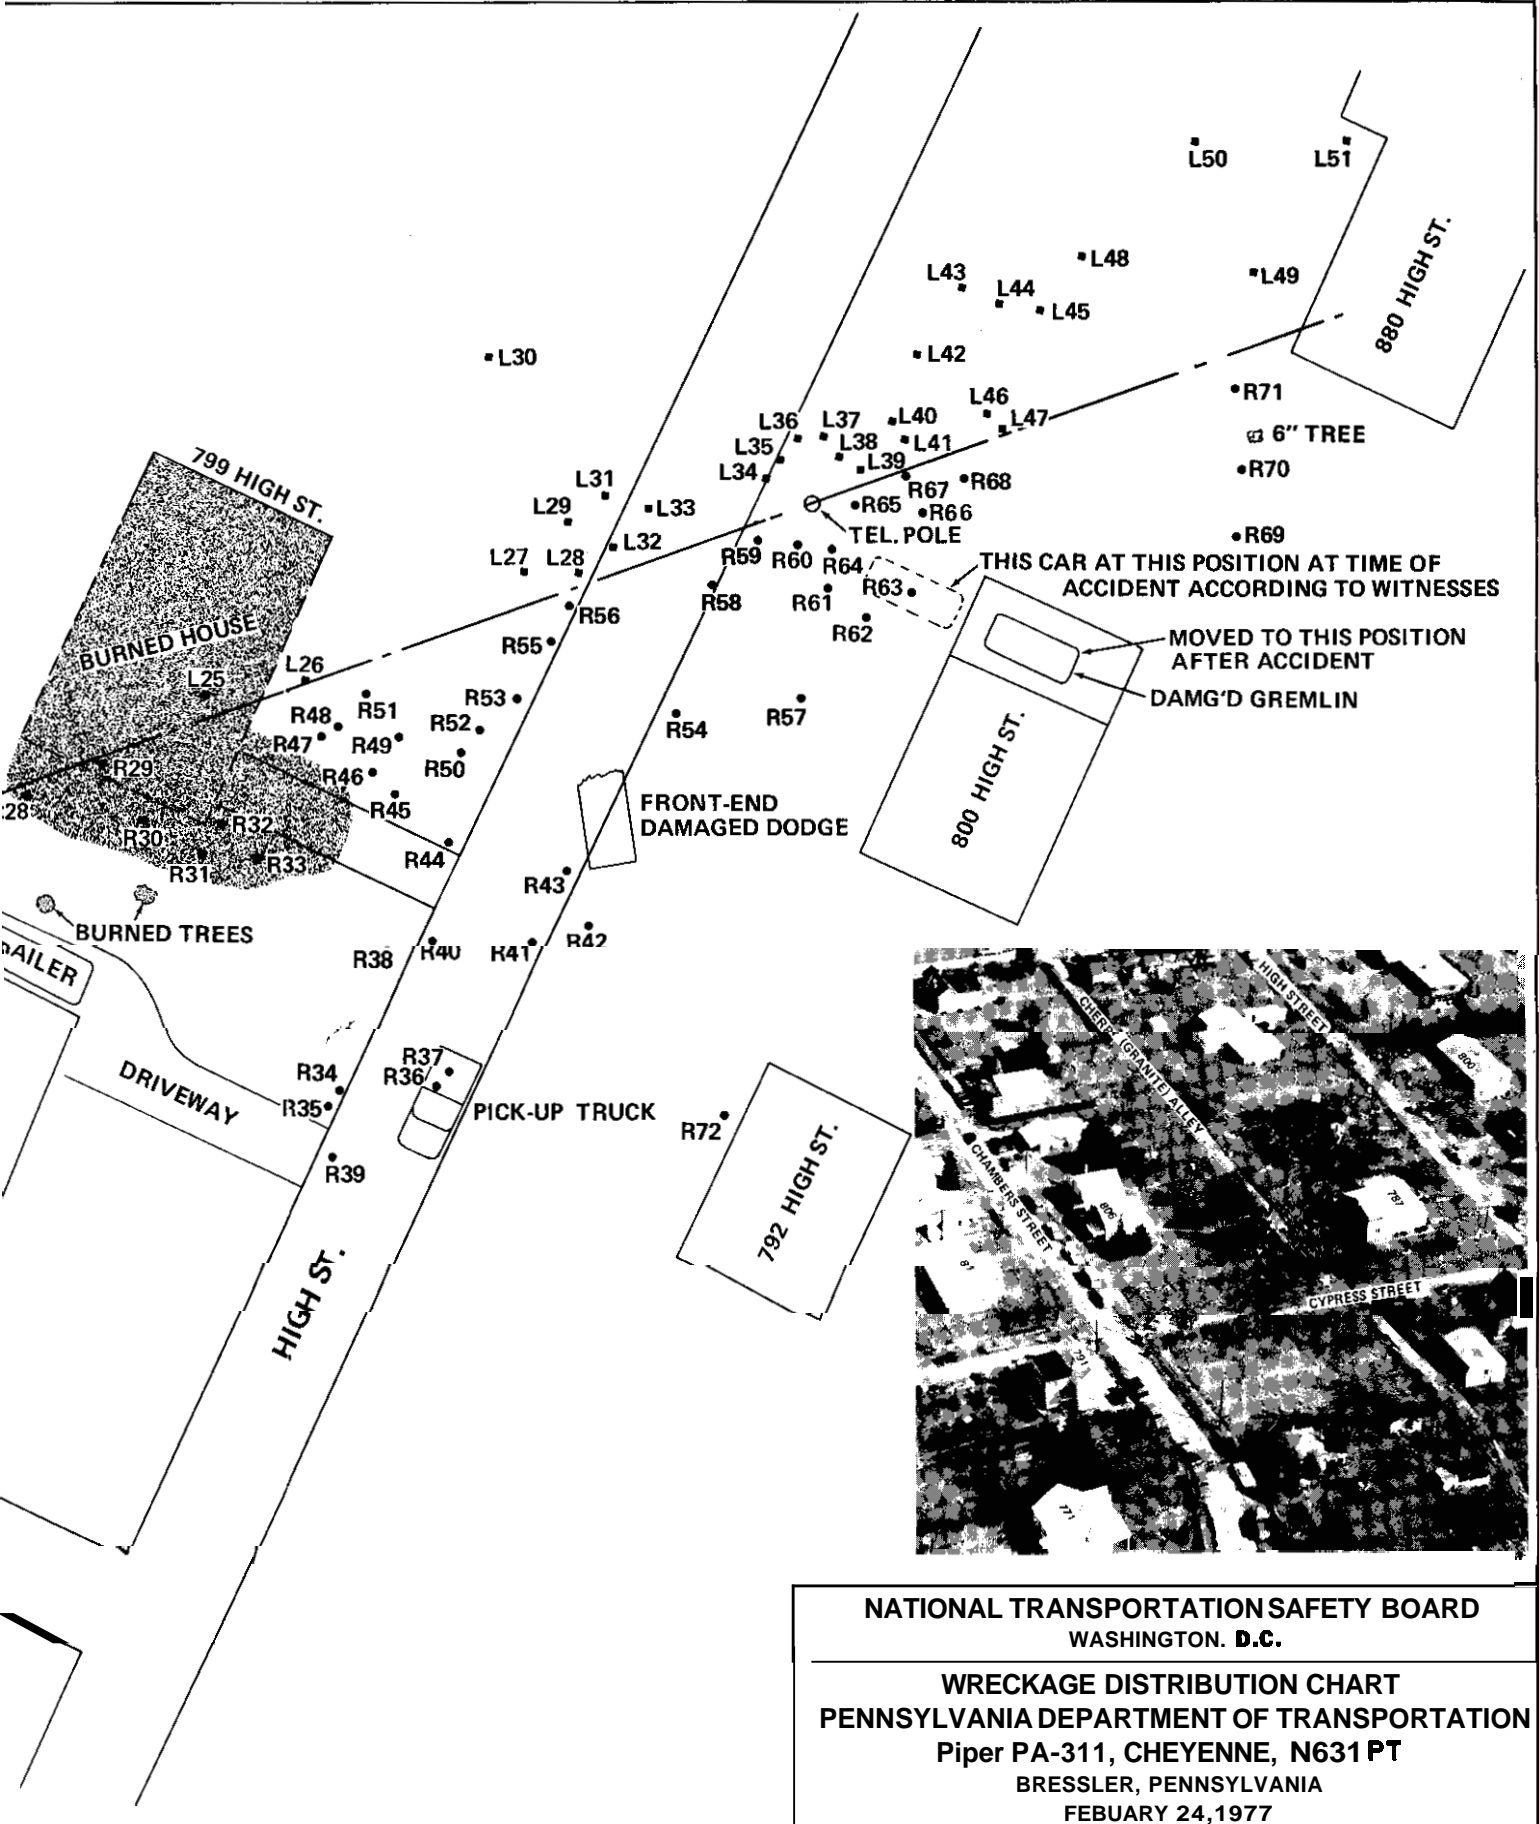
The first signs of contact were found 15 ft above the ground on a 23-ft tree. About 20 ft beyond the tree, the aircraft struck the macadam surface of a street. The marks in the street were made by the aircraft's fuselage and engine nacelles. Propeller slash marks were evident in the impact mark made by the left engine nacelle. The aircraft continued to slide on a magnetic heading of 075°. It struck and continued through a house which erupted in flames. The aircraft then struck and displaced an automobile in the driveway and a pickup truck parked in front of the house. The aircraft wreckage continued across another street and came to rest in a driveway against a telephone pole. The total wreckage area was about 755 ft long and about 210 ft wide. (See Appendix D.)

The aircraft broke up extensively. All but a few small aircraft parts evidenced some degree of ground fire damage. The nose and main landing gear and all flight control surfaces were found. There was no evidence on any structure examined to indicate in-flight fire, explosion, lightning strike, or bird strike. All structural fractures were typical of those caused by overload. The flaps were up and the three landing gear were retracted.
