**Aircraft Accident Report - Continental  
Air Lines, Inc., Boeing 727-224, N32725,  
Tucson, Arizona, June 3, 1977**

U.S. National Transportation Safety Board, Washington, D C

NTSB - AAR - 78 - 9  
C.5

CONTINENTAL AIR LINES, INC.  
BOEING 727-224, N32725  
TUCSON, ARIZONA  
JUNE 3, 1977

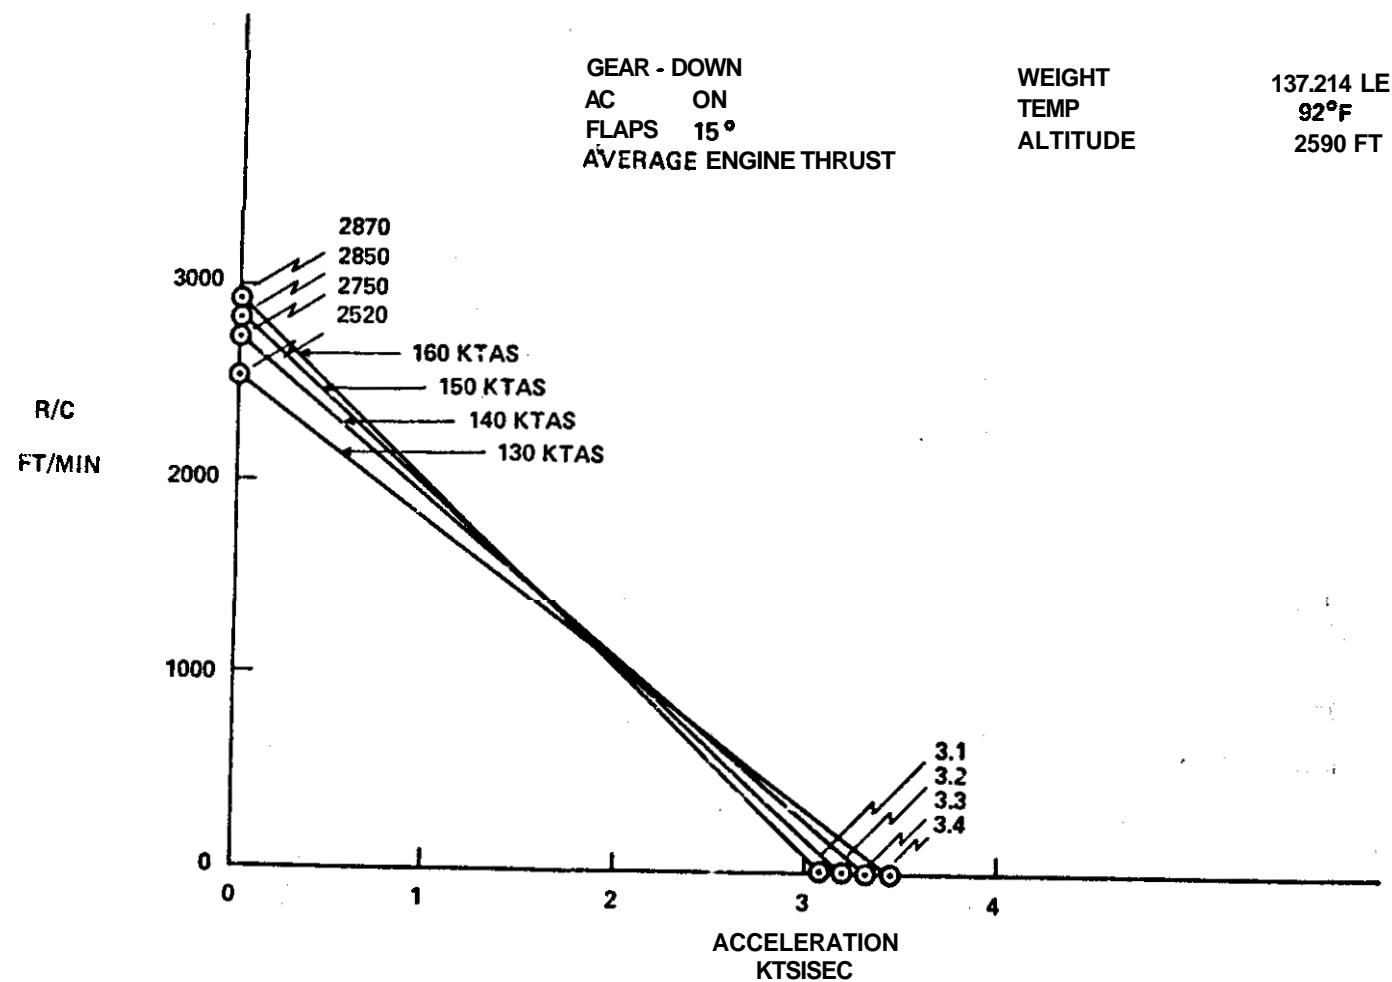
Figure 1. Acceleration vs rate of climb in ground effect Boeing 727-224.
