1. Report No. NTSB-AAR-78-14	2. Government Accession No.	3. Recipient's Catalog No.	
4. Title and Subtitle Aircraft Accident Report - Midair Collision Involving a Falcon Jet, N121GW and a Cessna 150M, N6423K, Memphis, Tennessee, May 18, 1978		5. Report Date November 30, 1978

AIRCRAFT ACCIDENT REPORT

MIDAIR COLLISION  
FALCON JET DA-20, N121GW  
AND  
CESSNA 150M, N6423K  
MEMPHIS, TENNESSEE  
MAY 18, 1978

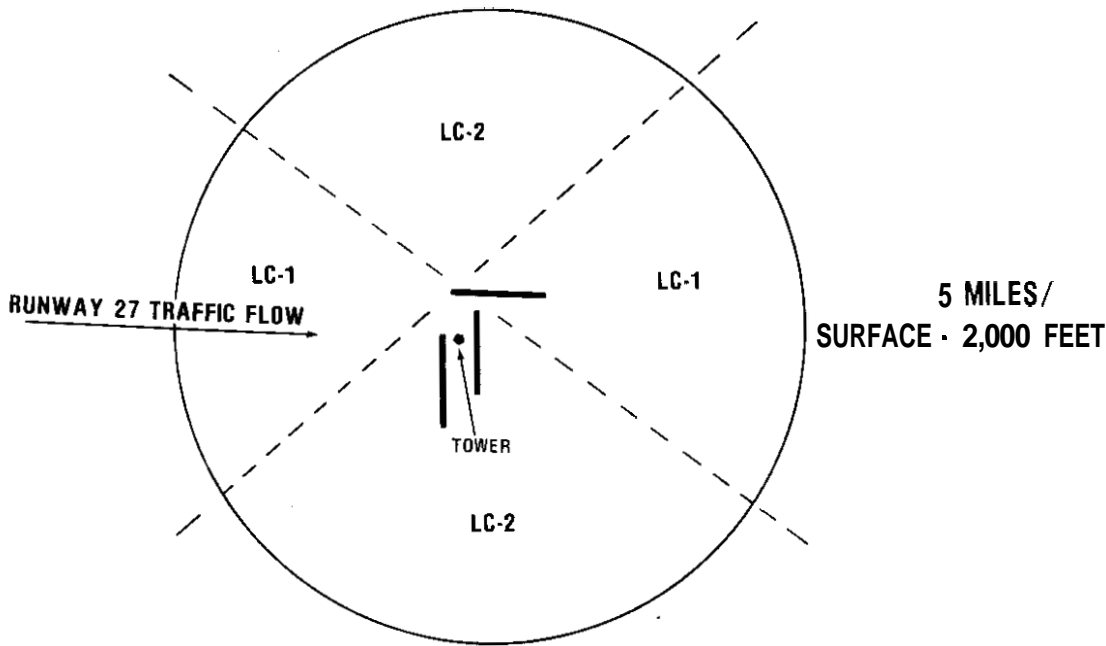
Figure 1. Memphis local controller area of responsibility.

The local controllers, LC1 and LC2, were responsible for controlling traffic in the airspace within a 5-mile radius of the airport from the surface to 2,000 feet. LC1, who controlled operations on runway 9/27, was assigned the airspace east and west of the airport. The airspace north and south of the airport was controlled by LC2, who was responsible for aircraft operations on runways 17L/R and 35L/R. LC1 and LC2 were physically located within 10 ft of each other but operated on separate frequencies. (See figure 1.) ~~On~~ the day of the accident, LC1 and LC2 assumed their operating positions at 1150.

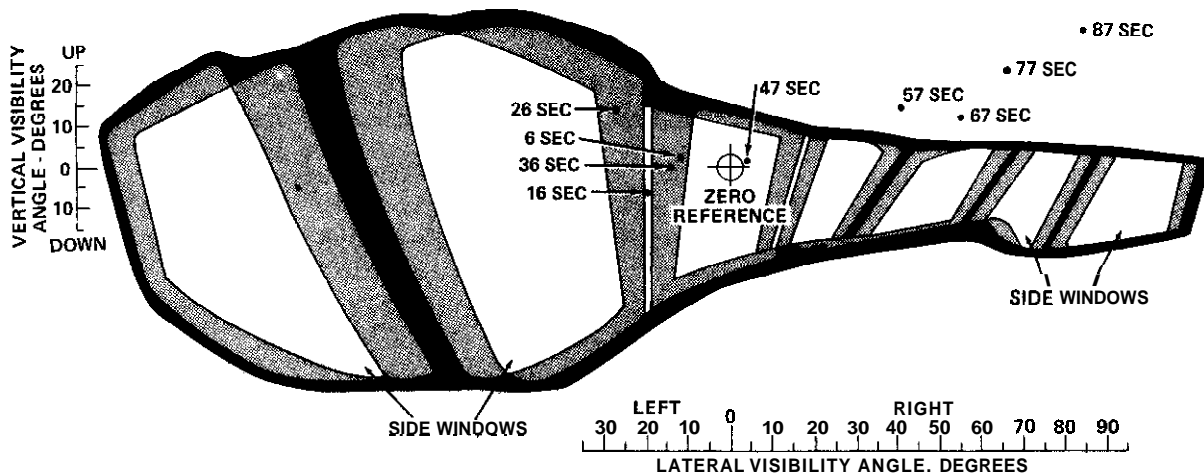
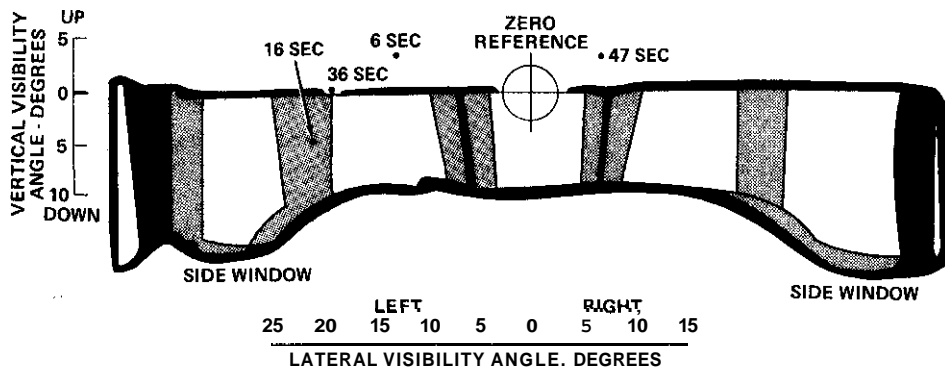
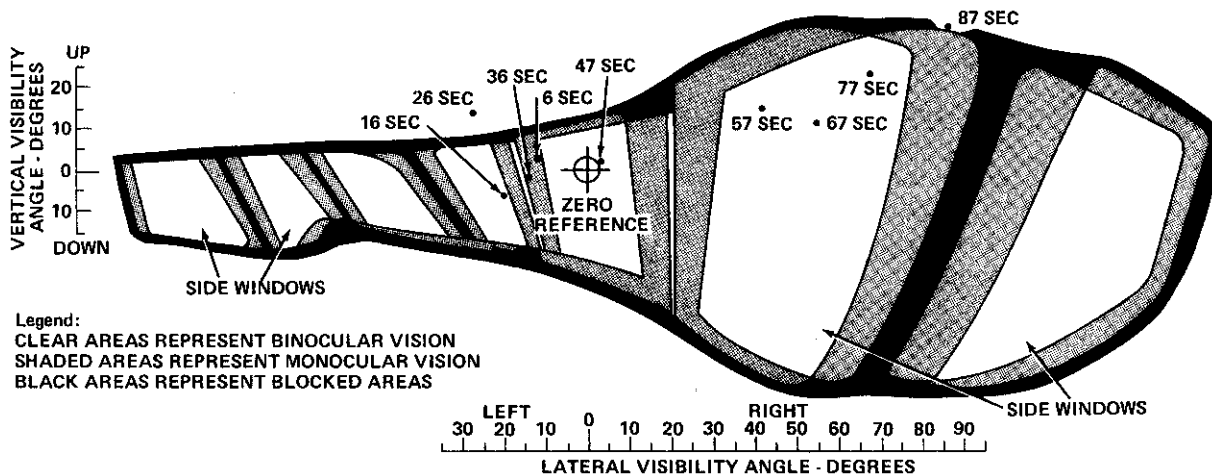
Figure 2. Falcon Jet visibility from design eye reference points.

Although both aircraft were visible at various times to each flightcrew, conditions existed which may have resulted in the failure of the pilots to detect the other aircraft. These conditions were:

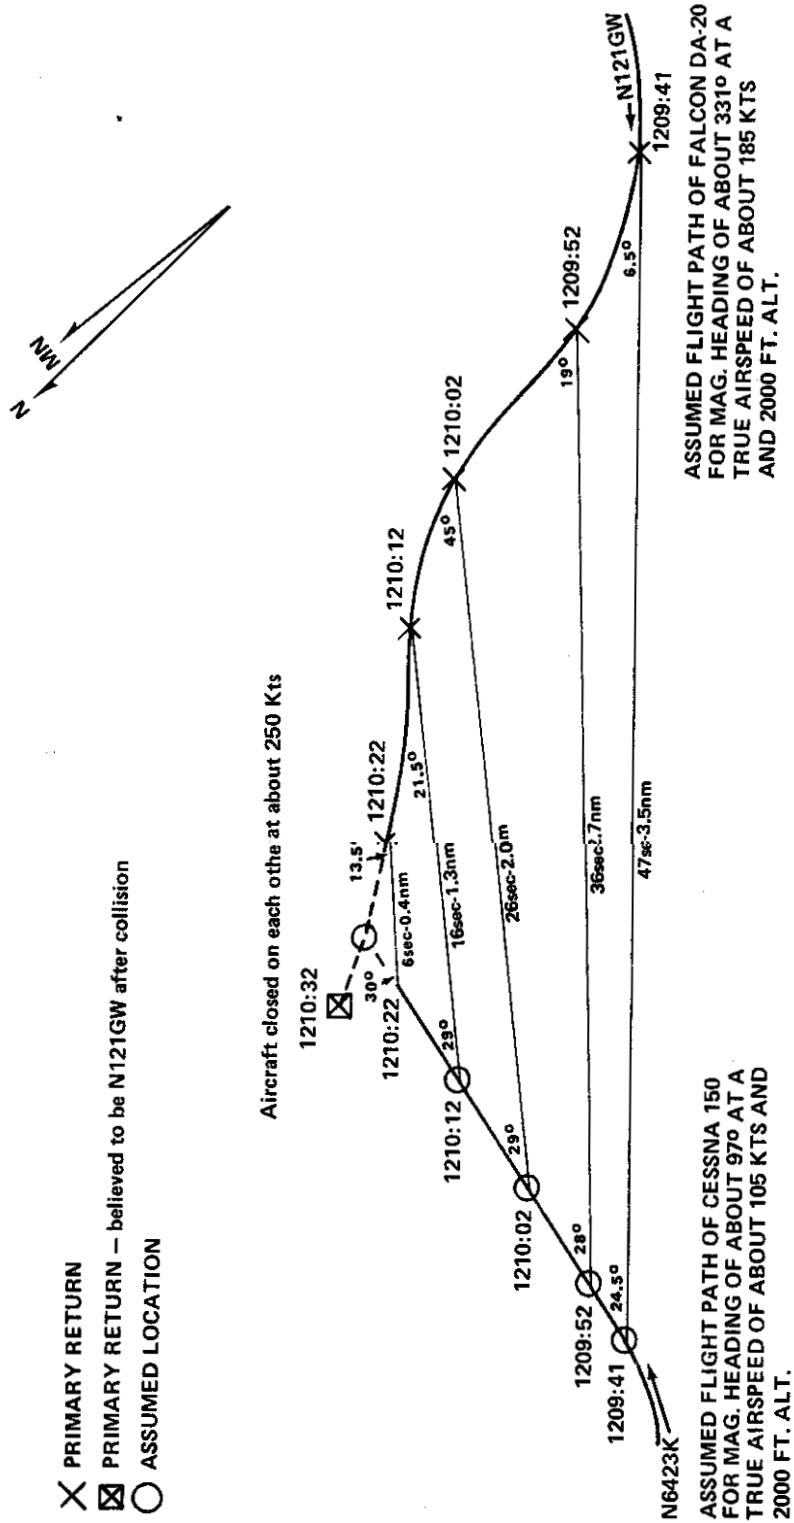
Figure 4. Probable flightpath.

Based on the communications from the local controllers to both aircraft, on radar data, on the scratch-mark analysis, and on the wreckage orientation, the Falcon Jet was probably returning to its assigned heading of  $350^{\circ}$  and passing through  $331^{\circ}$  when it was hit. This conclusion is supported by the  $330^{\circ}$  heading indicated on the copilot's radio magnetic indicator. Although the damage to the directional indicator on the Cessna would imply that the aircraft was on a heading of  $108^{\circ}$  magnetic, it appears more likely that its heading was about  $097^{\circ}$  magnetic. That heading correlates with the scuff marks on the wreckage, the radar position plot, and the heading which would be expected had the aircraft been proceeding to the position for a downwind entry for runway 27. Based on reported wind velocities and direction, true airspeeds would have been about 185 kns for the Falcon Jet and 105 kns for the Cessna. This collision geometry indicates that the planes collided 3 or 4 seconds before the single primary radar return was received at 1210:32. (See Appendix C.)

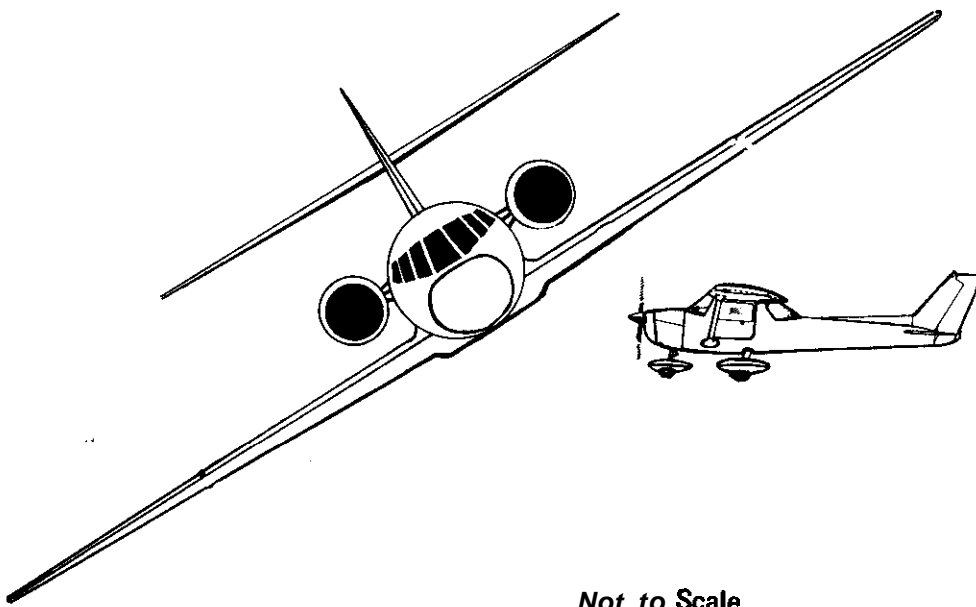
Figure 5. Relative positions of aircraft at impact.

in this area was bowed upward, and blue paint scuff marks were found on the lower side of the depression. The leading edge exhibited another smaller circular depression 55 to 60 inches inboard of the large depression. The inboard depression started 2 to 3 inches outboard of the right fuel tank.

The left wing leading edge, from the wing/fuselage root fairing outboard to rib 5, was broken into pieces of various sizes. Extensive red paint scuff marks were found on the lower skin surface. The red scuff marks extended outboard at 90° from the wing root rib for a distance of 69 inches. The scuff marks extended from the leading edge lower surface aft to the forward edge of the skin panel just forward of the rear spar. The red scuff marks were measured near the leading edge and near the wing root rib. This angle measured 27° from the wing root rib direction. The scuff mark angles after the initial impact point showed varied inconsistent angles.

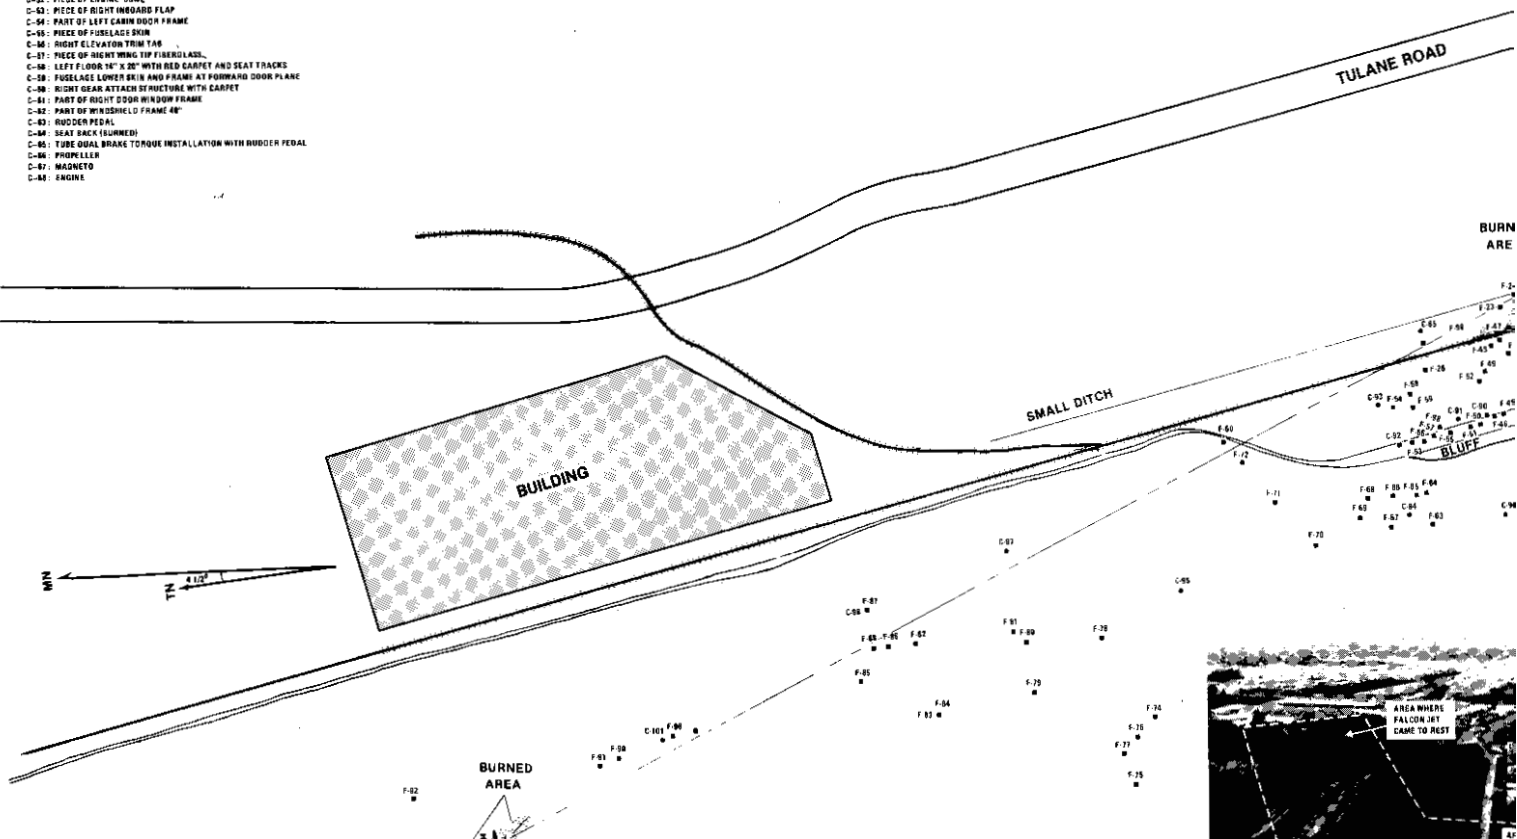
**NATIONAL TRANSPORTATION SAFETY BOARD**  
 WASHINGTON, D.C.  
 WRECKAGE DISTRIBUTION CHART  
 MIDAIR COLLISION  
 FLIGHT SAFETY INTERNATIONAL, FALCON JET,  
 N121GW AND MEMPHIS FLYING CLUB,  
 CESSNA 150M, N6423K

The debris from the Falcon was scattered over undeveloped land which bordered an industrial park. Three brush fires and limited ground damage resulted from the debris.
