1. Report No. NTSB-AAR-78-15		2. Government Accession No.		3. Recipient's Catalog No.	
4. Title and Subtitle Aircraft Accident Report -- Columbia Pacific Airlines, Beech 99, N199EA Richland, Washington, February 10, 1978				5. Report Date December 21, 1978

AIRCRAFT ACCIDENT REPORT

At 1650 P.s.t. on February 10, 1978, Columbia Pacific Airlines, Inc., Flight 23, a Beech 99, crashed in visual flight rules conditions on takeoff from runway 36 at the Richland Airport, Richland, Washington. Flight 23, a regularly scheduled passenger flight to Seattle, had 15 passengers and 2 crewmembers on board. After liftoff, the aircraft climbed steeply to 400 feet above the runway, then stalled and crashed 2,000 feet beyond the end of the runway. A severe fire erupted after impact. All persons on board were killed, and the aircraft was destroyed.

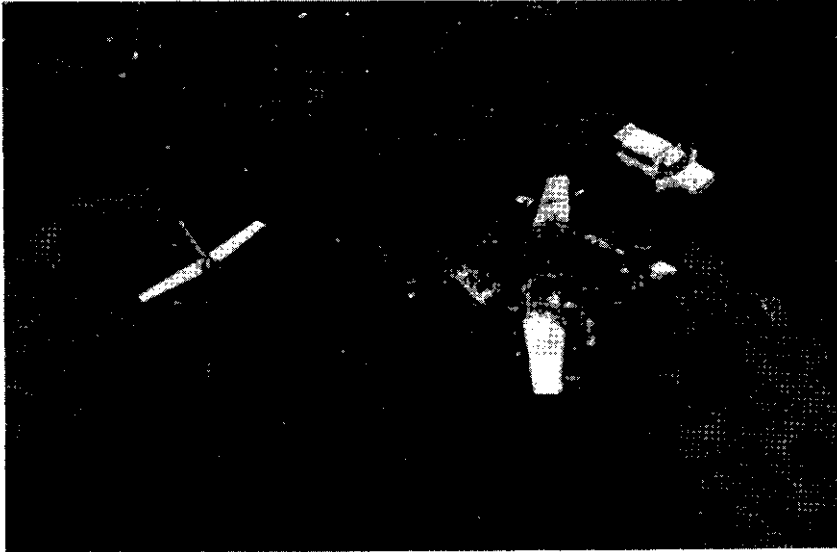
Figure 1. Aerial view of wreckage site.

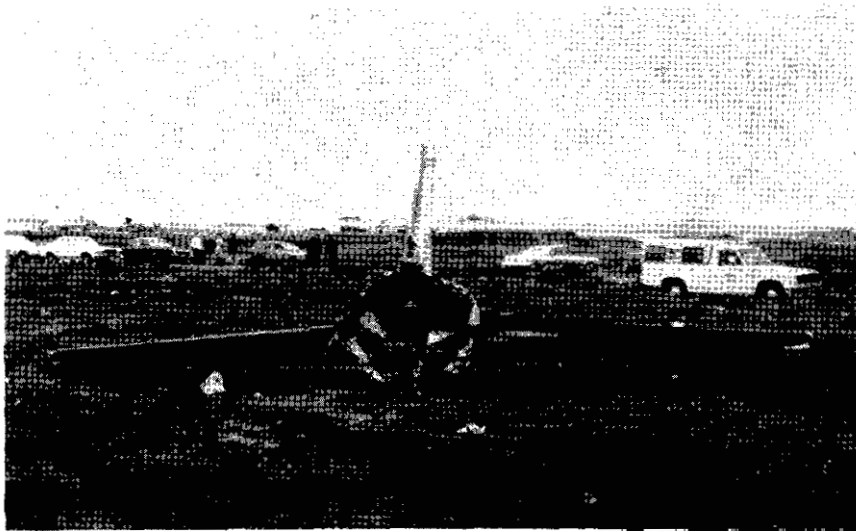
The empennage separated at fuselage station (FS) 409.50. It had broken circumferentially because of compressive forces--the lower half was deformed more than the top half. The torque tube in the horizontal stabilizer, its largest structural member, contained a transverse fracture at its midpoint in the tube-box assembly. Normally the stabilizer has a 7° dihedral angle. The torque tube was broken by impact forces, allowing the stabilizer to droop. (See figure 2.)

Figure 2. Front view of separated empennage.

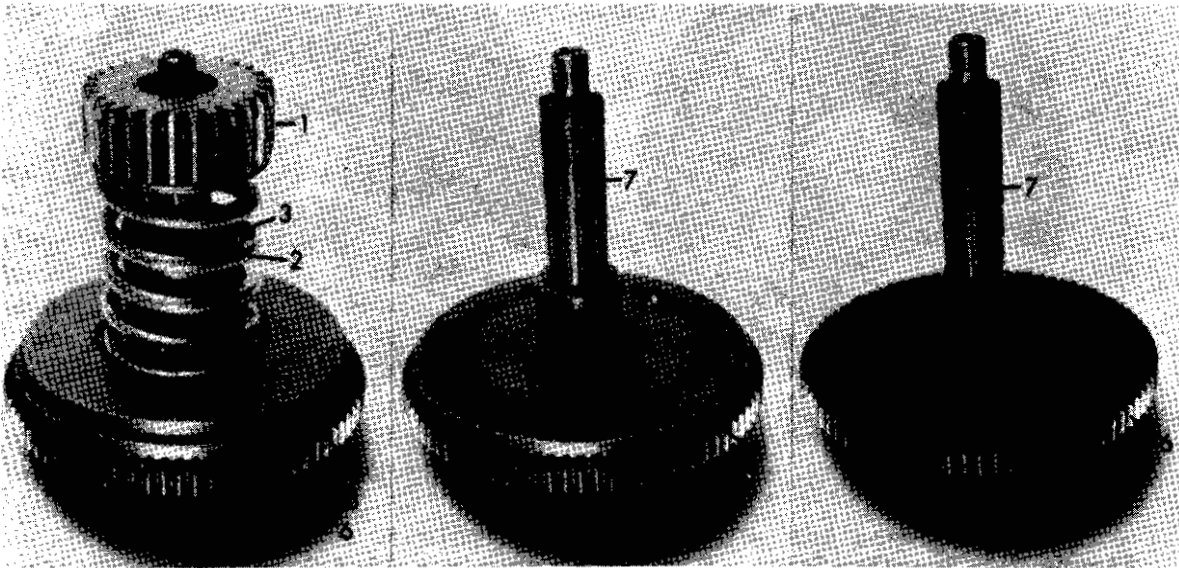
Safety Board investigators examined the actuator manufactured by the Talley Corporation of Newbury Park, California, at Talley's facility. Four of the ball bearings were loose and were outside the clutch detent plate--all exhibited little to no wear. Two ball bearings within the detent plate were worn to an oval shape. Engineering specifications require a 0.045-inch clearance between the spacer and the clutch output gear. When the clearance was measured with four unworn balls installed in the clutch, there was not sufficient clearance to allow a normal size ball bearing to miss the detent plate. (See figures 5 through 8.)

Figure 5. Clutch assembly in various stages of disassembly, 1) output gear, 2) spring, 3) spacer, 4) ball retainer, 5) detent plate, 6) torque limit gear, 7) shaft. All photos X2

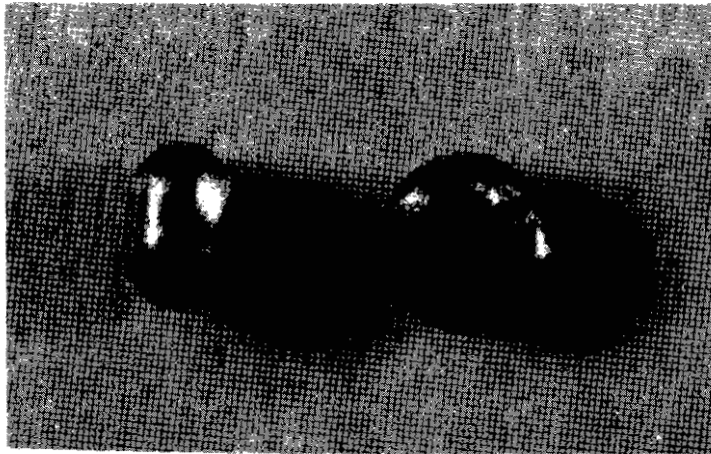
Figure 6. Balls taken from the clutch assembly. X10

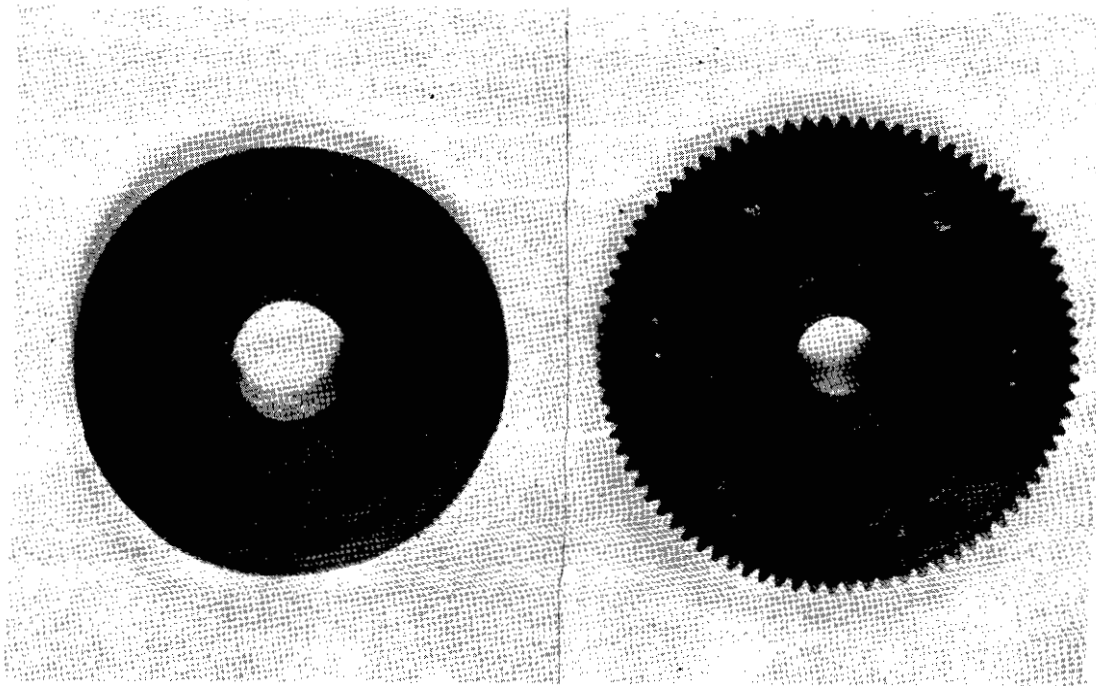
Figure 7. Bearing faces of the ball retainer (left) and torque limit gear (right). Brackets indicate rings of *ball* material deposited on these components. X2

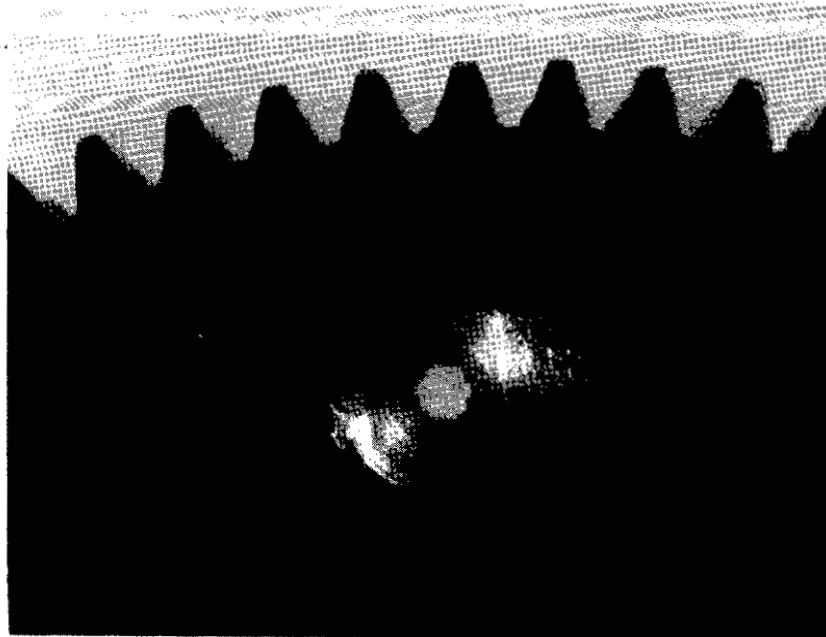
Figure 8. One of the ball depression holes on the torque limit gear showing areas of wear. X10

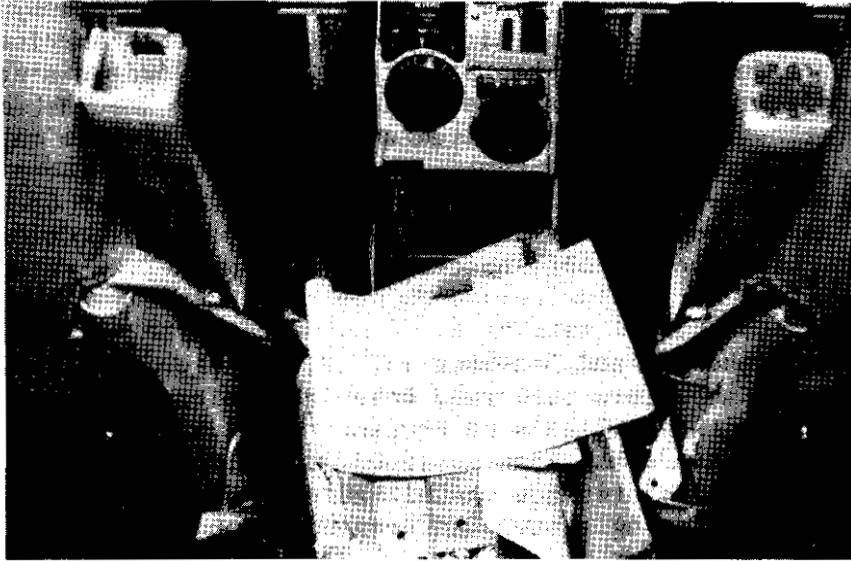
On February 23, 1978, a Safety Board investigator boarded Columbia Pacific Flight 11 (N1034S) at Richland to fly to Seattle. During the flight, the investigator noted that the crew had positioned their flight bag between their seats adjacent to the control pedestal. This is a normal procedure. The front left corner of the bag was against the horizontal stabilizer main and standby trim power switches. The seams of the front left and right rear corners of the bag were torn severely from placing or removing items such as the flight manual and daily flight log. (See figure 10.) Since the switches are only partially guarded, a crewmember can inadvertently turn the main power switch off by placing a flight log into the bag. During a survey of Beech 99 operators, investigators learned of eight reported instances of this; these pilots, however, immediately noticed the mistake.

Figure 10. Closeup of flight bag with front left corner against main and standby trim switches. Note the torn seams of the bag.
