1. Report No. NTSB-AAR-79-3		2. Government Accession No.		3. Recipient's Catalog No.	
4. Title and Subtitle Aircraft Incident Report E.S.M. Group, Inc., Cessna Citation, N51MW, North Central Airlines, Inc., DC-9-30, N957N, La Guardia Airport, Flushing, New York, June 21, 1978			5. Report Date February 22, 1979

AIRCRAFT INCIDENT REPORT

E.S.M. GROUP, INC., CESSNA CITATION, N51MW
NORTH CENTRAL AIRLINES, INC.
DC-9-30, N957N
LA GUARDIA AIRPORT, FLUSHING, NEW YORK
JUNE 21, 1978

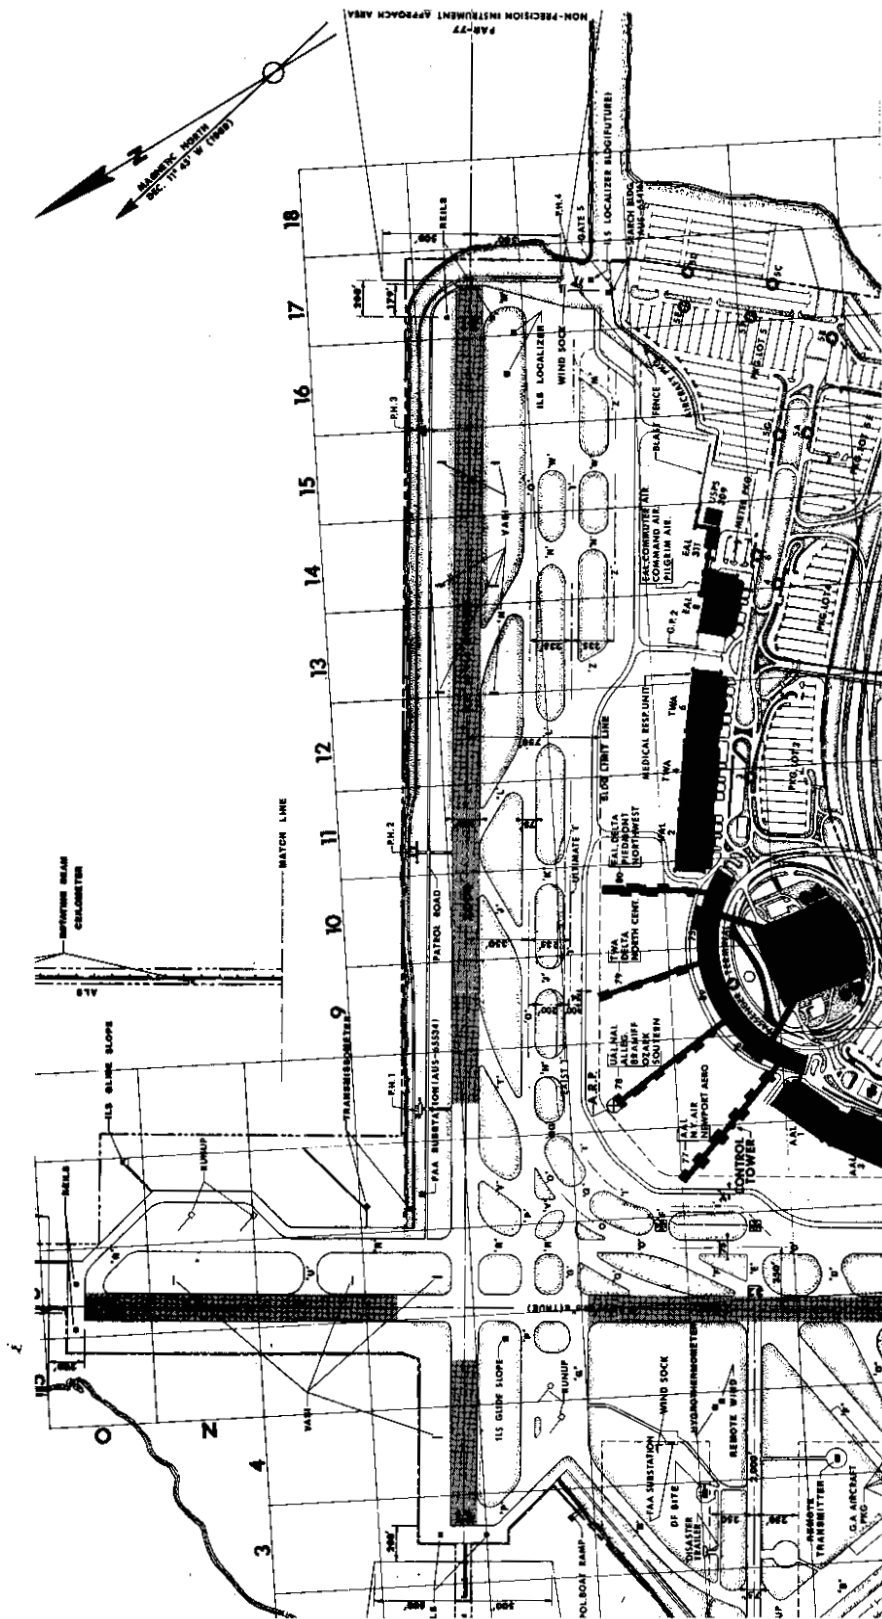
Figure 1 L3 Guardia Airport Runway 13/E1 and Associated Taxiways.

The captain said that he taxied on one engine. The taxi route required a right turn of almost 135° from taxiway Oscar to taxiway Tango and a left turn of almost 135° from Tango onto runway 31. Because the left turn onto the runway was more than 90°, he could not see the northwest end of the runway when he began the turn. As he was completing the turn -- the captain estimated he had "about 40" to go" -- he saw two lights coming down the runway at a high rate of speed. Shortly thereafter, he said he saw rotating beacons around the lights. He stopped his airplane and turned on his landing lights. The DC-9 stopped with its nose just over the runway's centerline. The flightcrew was not monitoring the local control frequency nor were they required to do so.

The 135° left turn from taxiway Tango to the active runway made it almost impossible for the DC-9 flightcrew to see the takeoff end of runway 13 before they began the turn and during the initial stages of the turn.

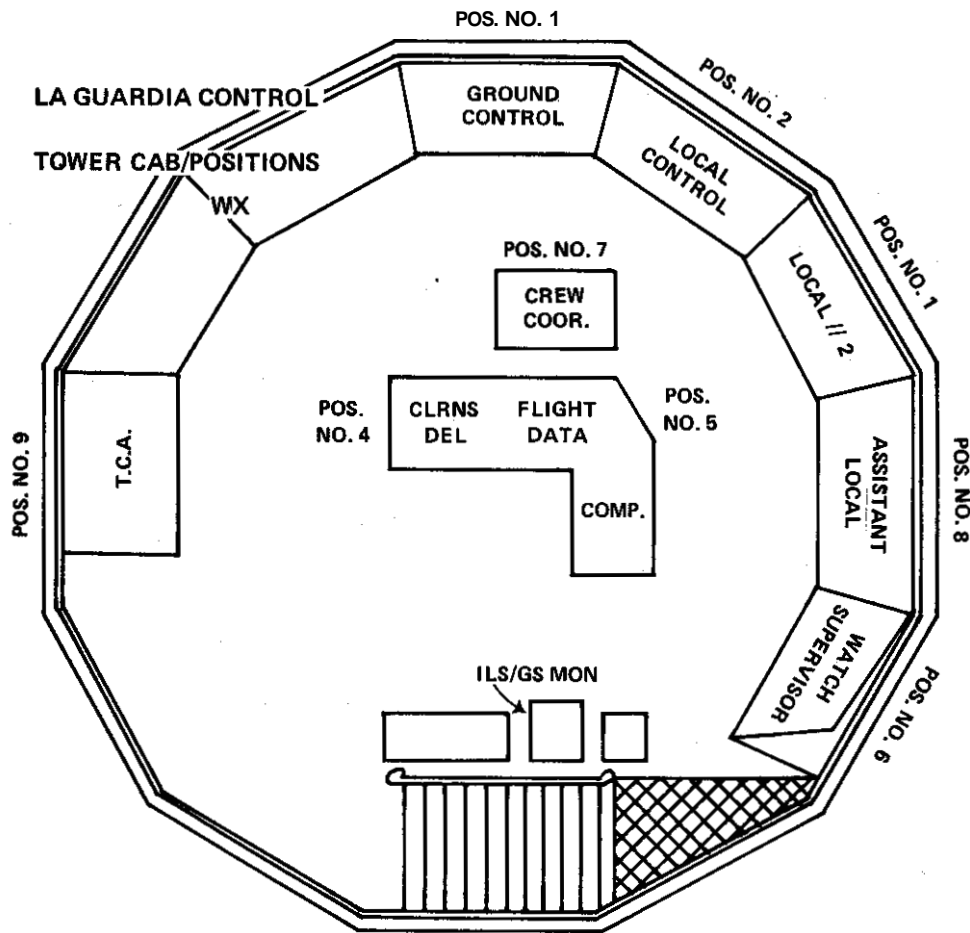
Figure 2. La Guardia control tower Cab positions.

The local controller and ground controller are positioned approximately side by side in the tower cab. The crew coordinator is positioned between and behind the ground and local controller positions. (See figure 2.) The local controller is responsible for handling all arriving and departing traffic and has the responsibility for the use of all runways on the airfield. The ground controller is responsible for the handling of ground movements of aircraft.

Although the crew coordinator cannot grant approval to use the active runway, he is authorized to relay an approval from the local controller to the ground controller. In this instance the crew coordinator stated that he heard the ground controller ask for approval to taxi the DC-9 along the active runway, and that the local controller answered, "yes, go ahead or some answer to the affirmative."
