# NATIONAL TRANSPORTATION SAFETY BOARD

## ERRATA

AIRCRAFT ACCIDENT REPORT - North Central Airlines, Inc.  
Convair 580, N4825C, Kalamazoo Municipal Airport,  
Kalamazoo, Michigan, July 25, 1978, Report Number -  
NTSB-AAR-79-4

AIRCRAFT ACCIDENT REPORT

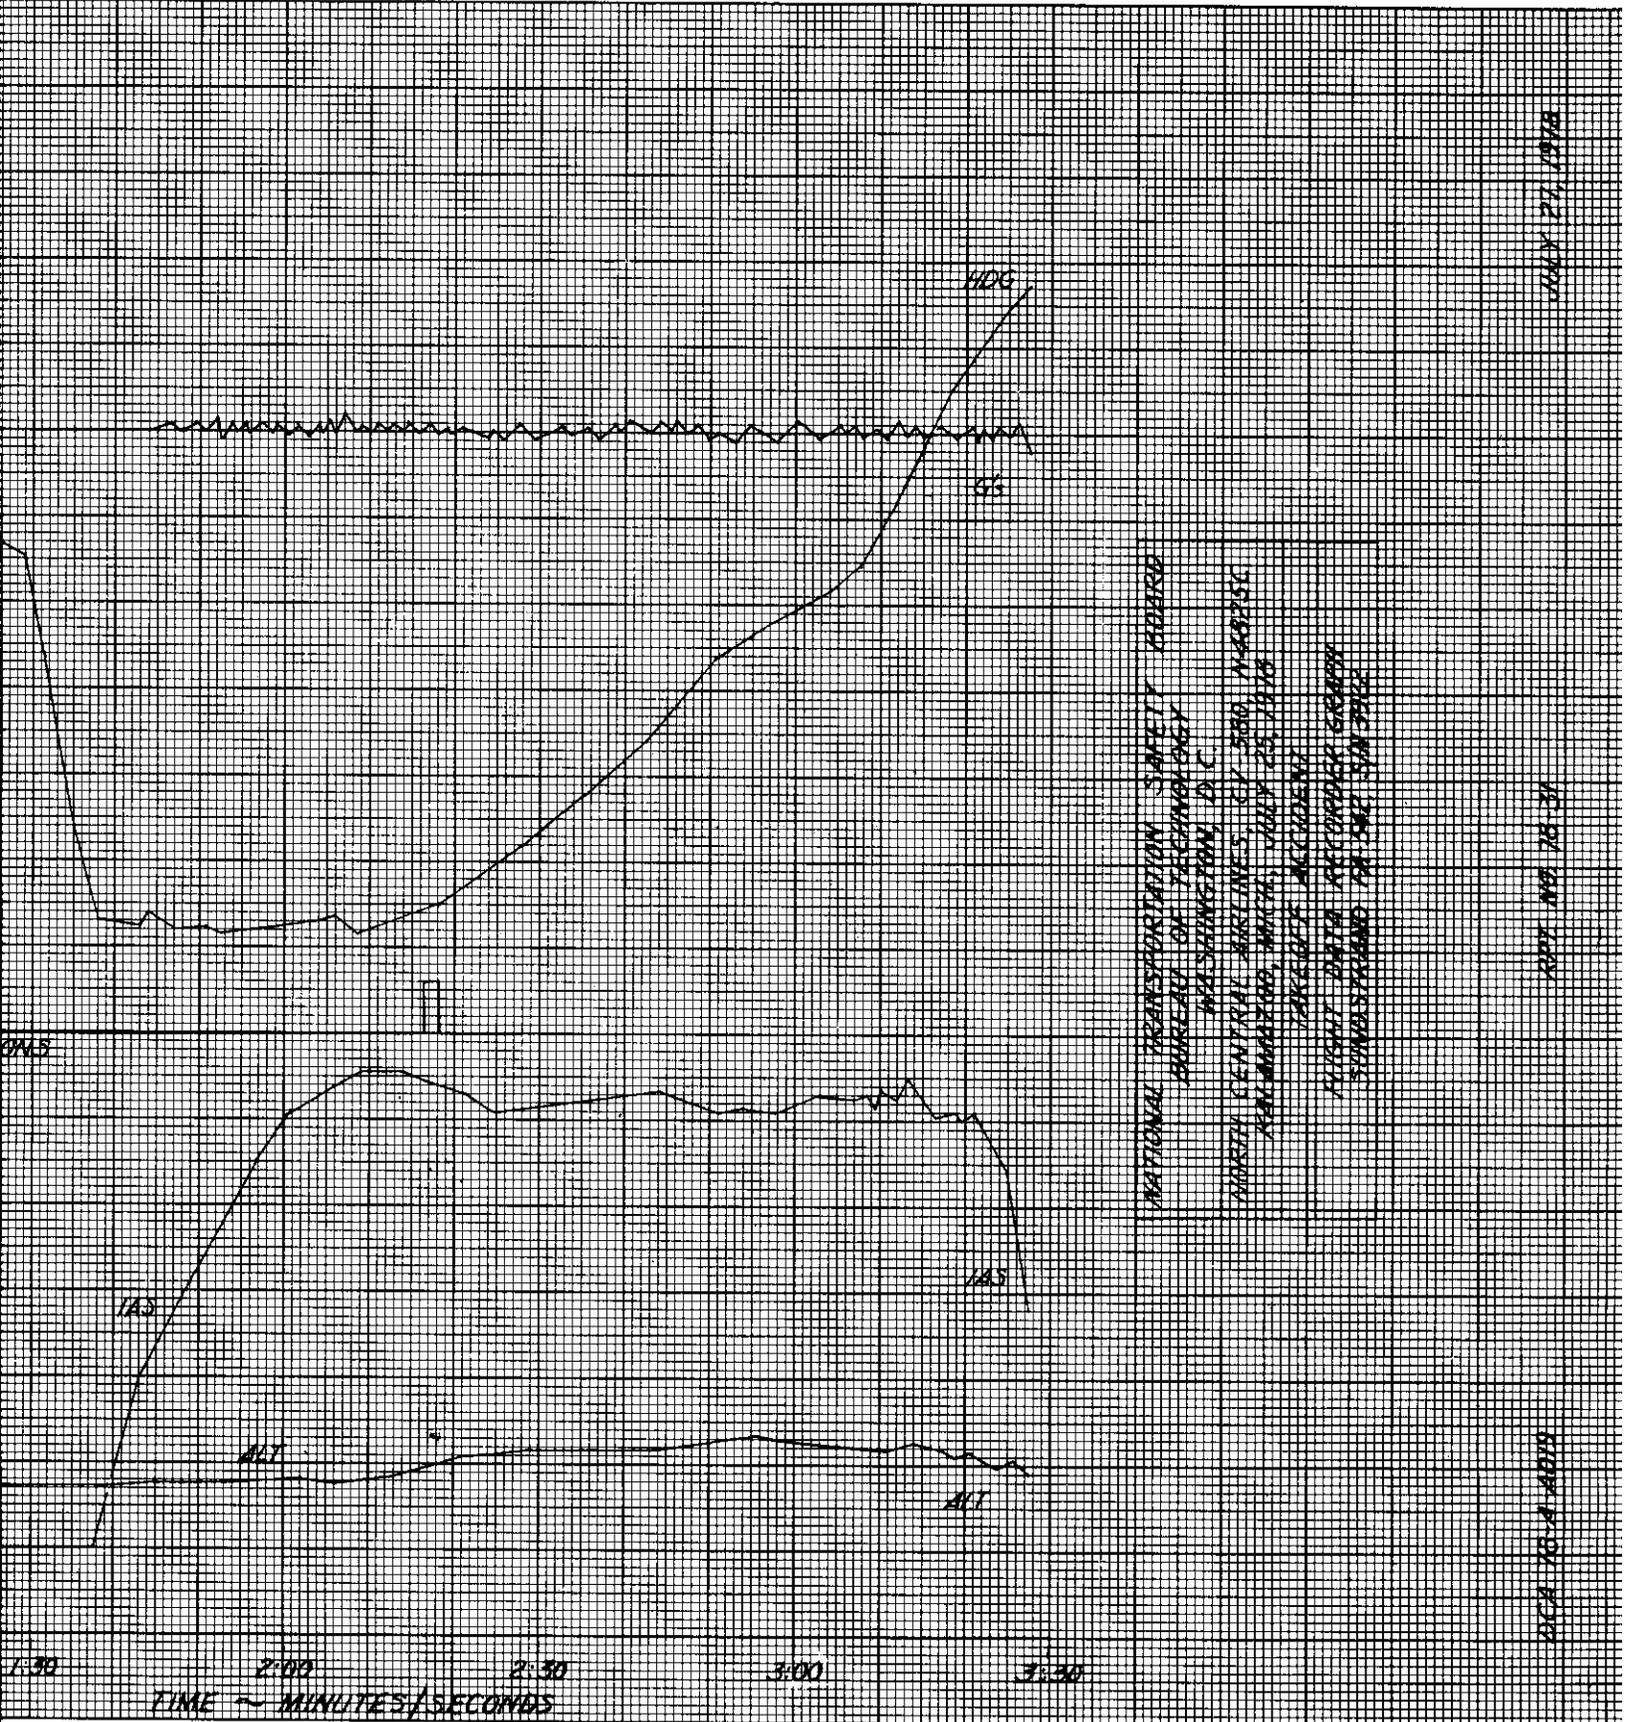
N4825C was equipped with a Sundstrand Data Control model FA-542 flight data recorder, Serial No. 3922. The FDR was not damaged, and all traces were clear and active. (See Appendix E.)

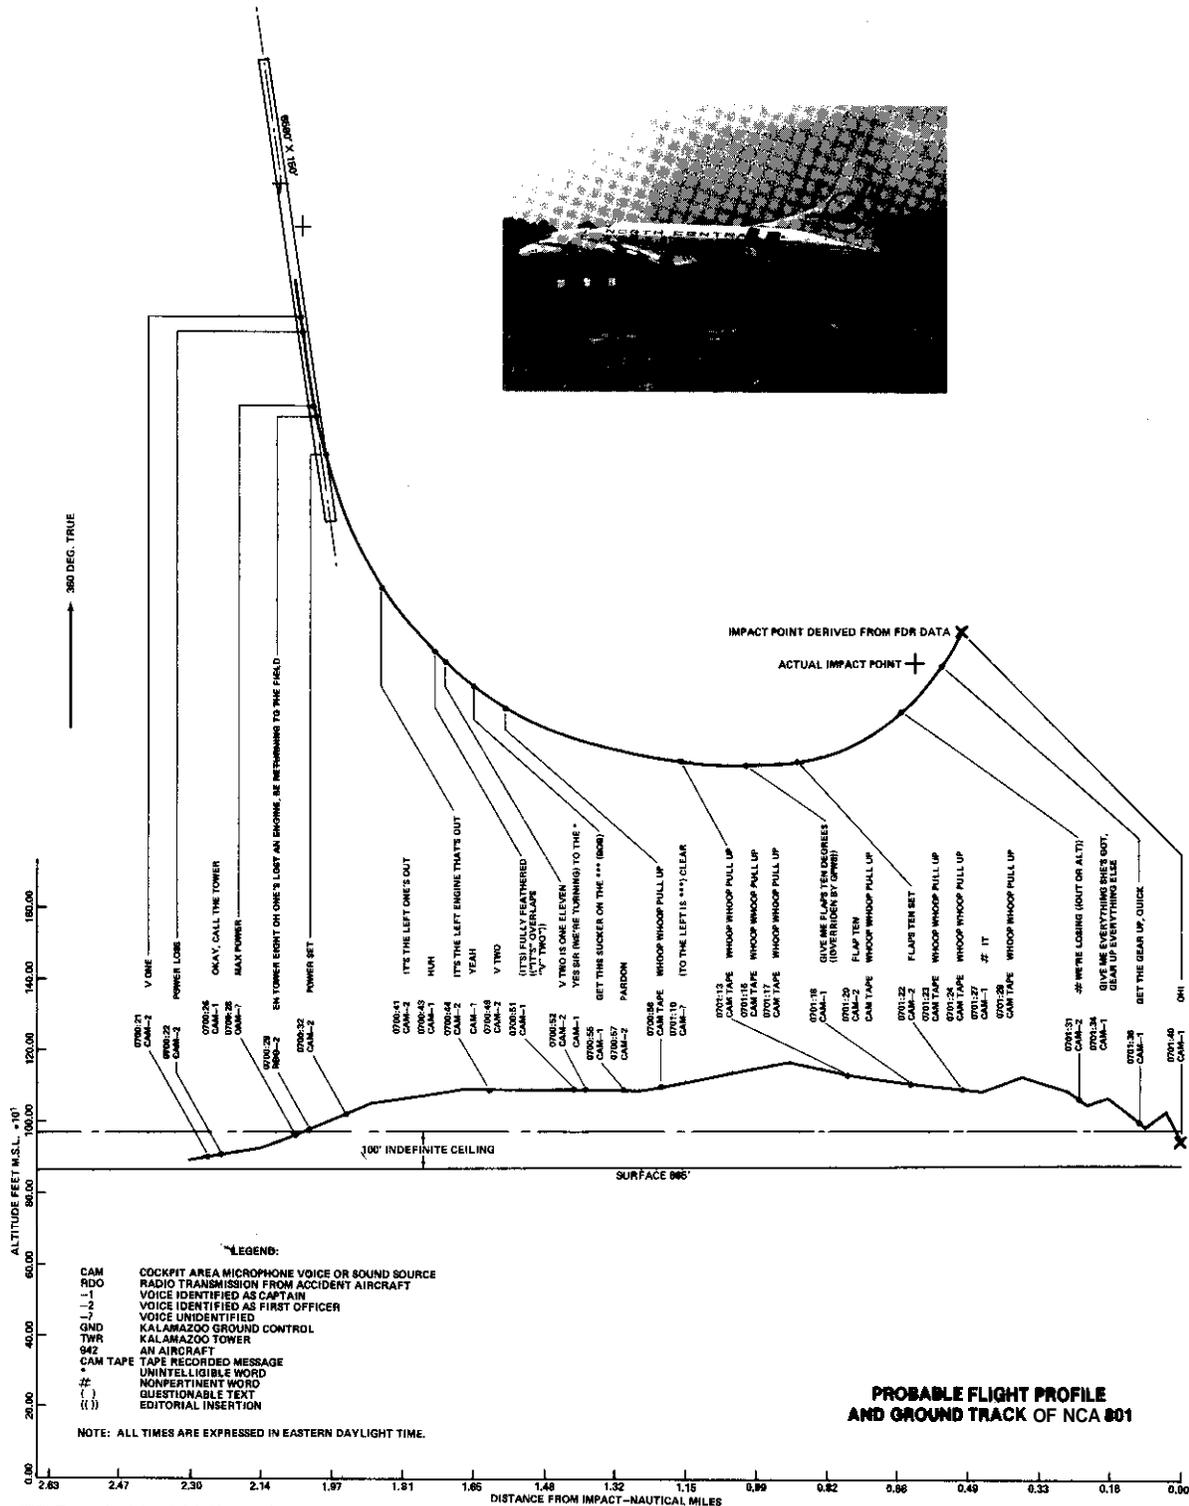
APPENDIX F

NOTE: The ground track shown is derived from aircraft speed, altitude, and heading as recorded by the FDR and does not reflect the influence of side-slip. Winds used in the plot are derived from tower and National Weather Service data.

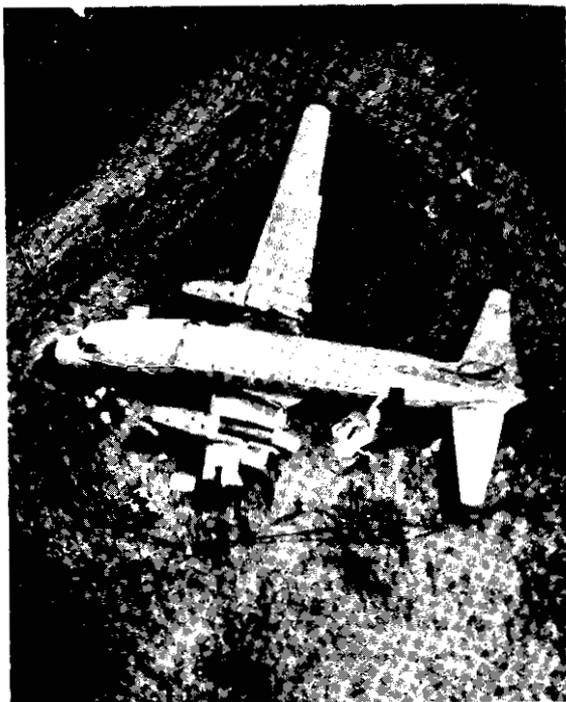
APPENDIX G

The wreckage area was about 433 ft long by 90 ft wide oriented on a magnetic heading of about 40°. (See Appendix G.) There was no evidence of in-flight structural failure of any aircraft part.

The left wing outboard of the nacelle separated at the rear spar about 80 ft beyond where the wingtip first hit the ground. The outboard left aileron also separated from the wing. The flap trailing edge measured 17 5/8 ins. from the aft wing skin edge, which corresponds to about a 12° flap setting. The right wing was damaged, but remained attached to the fuselage. The flap trailing edge measured 18 ins. from the aft wing skin edge--about a 12° flap setting.
