**NATIONAL
TRANSPORTATION
SAFETY
BOARD**

**LAS VEGAS AIRLINES
PIPER PA-31-350, N44LV**

**LAS VEGAS, NEVADA
AUGUST 30, 1978**

NTSB-AAR-79-8
c.3

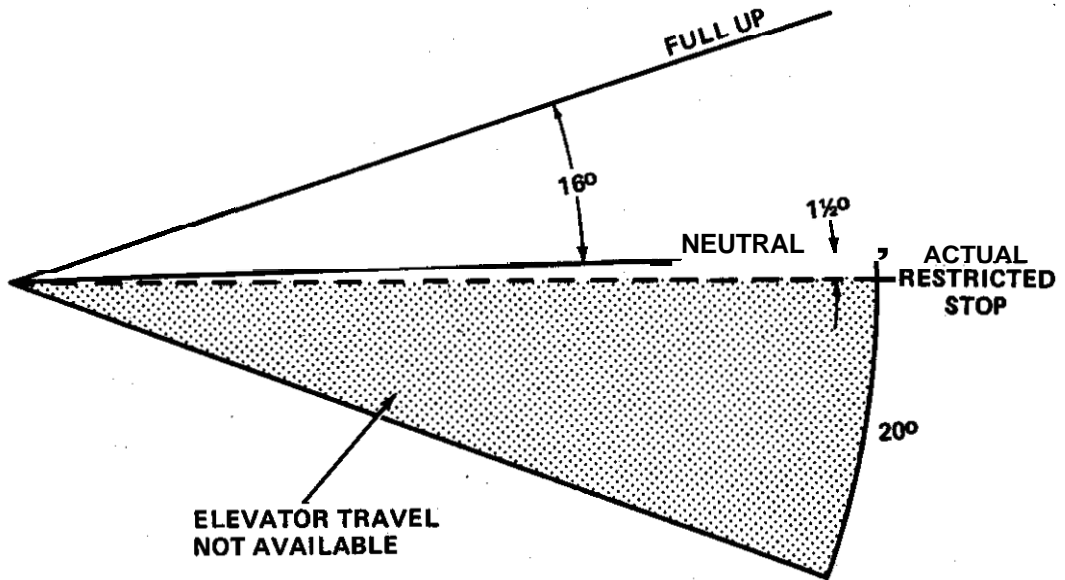
Figure 2. Elevator down travel restriction resulting from backed out down stop.

Except for the backed out elevator control stop bolt, all flight controls, flight control surfaces, and cables showed no evidence of preimpact failures or binding. The elevator down-stop bolt was found backed out from its correct position, which limited down elevator deflection to a maximum of $1\ 1/2^\circ$.

8. The down elevator control stop was found backed out from its normal installed position. The position of the bolt limited the down elevator travel to only $1\ 1/2^\circ$ of a normal 20° range.

On March 29, 1979, Piper Aircraft issued a Service Bulletin which required that PA-31 operators inspect their aircraft within the next 25 hours for loose elevator stop bolts and that the stop bolts be torqued to 20 to 25 in./lbs. Additionally, the Piper final quality control inspection of elevator rigging has been changed. Piper now torques the stop bolts to the recommended torque value when the elevator is rigged.

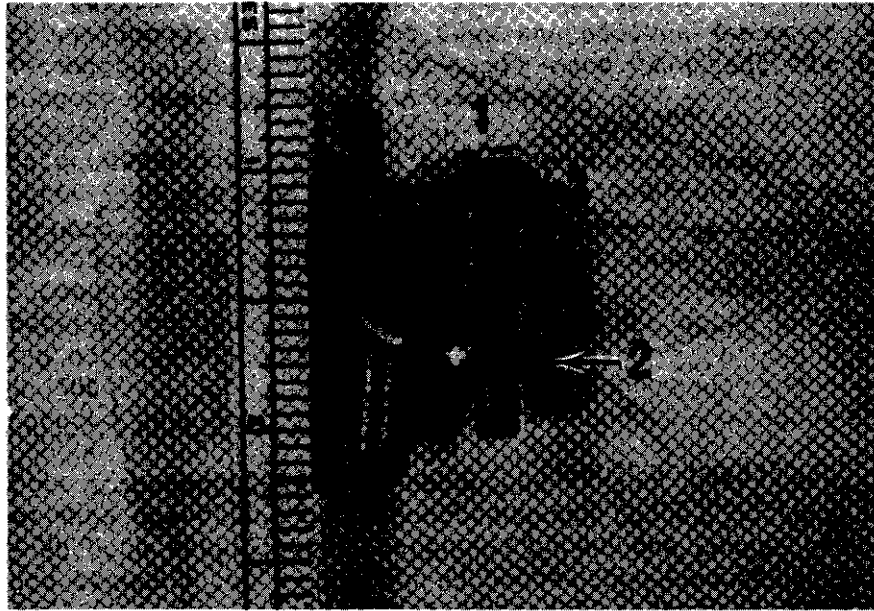
4. The head of the down-stop bolt was bent as if it had been struck by a slightly off-center blow to the longitudinal axis. (See figure 4.)
5. The area on the torque tube arm where the down-stop bolt had been striking had seven separate impact marks. The design of the assembly is such that the bolt strikes the torque arm at a different position depending on the length of the bolt extension. The farthest outboard impact was also the deepest and aligned with the length of the bolt as it was found. (See figure 5.)

Figure 4. Up elevator stop and down elevator stop 1) Bent head of down-stop bolt, 2) Jam nut location as found, 3) Overspray from aircraft paint. ■

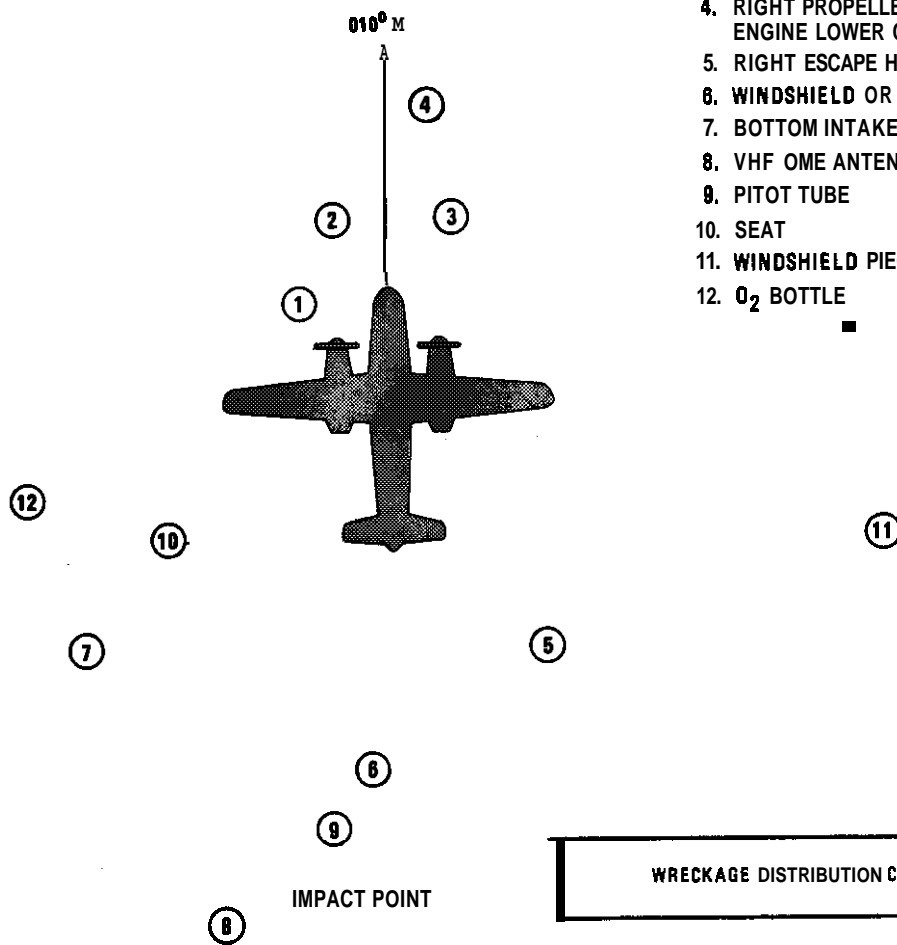
APPENDIX F

- 1. LEFT PROPELLER
- 2. TOP COWLING R. ENGINE
- 3. FRONT BAGGAGE DOOR
- 4. RIGHT PROPELLER AND RIGHT ENGINE LOWER COWLING
- 5. RIGHT ESCAPE HATCH
- 6. WINDSHIELD OR WINDOW
- 7. BOTTOM INTAKE MANIFOLD
- 8. VHF OME ANTENNA
- 9. PITOT TUBE
- 10. SEAT
- 11. WINDSHIELD PIECES
- 12. O₂ BOTTLE

NOTE
CIRCLES PHYSICALLY REPRESENT
LOCATION OF PARTS IMMEDIATELY
AFTER IMPACT
