ERRATA

AIRCRAFT ACCIDENT REPORT - NTSB-AAR-79-11

NEAR COLLISION OF
DELTA AIR LINES, INC.,
BOEING 727-200, N467DA AND
FLYING TIGER, INC.,
BOEING 747-F, N804FT
O'HARE INTERNATIONAL AIRPORT
CHICAGO, ILLINOIS
FEBRUARY 15, 1979

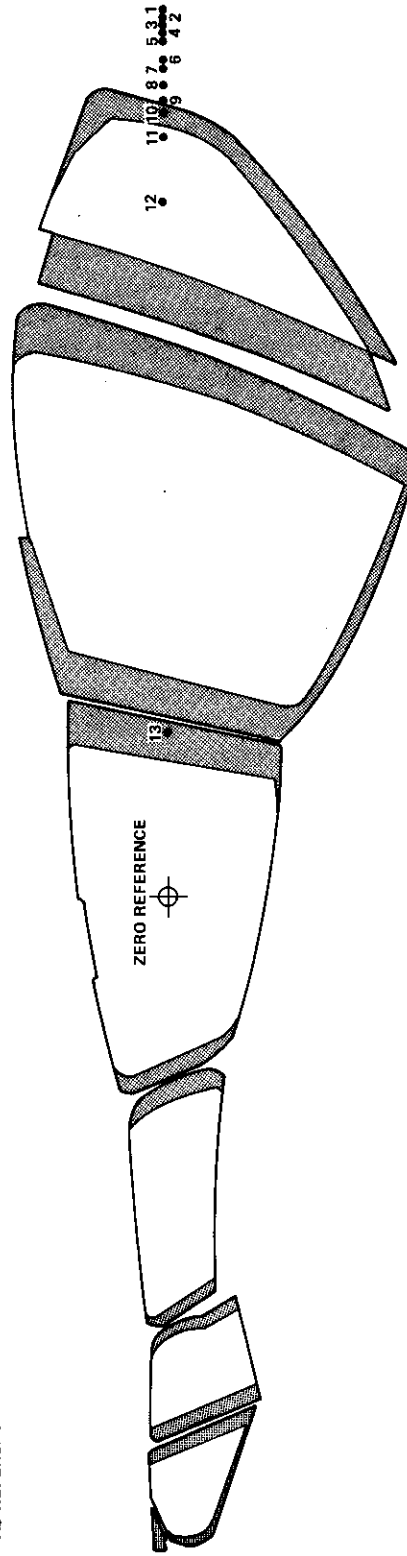
FIGURE 1

• REPRESENTS LOCATION OF BOEING 747
 NAFEC PHOTO AUB DECEMBER 1978

NUMBERS DENOTE TIME AND POSITION OF B-747
 AS REFERENCED APPENDIX D

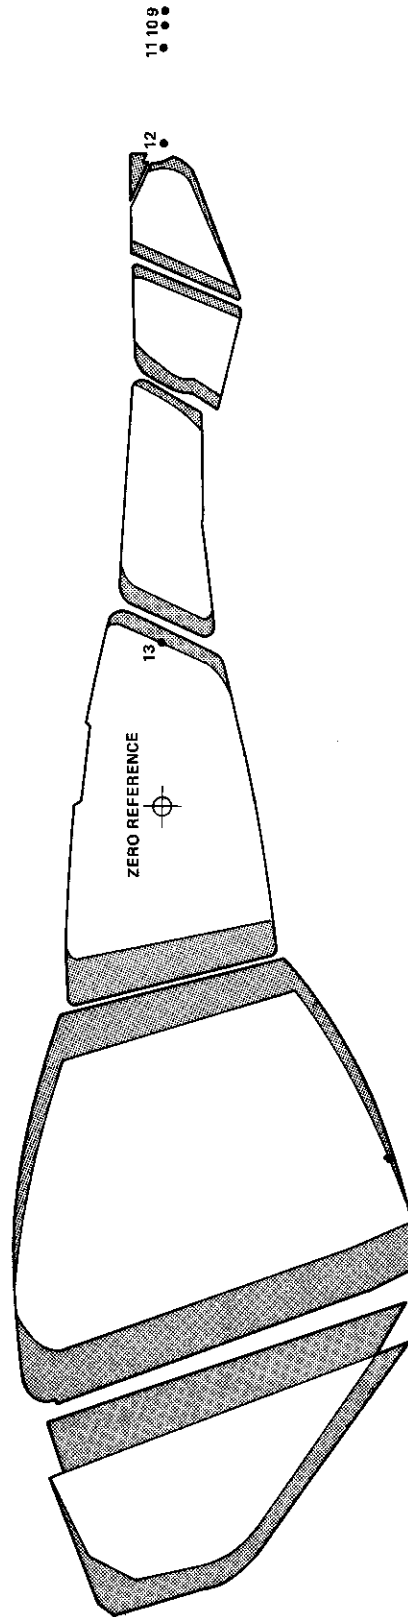
FIGURE 2

BOEING 727-200 QD326
 AIRCRAFT POSITION: LEVEL
 CAPTAIN'S NORMAL EYE REFERENCE POINT
 CAMERA POSITION:
 27.22" AFT OF INSTRUMENT PANEL LOWER EDGE
 20" LEFT BUTT LINE
 48" ABOVE DECK

- REPRESENTS LOCATION OF BOEING 747
 NAFEC PHOTO AJB DECEMBER 1978

NUMBERS DENOTE TIME AND POSITION OF B-747
 AS REFERENCED APPENDIX D

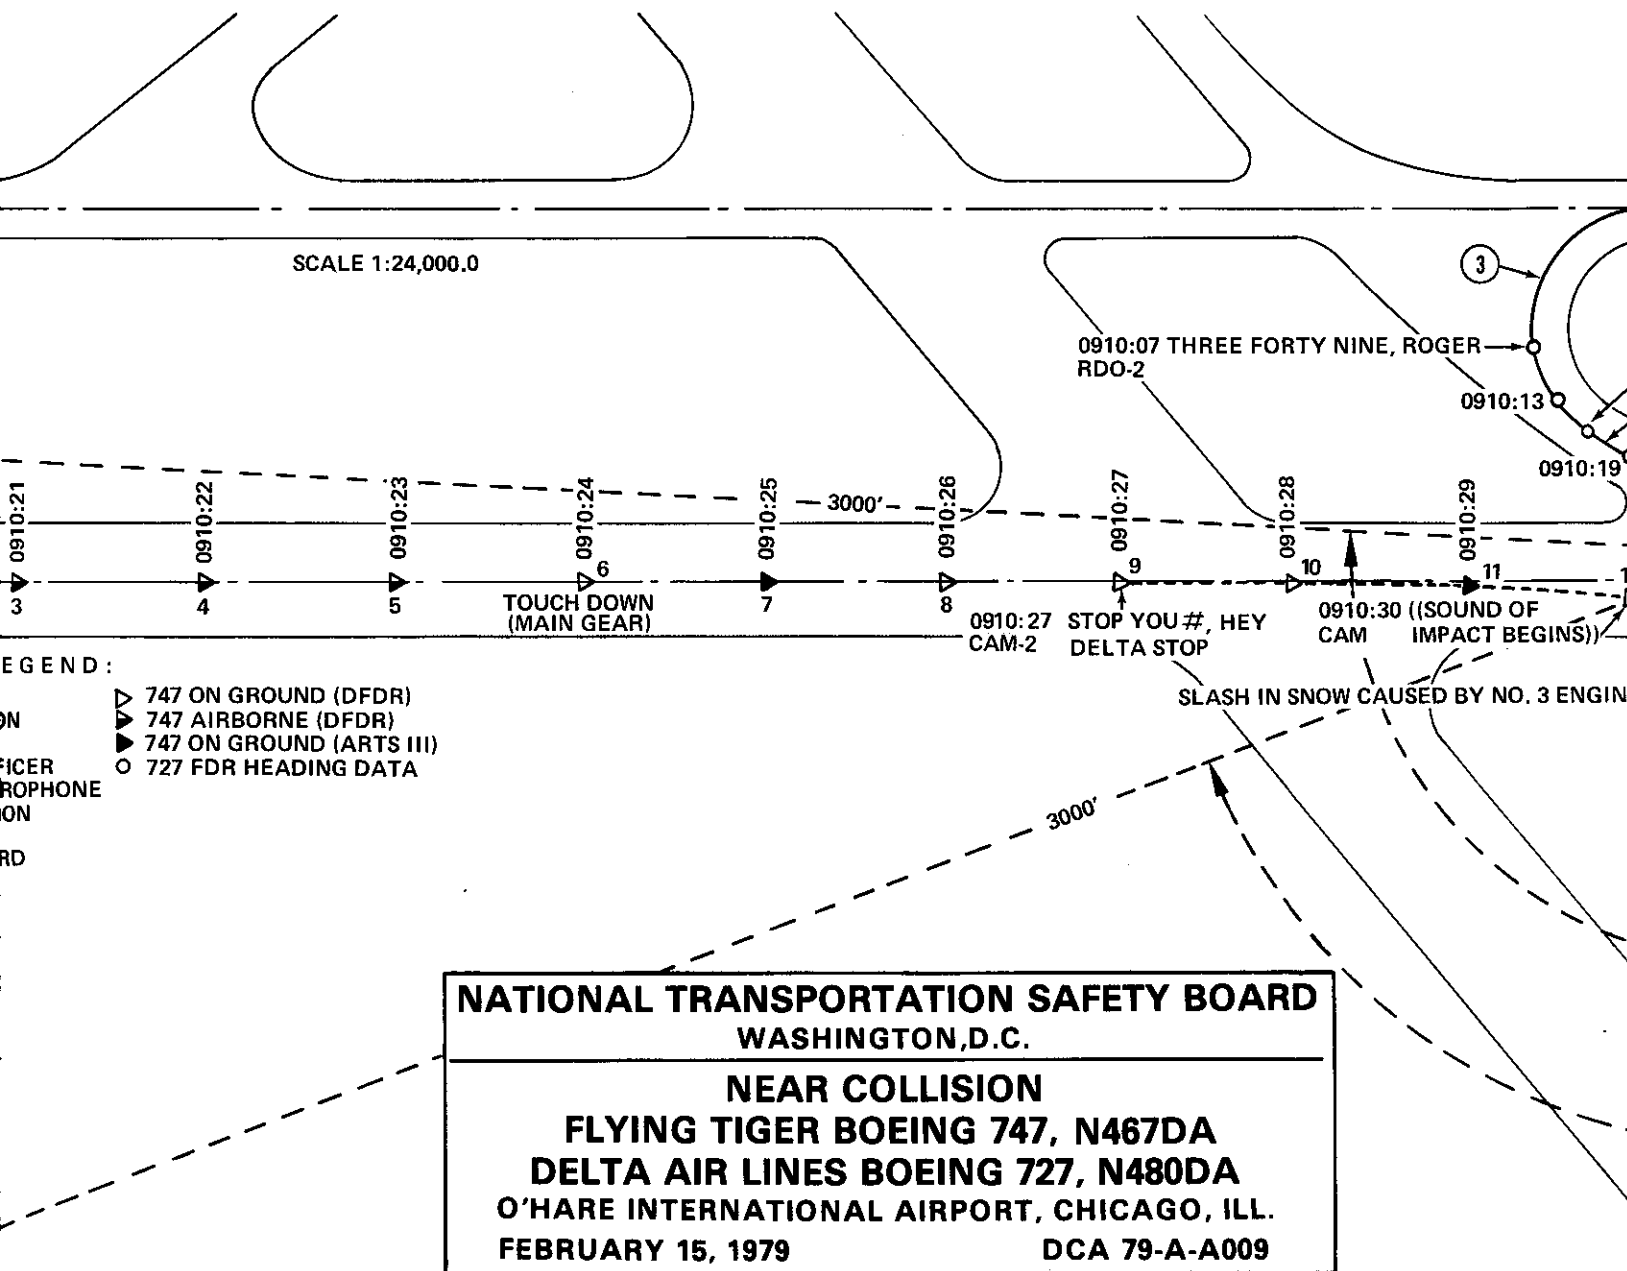
APPENDIX D

Appendix D. Move both airplane symbols on runway 9R a distance of 0.13 in. toward the south edge of the runway.

Change the taxi speed shown in Note 5 from 9.0 mph to 12.4 mph.
