AIRCRAFT ACCIDENT REPORT

UNIVERSAL AIRWAYS, INC.
BEECH 70, EXCALIBUR CONVERSION, N777AE
GULFPORT, MISSISSIPPI
MARCH 1, 1979

NTSB-AAR-79-16

1. Report No. NTSB-AAR-79-16		2. Government Accession No.		3. Recipient's Catalog No.	
4. Title and Subtitle Aircraft Accident Report: Universal Airways, Inc., Beech 70 Excalibur Conversion, N777AE, Gulfport, Mississippi, March 1, 1979				5. Report Date September 6, 1979

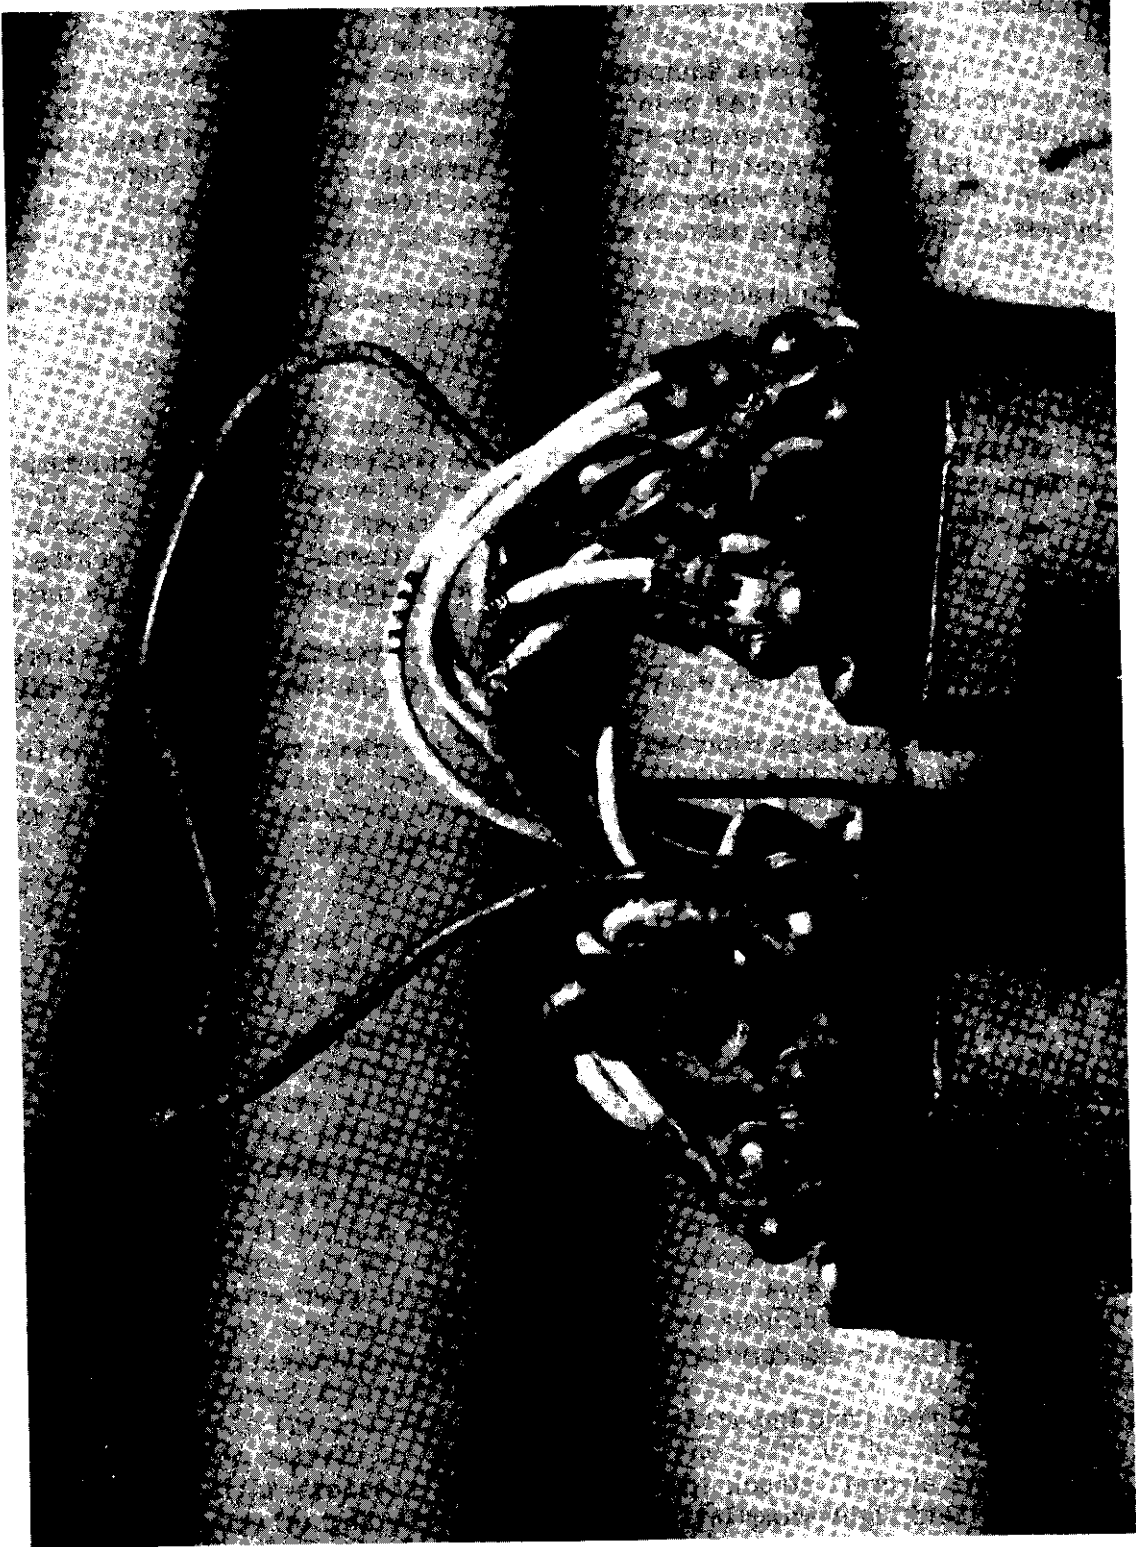
Figure 1. Wire connected to "BAT" terminal.

On the morning of January 4, the mechanic pulled the starter switches from under the control panel — he did not disconnect them. Before he removed the left starter, he noticed that a screw was missing from a terminal on the left starter and that two or three wires were loose. He connected the wires and the starter became activated. He replaced both starter switches in the control panel and signed off the aircraft logsheet as "Repaired starter circuit." The new starter switch was found in the wreckage of N777AE on March 1. The mechanic stated that when he repaired the left starter, he saw wires of different colors; he did not specifically remember seeing the red bypass wire. The Universal Airways employee who made the December repair could not recall ever seeing the red bypass wire.

The Safety Board was unable to determine when the red bypass wire was installed or who installed it. However, if it had been installed **before** Universal Airways acquired N777AE, we believe that it should have been discovered when the right starter switch was replaced in December 1978. Furthermore, after the left starter switch was repaired in Gulfport on January 4, 1979, the work should have been verified when the aircraft returned to Houston on January 5. Again, the wire should have been detected. Since the mechanic who worked on the aircraft on January 4 recalled only that there were different colored wires on the battery terminals, no conclusion can be drawn regarding whether the bypass wire was installed **before or** after the work in Gulfport. Finally, maintenance personnel should have been aware of the starter interrupt system **so that** a nose baggage **door** propeller strike would alert them that the safety system was inoperative. However, the fact that the safety system was bypassed reflects poorly on the management and quality control of the Universal Airways' maintenance program, since the initial cut in the door should have indicated the presence of the bypass wire.

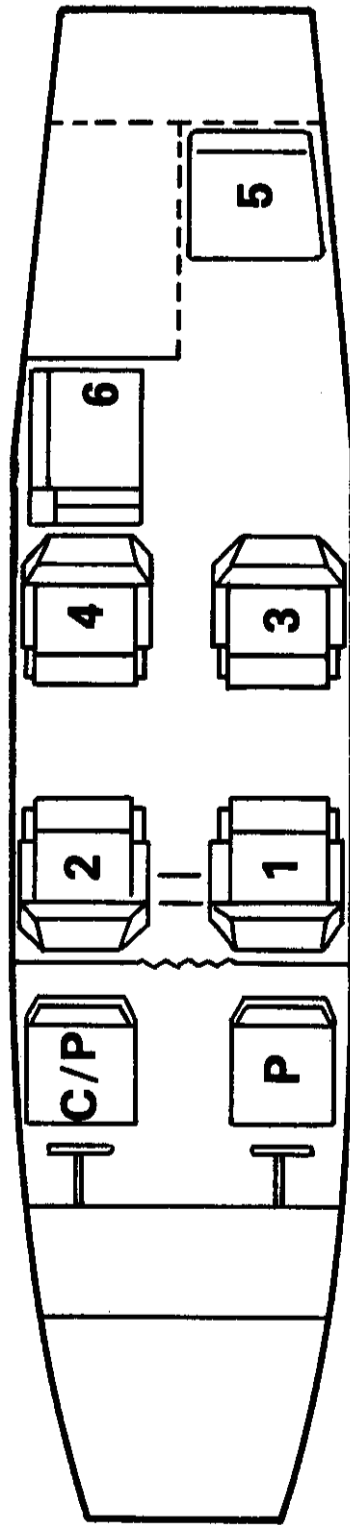
Seat 6, a plywood, side-facing seat, collapsed and failed completely. The insert hardware on the seatbelt faced toward the rear of the aircraft and the buckle hardware toward the front. The belt adjusted only on the buckle side and was found in the full length adjustment.

Figure B Seat arrangement for N777AE.

The rear baggage area was separated from the passenger area by a bulkhead aft of seat 6 and a net of nylon straps next to seat 5. The net failed, and most of the baggage was found at the seat 6 position.
