## AIRCRAFT ACCIDENT REPORT

INLET MARINE, INC.  
GATES LEARJET N77RS  
CENTURY III, MODEL 25C  
ANCHORAGE INTERNATIONAL AIRPORT  
ANCHORAGE, ALASKA  
DECEMBER 4, 1978

NTSB-AAR-79-18

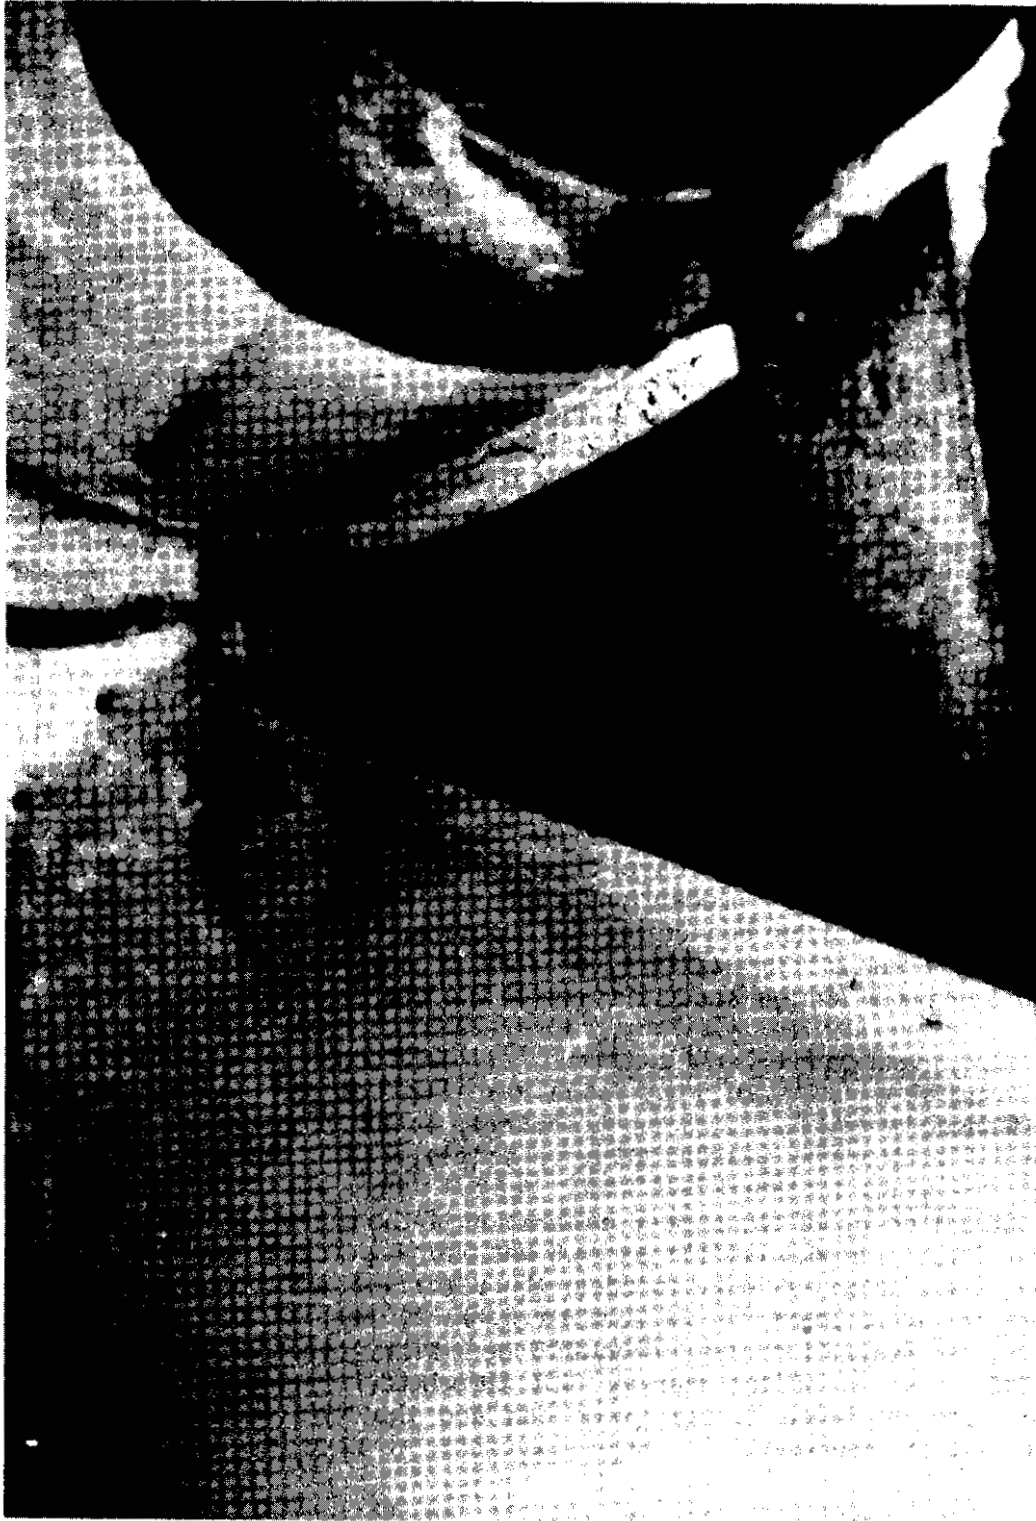
Figure 1.--Ice accumulation on left engine pylon.

12. An accumulation of rime and clear ice which was found on the engine pylons indicated that the aircraft had descended through icing conditions. Evidence of ice accumulations on the wings and horizontal stabilizer may have been destroyed by rescue operations.
