AIRCRAFT ACCIDENT REPORT

COMAIR, INC.
PIPER PA-31, N6642L
COVINGTOW, KENTUCKY

OCTOBER 8, 1979

NTSB-AAR-80-8

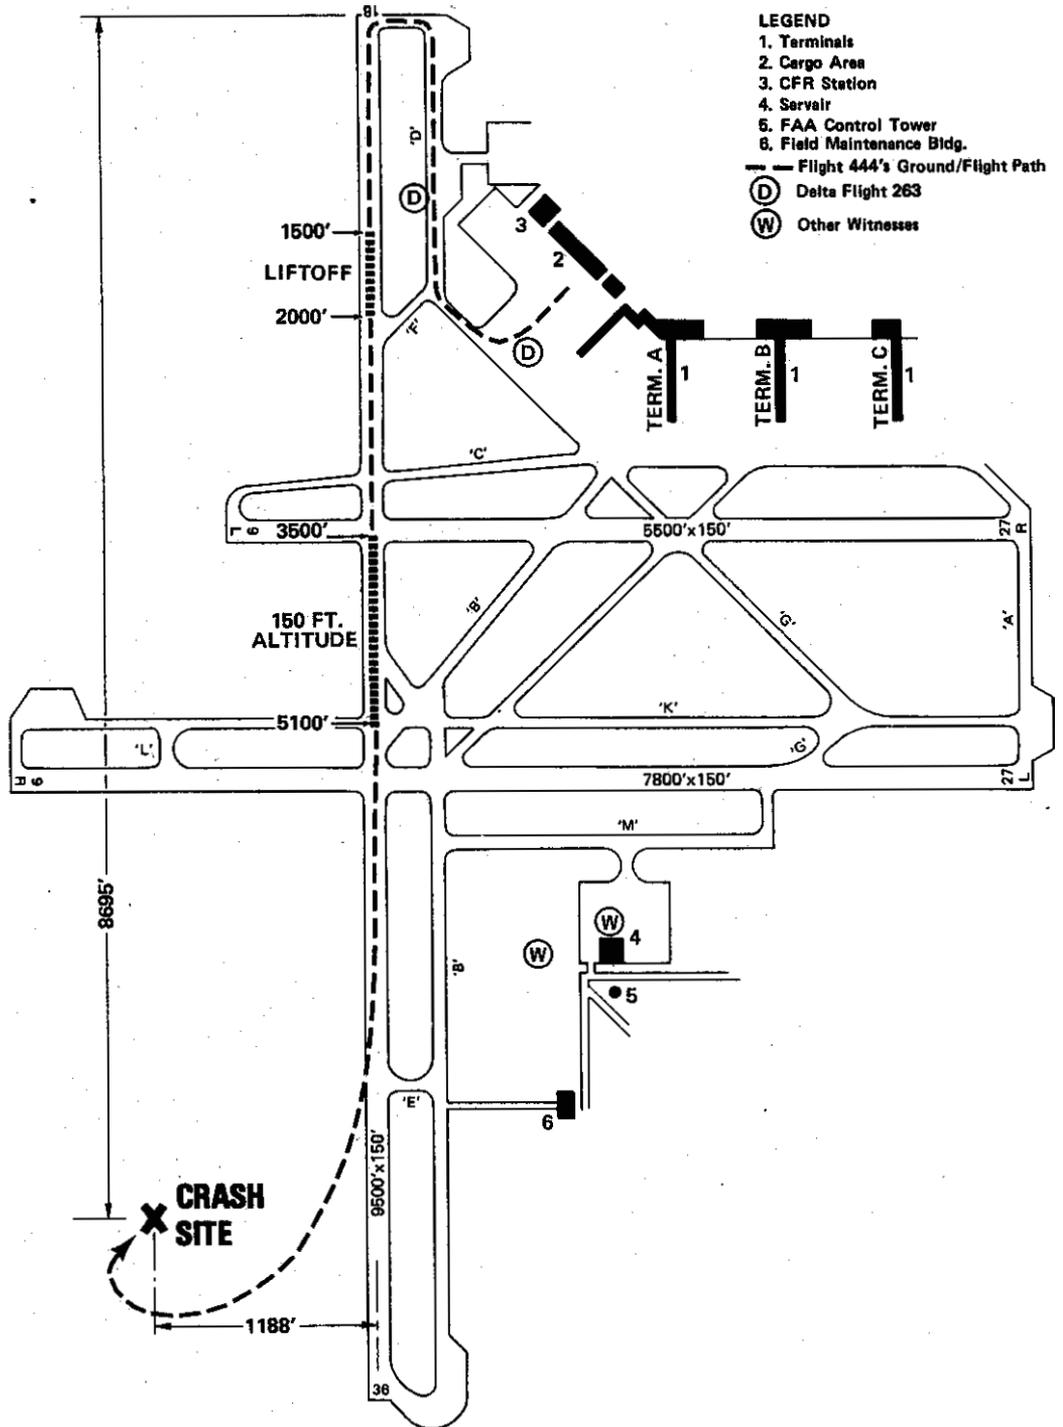
Figure 1.--Diagram of Great Cincinnati Airport.

Another witness stated that as the aircraft commenced a slight right bank turn, the nose came up slightly, and the aircraft rolled into an inverted, nosedown attitude. (See figure 1.)
