# NATIONAL TRANSPORTATION SAFETY BOARD

## AIRCRAFT INCIDENT REPORT

AEROMEXICO  
DC-10-30, XA-DUH  
OVER LUXEMBOURG, EUROPE  
NOVEMBER 11, 1979

NTSB-AAR-80-10

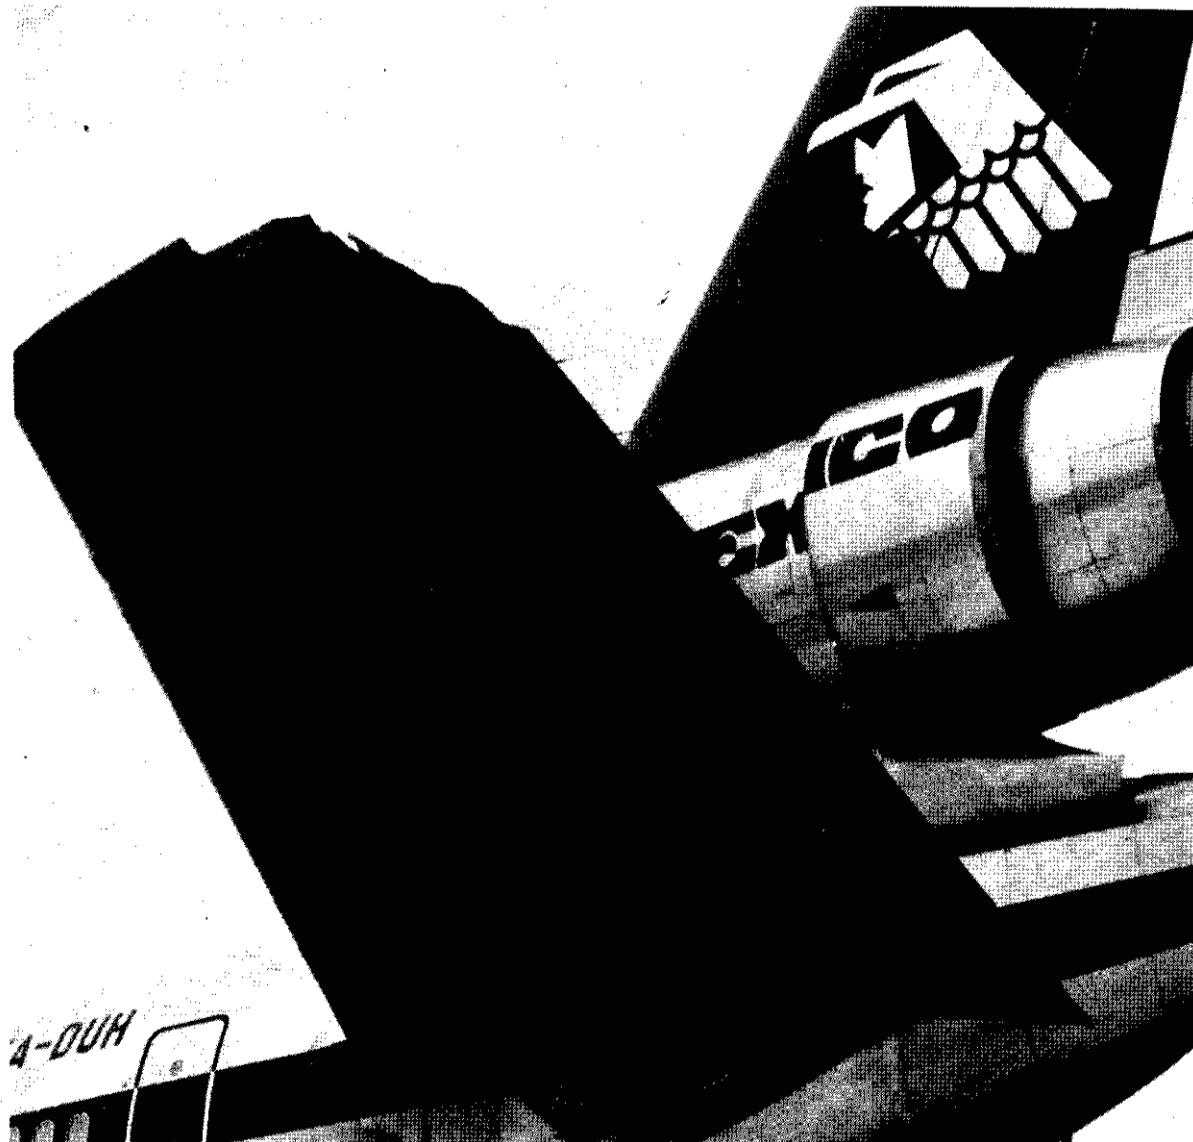
The aircraft damage was confined to both aircraft outboard elevator tips and related counterweights and the tail lower area access door. (See figures 1 and 2.)

Figure 1.--View of left outboard elevator tip.

Approximately 4 ft of the outboard ends of both outboard elevators were missing and had separated at almost identical locations. The approximate line of separation connected the trailing edge channel at Station XE 436 to the elevator spar at Station XE 455. The elevator outboard hinge fitting mounted on the elevator spar and the eyebolt mounted on the hinge fitting had separated with the outboard end of the elevators. Visual examination of the fracture surfaces on the elevator showed no indication of prior cracking. The fracture surfaces were clean and bright with smearing on some portions of the sheet metal surfaces.

The left outboard elevator hinge fail safe "A" frame attached to the horizontal stabilizer sustained minor damage. Scrape marks a few thousandths of an in deep were evident in the bore and flange of the bushing. The outboard lug of the two lugs on the outboard hinge "A" frame was broken about 1 in forward of the elevator hinge line. The inboard lug was bent inboard approximately 1/8 in, and

The tips of both the right and left elevators separated similarly indicating that the failures were produced by a symmetrical loading condition. The evidence indicated a torsional buckling failure of the elevator skin and an aft bending failure of the spar. Smearing on some of the sheet metal fracture surfaces was consistent with a cyclic load application.

12. The stall buffet which was encountered as the aircraft approached and entered the stall produced a dynamic load on the elevator balance weights which resulted in structural overload and failure of the outboard elevator tips.

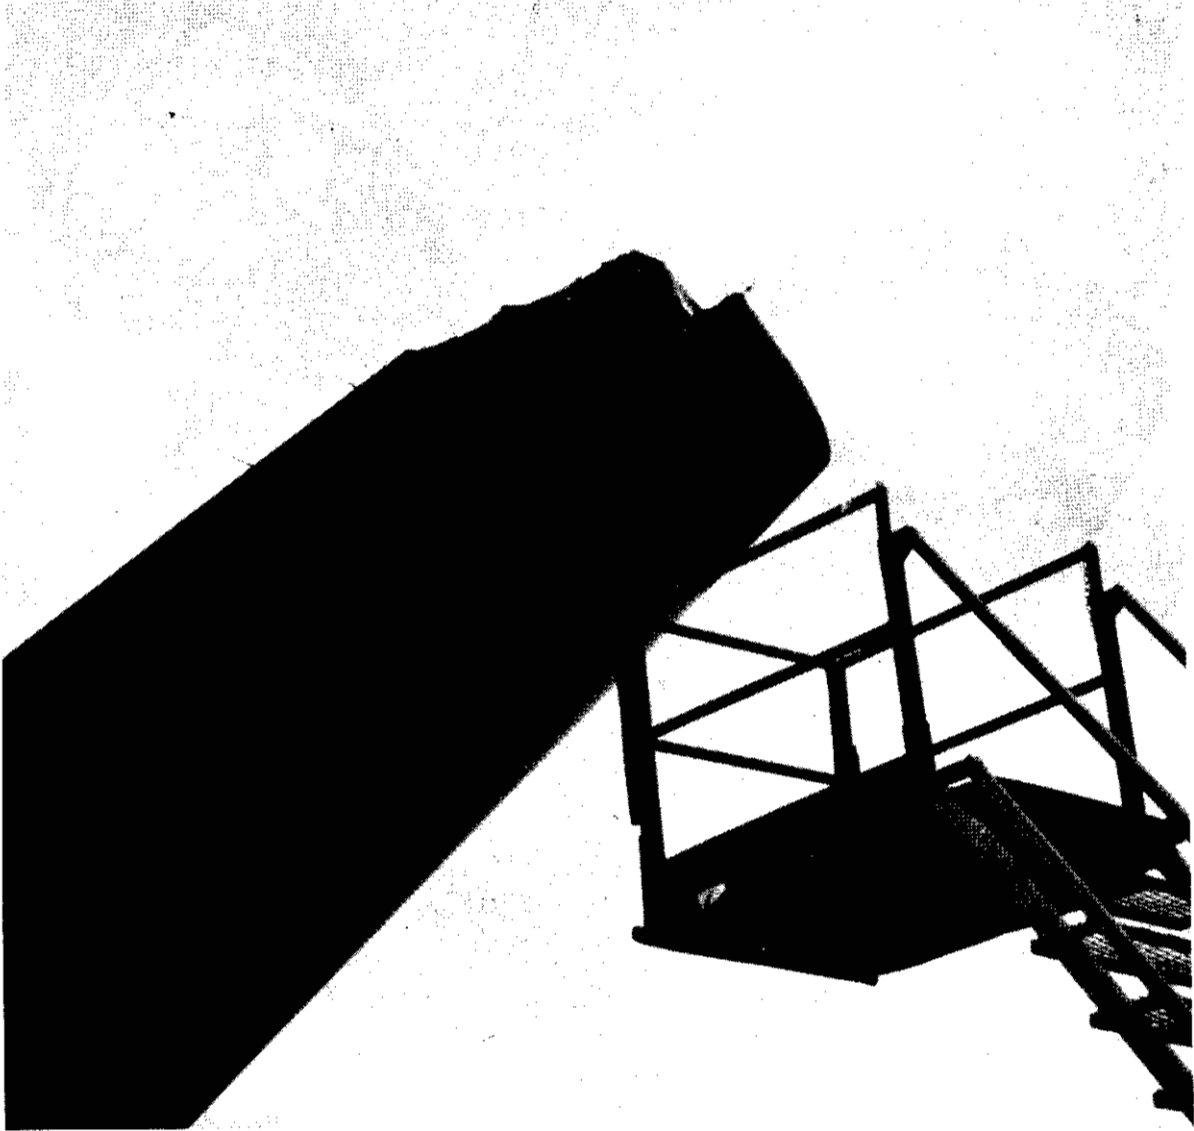
**Figure 2.--View of right outboard elevator tip.**

The right outboard elevator outboard hinge fail safe "A" frame attached to the horizontal stabilizer was broken about 2 in forward of the hinge line. No indication of prior cracking was evident. The outboard lug of the two lugs on the outboard hinge "A" frame was broken about 2 in forward of the hinge line. No indication of prior cracking was evident. The inboard lug was bent inboard about 1/2 in. A scrape mark approximately .005 in deep was observed on the outboard side of the inboard lug. The scrape mark extended from the edge of the hinge hole to the upper edge of the lug. The horizontal stabilizer tip fairing had two small buckles about .060 in deep and 2 in long located just forward of the aft closing rib. The aft edge of the fairing was bent outboard approximately 1/16 in and an impact mark was evident on the aft edge of the fairing.
