AIRCRAFT ACCIDENT REPORT.

AIRTRADERS INTERNATIONAL
LOCKHEED 1049H, N74CA
COLUMBUS, INDIANA
JUNE 22, 1980

NTSB-AAR-80-14

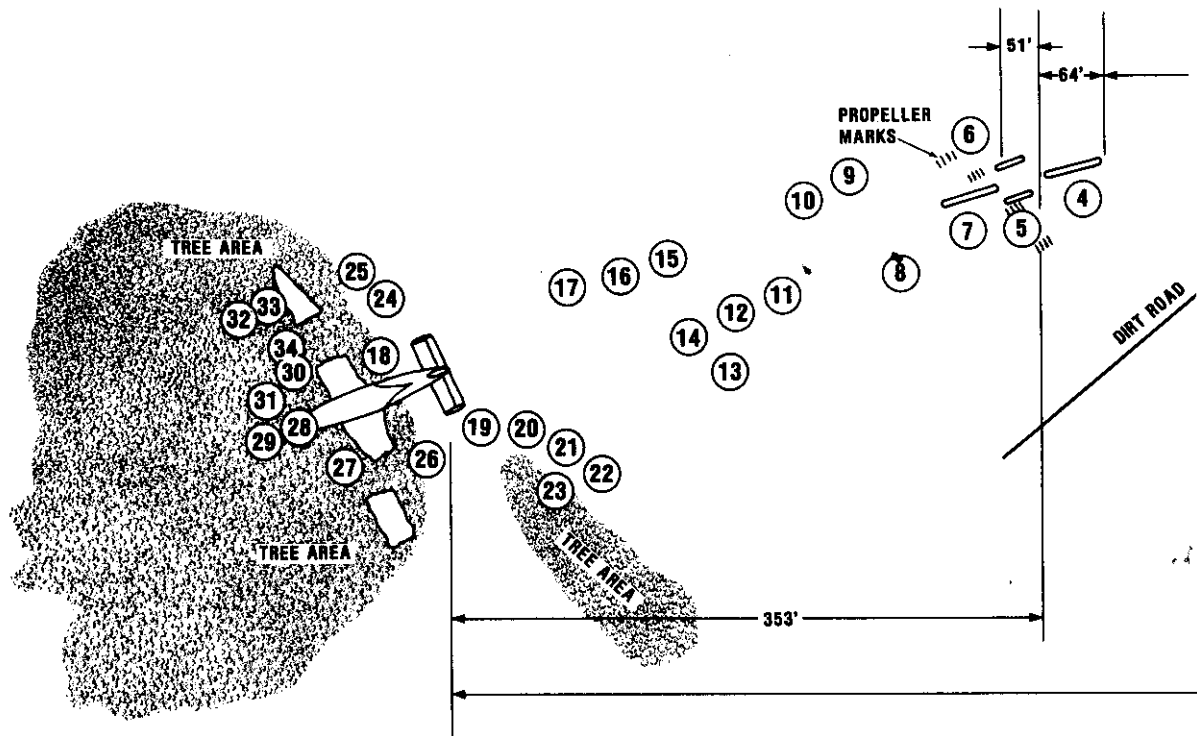
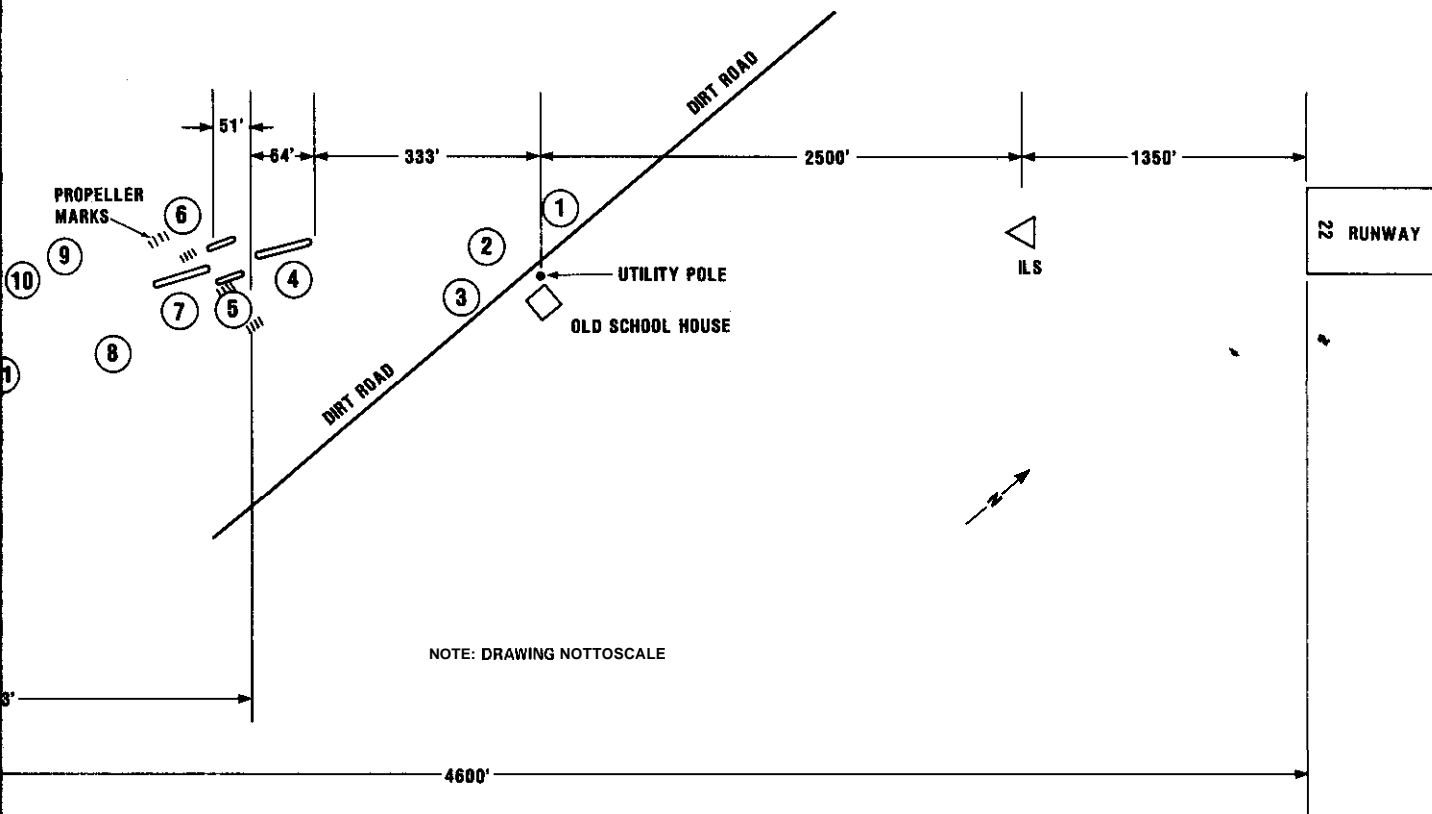
Figure 1

The aircraft crashed at 1359 at latitude $39^{\circ} 15' N$ and $085^{\circ} 54' W$ at an elevation of about 650 feet, approximately 4,600 feet beyond the departure end of the runway. (See figure 1.)

The aircraft settled in a thickly wooded area. The diameter of the trees ranged from about 6 to 24 inches. The left and right wings, the cockpit, and the forward fuselage area sustained severe impact damage in a generally rearward direction. Postimpact ground fire consumed portions of both wing assemblies and the forward fuselage structure.

The left wing tip was separated and found among trees and brush just to the left of the empennage. The Nos. 1 and 2 engines and propellers had separated from the wing. The flap roller assembly, located on the left wing inboard flap, was intact and within its associated operating channel. The roller assembly was positioned about 34 inches from the forward or retract end of the channel. This measurement relates to a flap extension of about 60 percent, which is the takeoff position for the aircraft.
