AIRCRAFT ACCIDENT REPORT

AR PENNSYLVANIA 501
PIPER PA-31-350, N5MS
PHILADELPHIA, PENNSYLVANIA
JULY 25, 1980

NTSB-AAR-81-1

Adopted: January 21, 1981

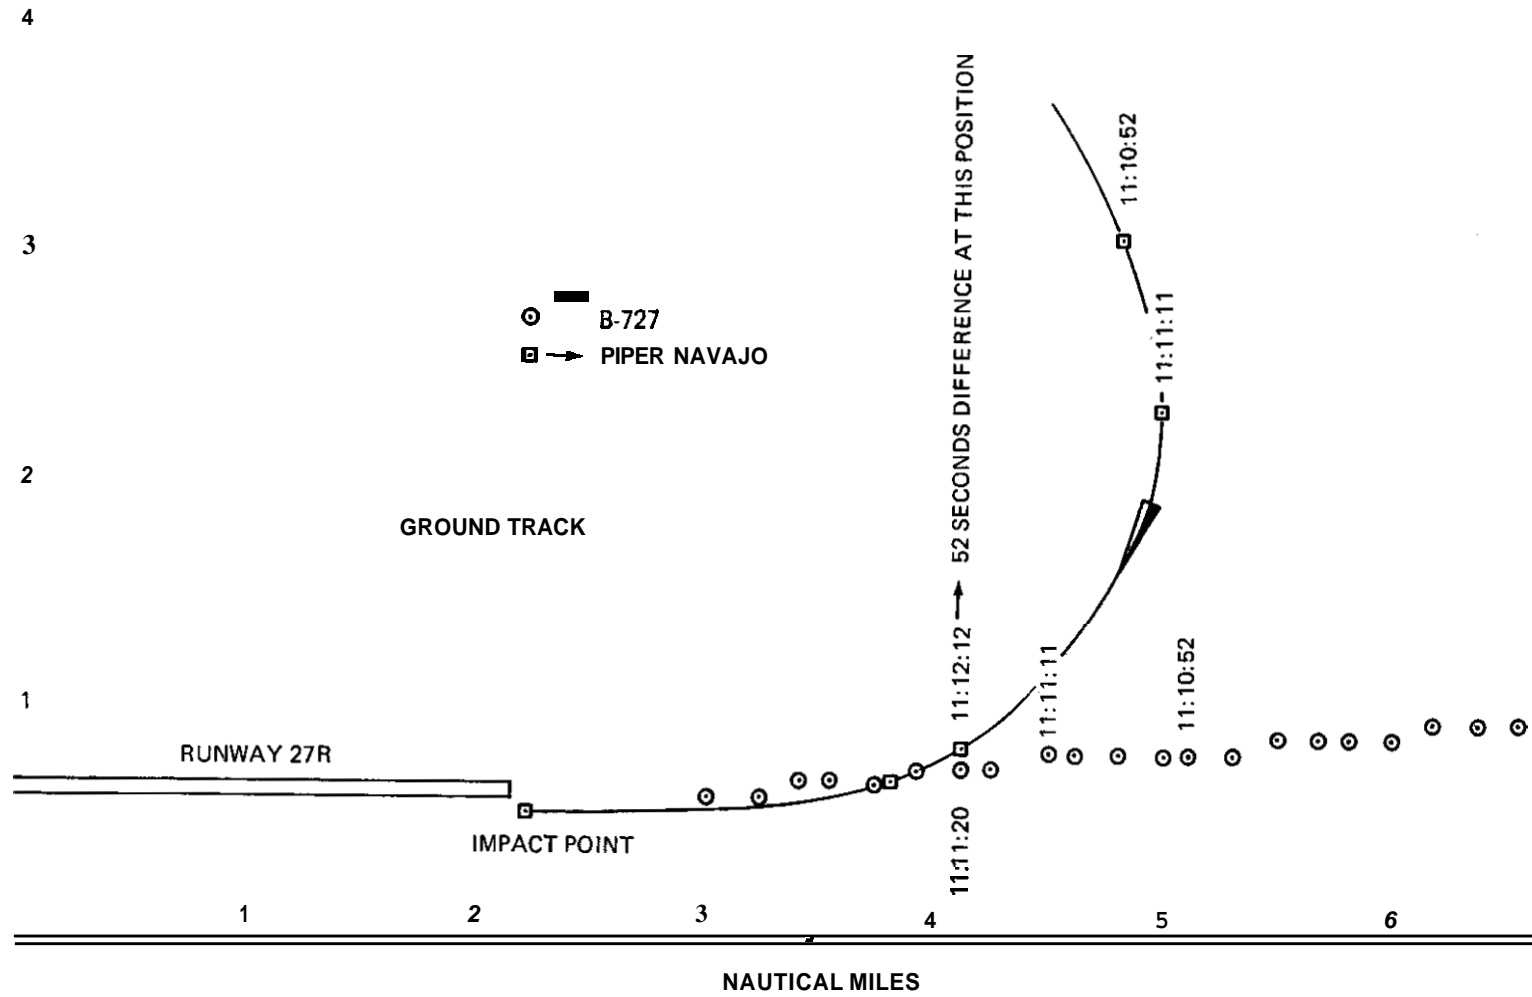
Figure 1. ARTS III ground track and glideslope (ground track).

Automated Radar Terminal System III (ARTS III) ground track data for Air Pennsylvania **501** and United **555** were provided by Philadelphia Approach Control personnel under Safety Board direction. The data were plotted in three dimensions by the Safety Board's performance engineers. (See figures **1** and **2**). **3/**

United Flight **555's** ground track indicated that the aircraft was about **1,800** feet right (north) of the runway **27R** centerline when it was **4** miles from the runway. The track gradually merged left, joining the centerline about **3/4** mile from the end of the runway. United **555's** glidepath indicated a constant rate of descent on a **3.6°** glideslope. At **0711:20**, the aircraft was **2** miles from the runway end at **800** feet.

Air Pennsylvania **501's** ground track indicated that the aircraft turned onto the final approach course **2** miles out, overshooting the runway slightly to the left (south). Air Pennsylvania **501's** glidepath indicated descent on an approximate **2.3°** glideslope. At **0712:12**, the aircraft was **2** miles from the runway end at **500** feet.

The Automated Radar Terminal System III (ARTS III) ground track data (figures 1 and 2) indicated that United 555 made a straight-in precision ILS approach to runway 27R. Flight 501 made a visual approach from the north and entered onto the final approach to runway 27R approximately 2 miles from the threshold at 500 feet aboveground level (agl). The rollout on final approach was at

0712:12 at a position slightly to the left and 300 feet below the flightpath of United 555. Time separation was 52 seconds. Flight 501 was above the influence of the wake turbulence until it was within 1 mile of the runway.
