NATIONAL TRANSPORTATION SAFETY BOARD

AIRCRAFT ACCIDENT REPORT

EAGLE COMMUTER AIRLINES, INC.,
PIPER PA-31-350, NAVAJO CHIEFTAIN, N59932
WILLIAM P. HOBBY AIRPORT
HOUSTON, TEXAS
MARCH 21, 1980

NTSB-AAR-81-4

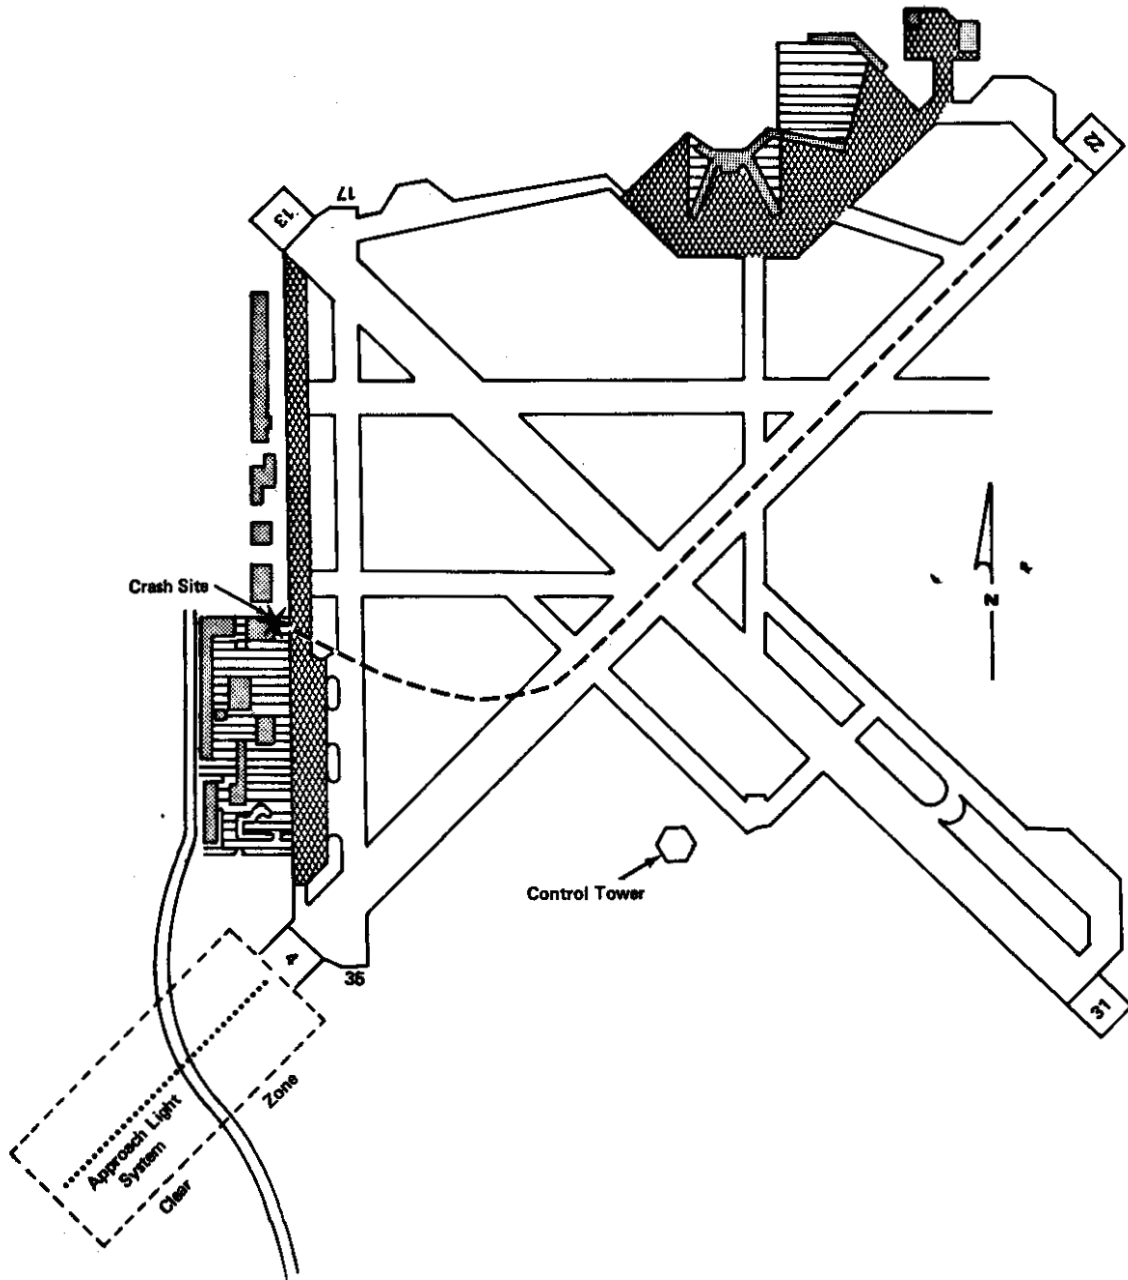
Figure 1--Diagram of William P. Hobby Airport and probable flight track of Flight 108.

The Safety Board believes that Flight 108 climbed to about 90 ft before it experienced a power loss in the right engine since (1) the captain probably would have aborted the takeoff before liftoff if the engine malfunction occurred earlier, (2) the ground roll and initial climb computations were compatible with the observed flight profile performance requirements, and (3) survivors reported that the aircraft was airborne when the engine problem started. Additionally, the tower controller and ground witnesses stated that the aircraft was about 100 ft above the ground when the crew reported the loss of the engine. Flight 108 would have required about 1,669 ft to climb to 50 ft after liftoff, a total of 2,991 ft from the start of the takeoff roll. (These computations are reasonable for a 2-engine climb of a 7,278 lb-aircraft, since the flight manual figure for a 7,000-lb aircraft is 2,875 ft.) Flight 108 would have reached 90 ft of altitude in another 1,334 ft, a total of 4,325 ft or 38.2 sec from the start of the takeoff roll. The difference between the cleared-for-takeoff time at 1947:50 and the report of the loss of the right engine at 1948:35 was 45 sec, which would have allowed the 38.2 sec to climb to 90 ft and 6 sec to initiate the transmission to the air traffic control tower and begin the takeoff roll. This sequence is confirmed by witnesses' observations, times on the air traffic control tapes, and the computed flight profile based on flight manual performance data.

Assuming that the aircraft lifted off the runway at an airspeed of 90 mph to 95 mph, its speed would have been about 116 mph at 50 ft above the runway and about 125 mph at 90 ft above the runway. These airspeeds are consistent with flight manual performance data and with the observed performance of Flight 108 from the start of the takeoff roll to a point 4,325 ft down and 90 ft above the runway.

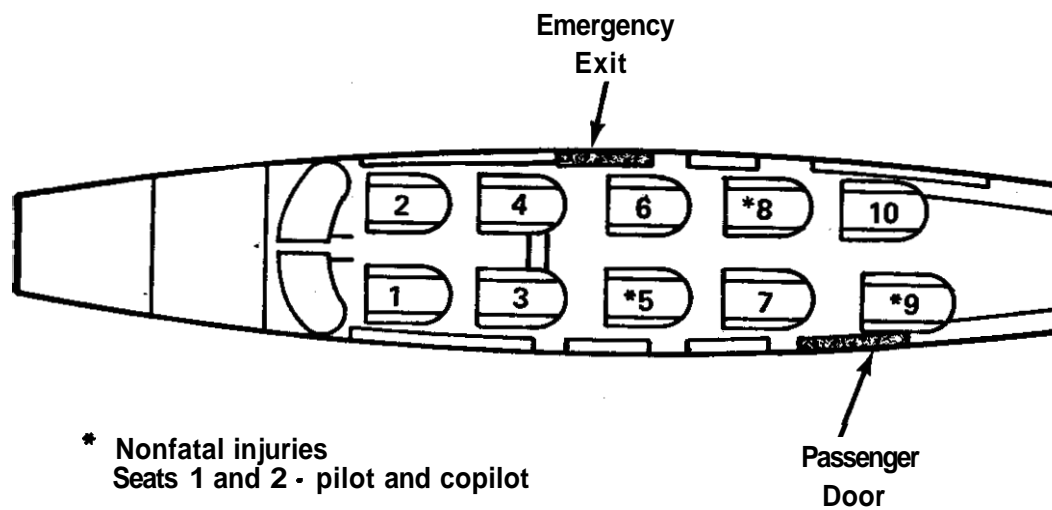
Figure 2--Seat diagram.

The structural damage to the aircraft seats indicated high downward vertical forces, which inflicted downward damage to the seat pans and leg structures of the two cockpit seats. In addition, they were displaced slightly to the right. The seat pans for seats 3 and 4 were separated from the leg structures, which were damaged severely. (See figure 2.) The inboard floor track was torn loose. The areas of attachment for both seat tracks had been displaced downward. Seats 5 and 7 remained attached to the floor, but had collapsed down and to the right. Seat 8 was attached to the rear outboard leg; the front legs had collapsed downward. Seat 10 was torn loose from the attachment plate. The inboard rear leg attach pin separated from the leg and remained in the floor plate while the other pins remained with the seat. The cabin floor was crushed downward about 3 in at the front leg position. Seats 6 and 9 were not found.

The occupants of seats 5, 7, 8, 9, and 10 survived the impact. The occupants of seats 5, 8, and 9 were able to escape by themselves, while the occupant of seat 10 was removed from the aircraft by persons at the accident site. He later died in the hospital. The occupant of seat 7 did not escape from the aircraft. However, the postmortem examination indicated that he received a nonfatal fractured skull injury and died in the postcrash fire.

Initially, five of the six occupants who were seated aft of the wing spar survived the impact, while all four occupants forward of the spar died. With the exception of two of the survivors' seats that exhibited slightly more seat leg deformation than the other seats, the examination of the cabin interior revealed that the areas on both sides of the wing spar received virtually identical damage. The distribution of the survivors in relation to the wing spar was probably caused by the slight nosedown attitude of the aircraft at the initial impact. The occupants forward of the spar would have received greater vertical deceleration loads than the rear occupants, who would have been protected by the absorption of energy in the forward fuselage and the continuing collapse of the fuselage structure aft of the spar. It is also likely that the engines and the wing spar were still absorbing energy after the forward occupants had received the peak vertical decelerative load. Finally, the rearmost occupants benefited from the upward slope of the fuselage beneath seats 7, 8, 9, and 10 which probably allowed more time for the decelerative forces to be absorbed.
