AIRCRAFT INCIDENT REPORT

**NORTHWEST AIRLINES 79
McDONNELL DOUGLAS DC-10-40, N143US
LEESBURG, VIRGINIA**

JANUARY 31, 1981

NTSB-AAR-81-10

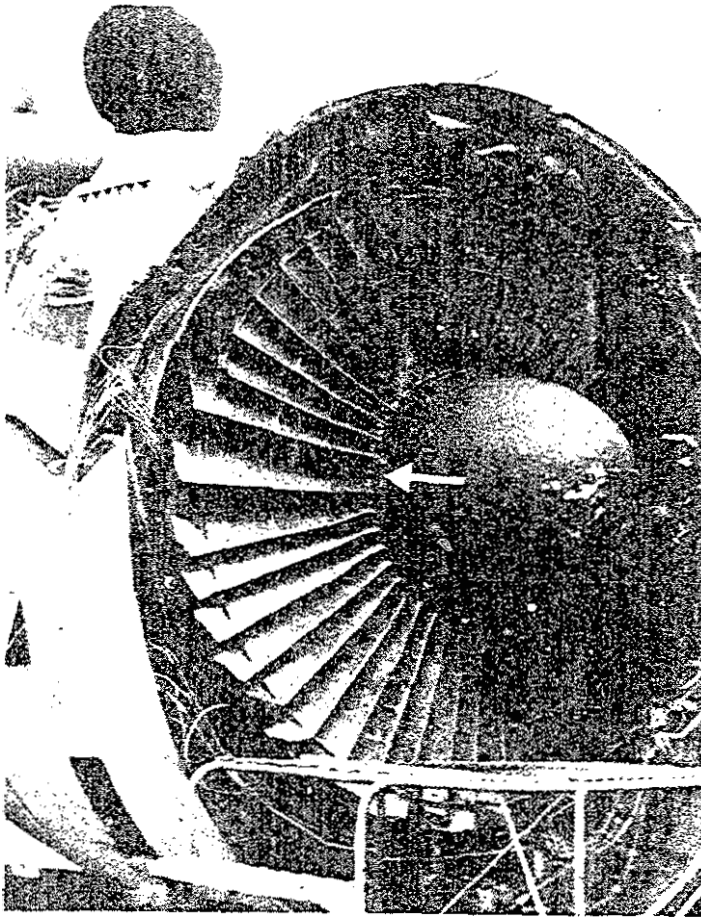
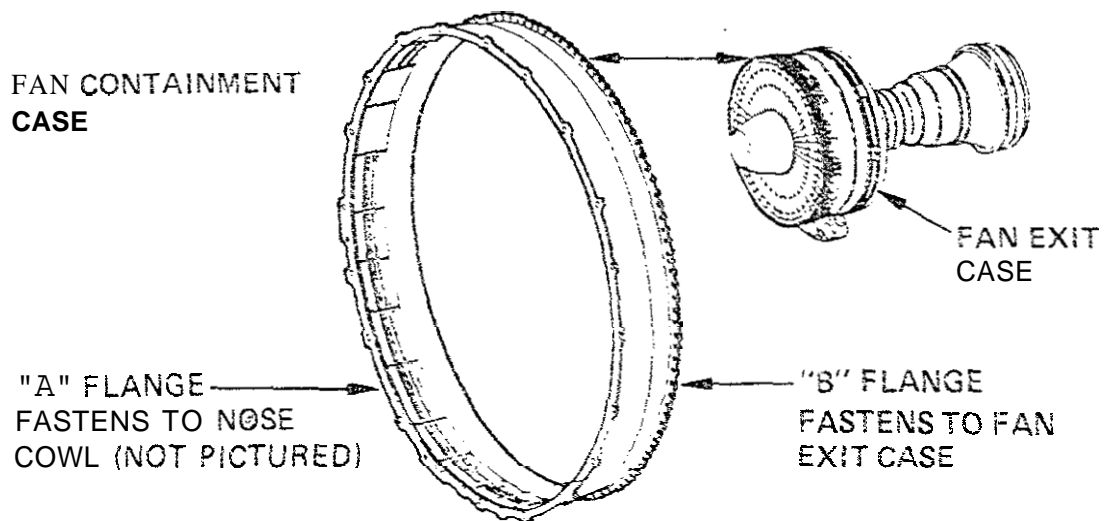
Figure 1.--No. 3 engine after incident,

The nose cowl assembly, the fan containment case forward of the B-flange, and their associated fixtures and components were missing from the aircraft. (See figure 1.) The rear of the nose cowl and the front of the fan case are mated at A-flange. The rear of the fan case and the front of the fan exit case are mated at B-flange. The fan exit case was torn and crushed around its leading edge. The compressor blades were damaged, all fan blades were damaged at the tips, and the No. 30 blade was missing.

The No. 30 blade had separated at a point about 1 inch outward from the blade platform. Two pieces of blade, representing about 80 percent of the blade area, were recovered. One piece was imbedded in the fan exit case stator end and the other was found on the runway after the aircraft landed. The critical areas of the leading edge of the remaining 45 fan blades were inspected with a 10-power magnification lens and were found to exhibit no cracks or other significant anomalies. Minor in-service and typical FOD nicks were present in the areas examined. A 1/2-inch outward bulge was found in the trailing edge of the fan spinner in front of the No. 35 fan blade. There was no other damage to the spinner. A 1/4- by 7/16- by 3/8-inch section was missing from the convex side of the No. 35 blade slot in the fan disk forward surface.

NO. 3 ENGINE AFTER INCIDENT.
ARROW DENOTES SEPARATED
NO. 30 FAN BLADE.

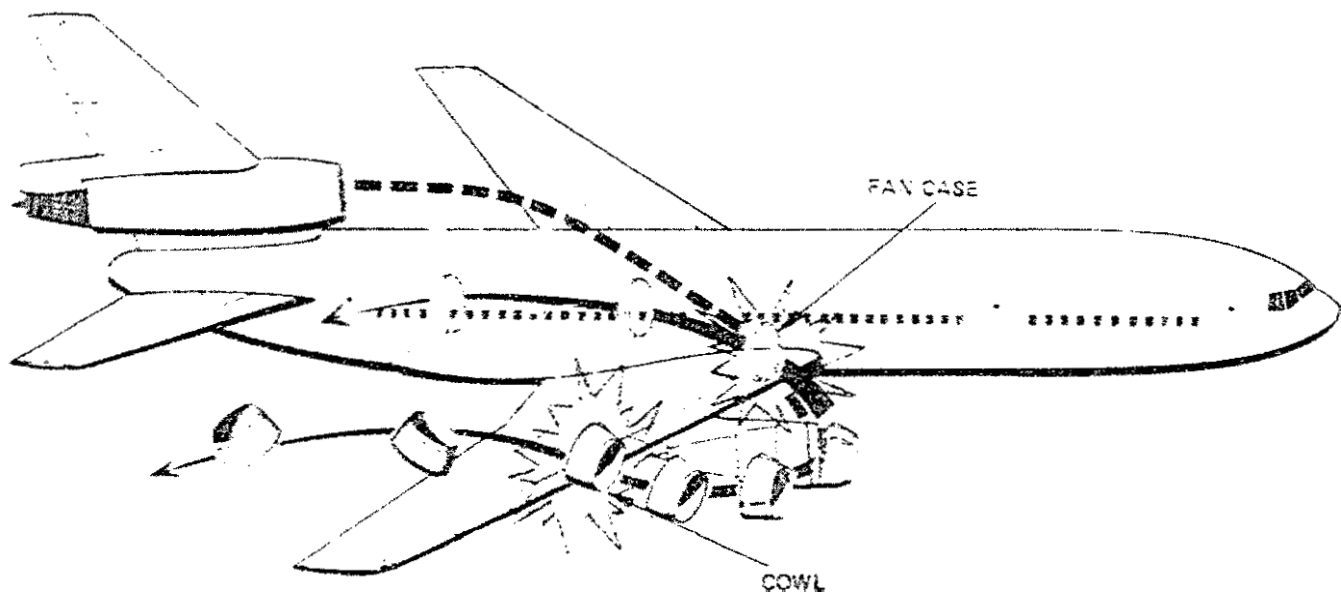
When the fan blade fractured, it struck the fan case and the inner nose cowl near the 6-o'clock position, causing the loss of two to five A-flange inlet cowl retention bolts in the area of the impact. The impact loads may have also caused the B-flange bolt

fractures or A-flange breakout in an arc corresponding to the A-flange failures. The engine dynamic imbalance and the aerodynamic loads on the engine nose cowl loaded the remaining A-flange fasteners beyond their tensile strength and the flange joint began to separate. The bolts sheared in a sequential circumferential (unzipping) manner until only fasteners between the 1- and 3-o'clock positions remained. Aerodynamic forces then lifted the cowl away from the engine, pivoting about the remaining bolts, stripping the bolts from their nut plates, and bending the flange backward and outboard. The cowl separated upward and outward and struck right wing slat No. 5. As the A-flange fasteners progressively separated, additional aerodynamic loading caused interaction between the fan blade tips and the fan case and caused increased loading on the B-flange. The torsional loads imposed by fan blade tips striking the fan case and the additional aerodynamic loading caused failure of the B-flange fasteners. The unrestrained fan case moved in and out of the fan exit case and struck the fan exit guide vanes at random locations. The fan case was driven forward and was radially swung away from the engine, striking the fan exit case. The impact caused the fracture of a small section of the fan exit case B-flange end bent it backward and inboard. The fan case departed upward and inward and struck the leading edge Nos. 1 and 2 slats on the right wing. (See figure 4.)

Figure 4.--Graphic analysis of the loss of the nose cowl and fan case.

7. The nose cowl, which separated upward and outward, struck and damaged slat No. 5.
8. Increased aerodynamic loading and fan blade tip/fan case interaction caused shearing and overloading of the B-flange fasteners.

9. The fan case, which separated upward and inward, struck and damaged slats Nos. 1 and 2.
10. The No. 2 engine was damaged by material from the fan case and/or fan exit case.
