AIRCRAFT ACCIDENT REPORT

CASCADE AIRWAYS, INC.
BEECHCRAFT 99A, N390CA
SPOKANE, WASHINGTON
JANUARY 20, 1981

NTSB-AAR-81-11

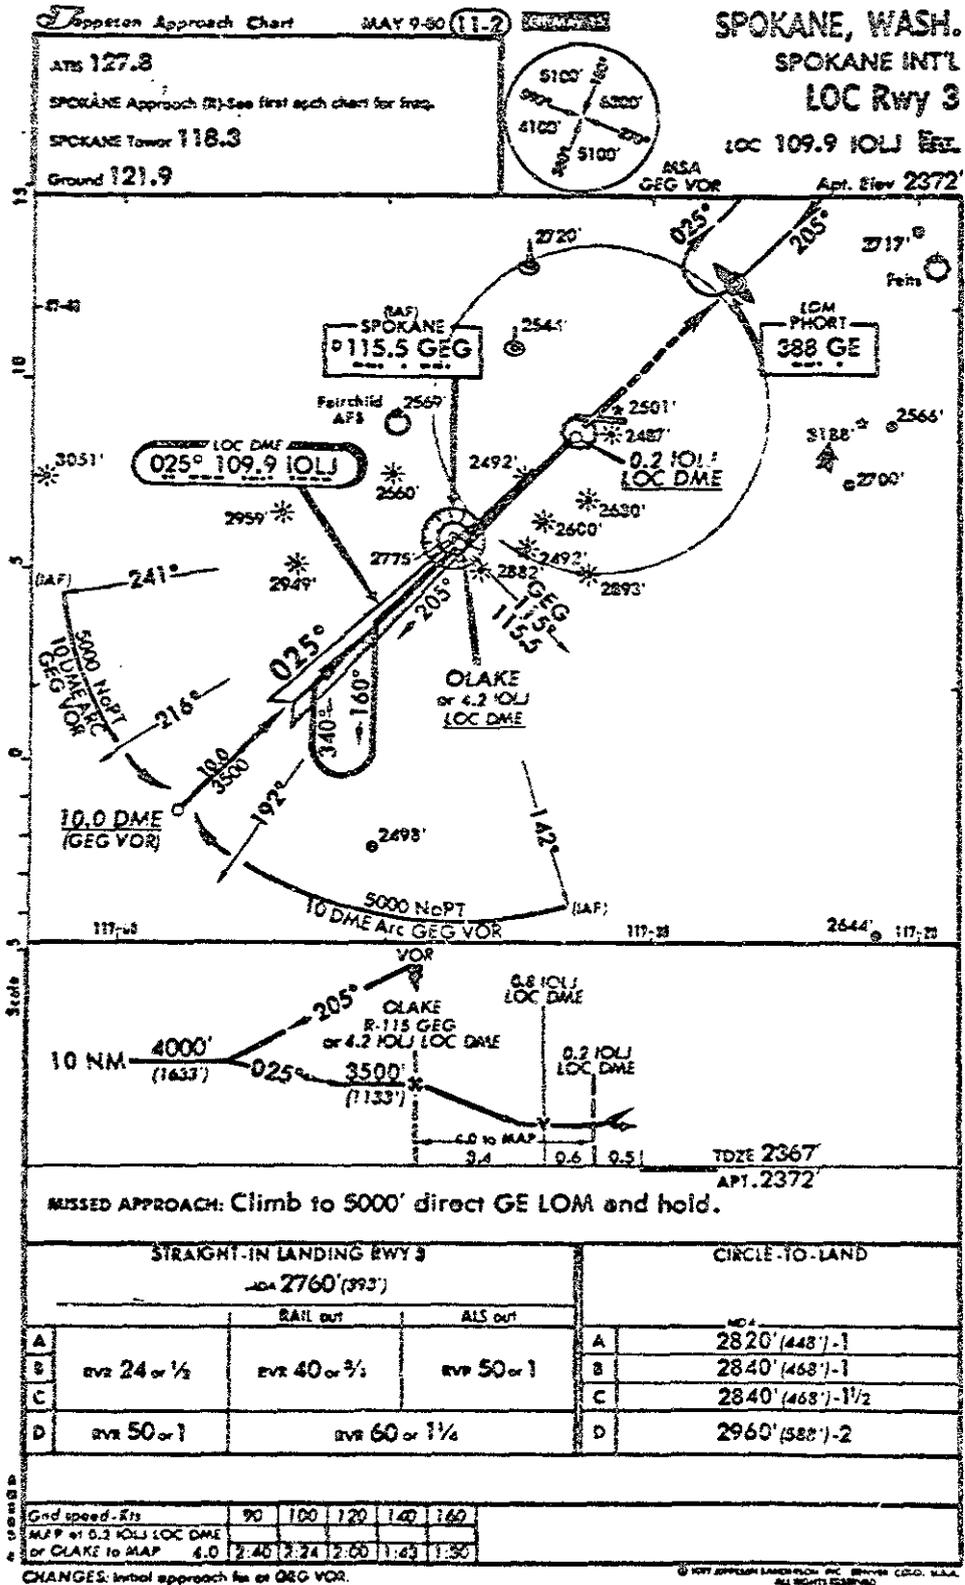
Figure I.-- Localizer runway 3 approach chart.
 (Not to be used for navigational purposes.)

13. The localizer 3 approach chart could cause confusion by portraying two DME frequencies without including a precautionary note to pilots about use of the correct frequency.

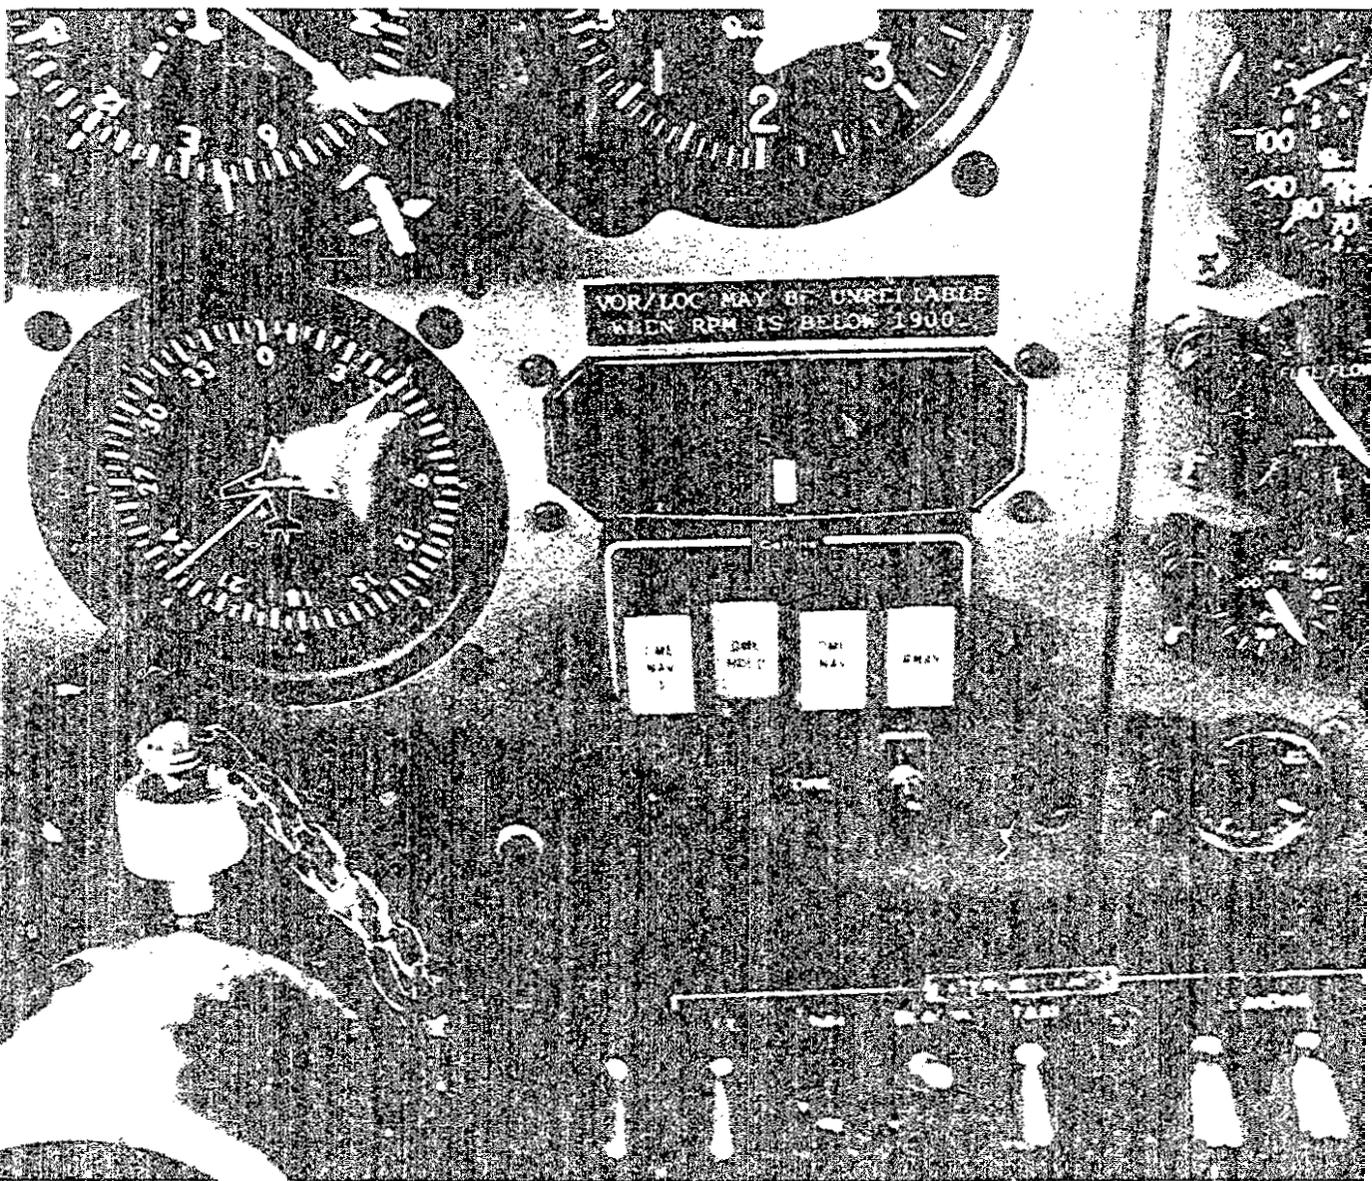
Figure 2.-- DME mode selector.

14. The flightcrew descended prematurely to the minimum descent altitude based on a 4.2 DME indication which emanated from the Spokane VORTAC.
15. The premature descent was a result of improper operation of the DME mode selector.

16. The flightcrew failed to identify the localizer DME facility.
17. The aircraft was in instrument meteorological conditions at impact.
18. The flightcrew apparently noted the DME mode selector error just before impact but not in time to initiate a climb to a safe altitude.
