NATIONAL TRANSPORTATION SAFETY BOARD

AIRCRAFT ACCIDENT REPORT

NORTHEAST JET COMPANY
GATES LEARJET 25D, N125NE
GULF OF MEXICO
MAY 19, 1980

NTSB-AAR-81-15

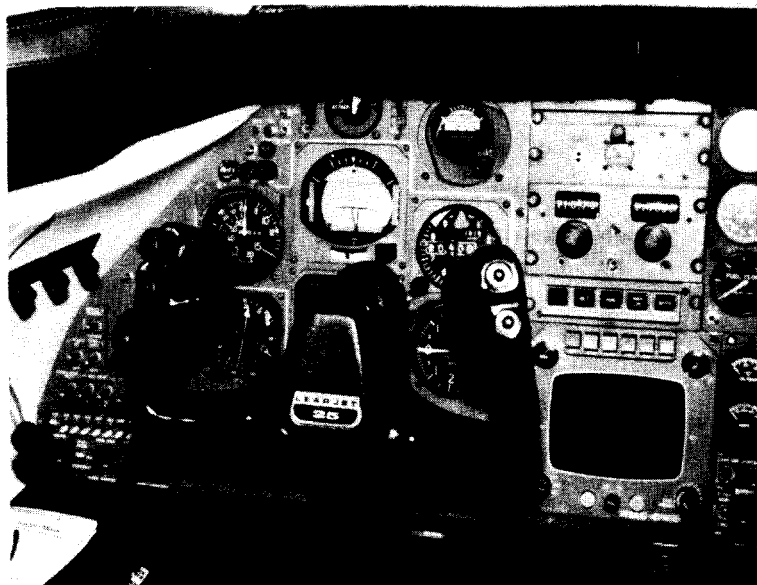
Figure 1.--Wheel master button on pilot's control wheel. The microphone switch is located on the front side of the wheel, opposite the wheel master button.

In a sudden upset, a pilot would reactively grab the control wheel in an attempt to maintain control of the aircraft. Under these circumstances, it would have been easy for the copilot to inadvertently key the microphone. Further, with the copilot holding the control wheel, the turbulence could have caused the force sensor to disconnect the altitude and heading hold functions of the autopilot, or he could have easily disengaged the pitch trim function with 6 to 8 pounds of force applied to the control column. Either type of disengagement would not have been readily apparent to the flightcrew because there are no associated artificial warnings. As a result, the copilot could have been confronted with a mistrim condition and a need to exert a significant amount of pull force to maintain level flight because of the possible nosedown trim the autopilot may have used to counteract the increased airspeed caused by the turbulence. The necessary pull force would have continued to increase with an increase in speed because of the "Mach Tuck" tendency. Additionally, since the wheel master button was inside the copilot's left hand grip, opposite the microphone switch, it is probable that he could have accidentally disengaged the autopilot and yaw damper. The absence of these critical items under these conditions would have significantly contributed to the copilot's difficulty in controlling the aircraft.

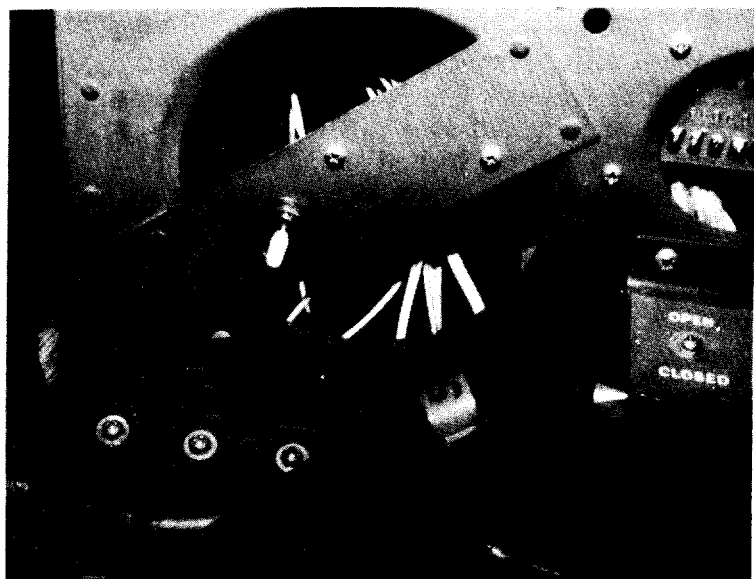
Figure 2.--The unauthorized overspeed warning horn cut-out switch is identified within the circle.

The lack of the Mach overspeed warning sound on the ATC tape probably indicates that the warning horn was disabled because of the cut-out switch. Not until 20.4 seconds after the burst of static is there recorded evidence that the flightcrew took action to correct the overspeed condition when the pilot gave the command to use the spoilers. However, his statement was made 12 seconds after the aircraft had already reached 0.81M₁. Considering the computed rate of the aircraft's speed increase, the aircraft probably had substantially exceeded M_{MO} before the spoilers were extended. Consequently, extension of the spoilers would have further aggravated the situation by significantly increasing the pull force needed to restore the aircraft to level flight.

11. There was no conclusive evidence of a failure or malfunction of the aircraft's systems. However, unauthorized installation of the overspeed warning horn cut-out switch rendered the aircraft unairworthy.

Shortly after the accident, the FAA issued a general notice alerting its field offices of the unauthorized switch installation. A special airworthiness alert was issued later which alerted all air carrier and general aviation operators of the unauthorized switch installation. The FAA expressed concern that all flightcrews and operators might not be aware of the existence of such a switch and that operators should have their aircraft inspected and have the switch removed, if installed.
