AIRCRAFT ACCIDENT REPORT

AR FLORIDA AIRLINES, INC.
McDONNELL-DOUGLAS, INC.,
DC-10-30CF, N101TV
MIAMI INTERNATIONAL AIRPORT
MIAMI, FLORIDA
SEPTEMBER 22, 1981

NTSB-AAR-82-3

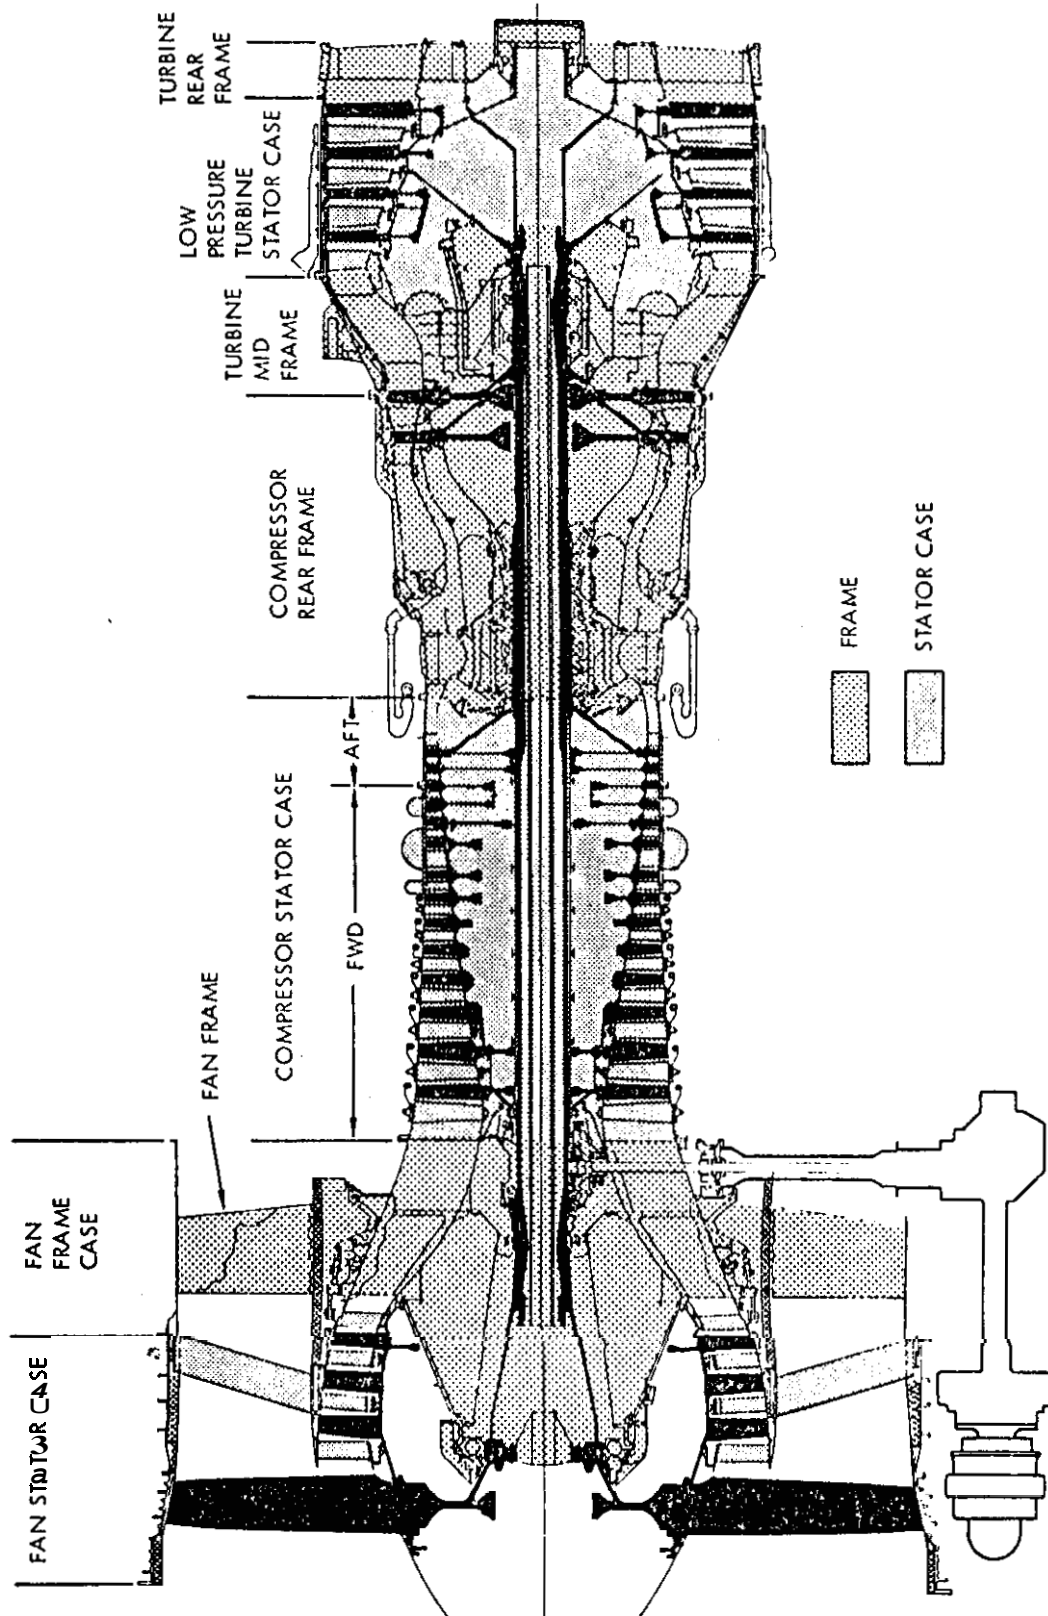
Figure 3.--CF6-50/-45 frames and stator assemblies.

The examination showed that the major damage to the engine was incurred aft of the high pressure turbine section. The low pressure turbine stator ~~assembly case had~~ separated circumferentially along the flange attaching its forward end to the turbine mid-frame housing. This separation, located at engine station (ES) 294, was just forward of the plane of rotation of the stage 1 low pressure turbine rotor. The stator case separated fore and aft along the top of the engine; it tore horizontally above its outboard split flange and the forward one-third of the inboard split flange had separated. The stator assembly case had split into three large segments and numerous smaller segments which separated from the engine and fell to the runway. (See figure 3.)

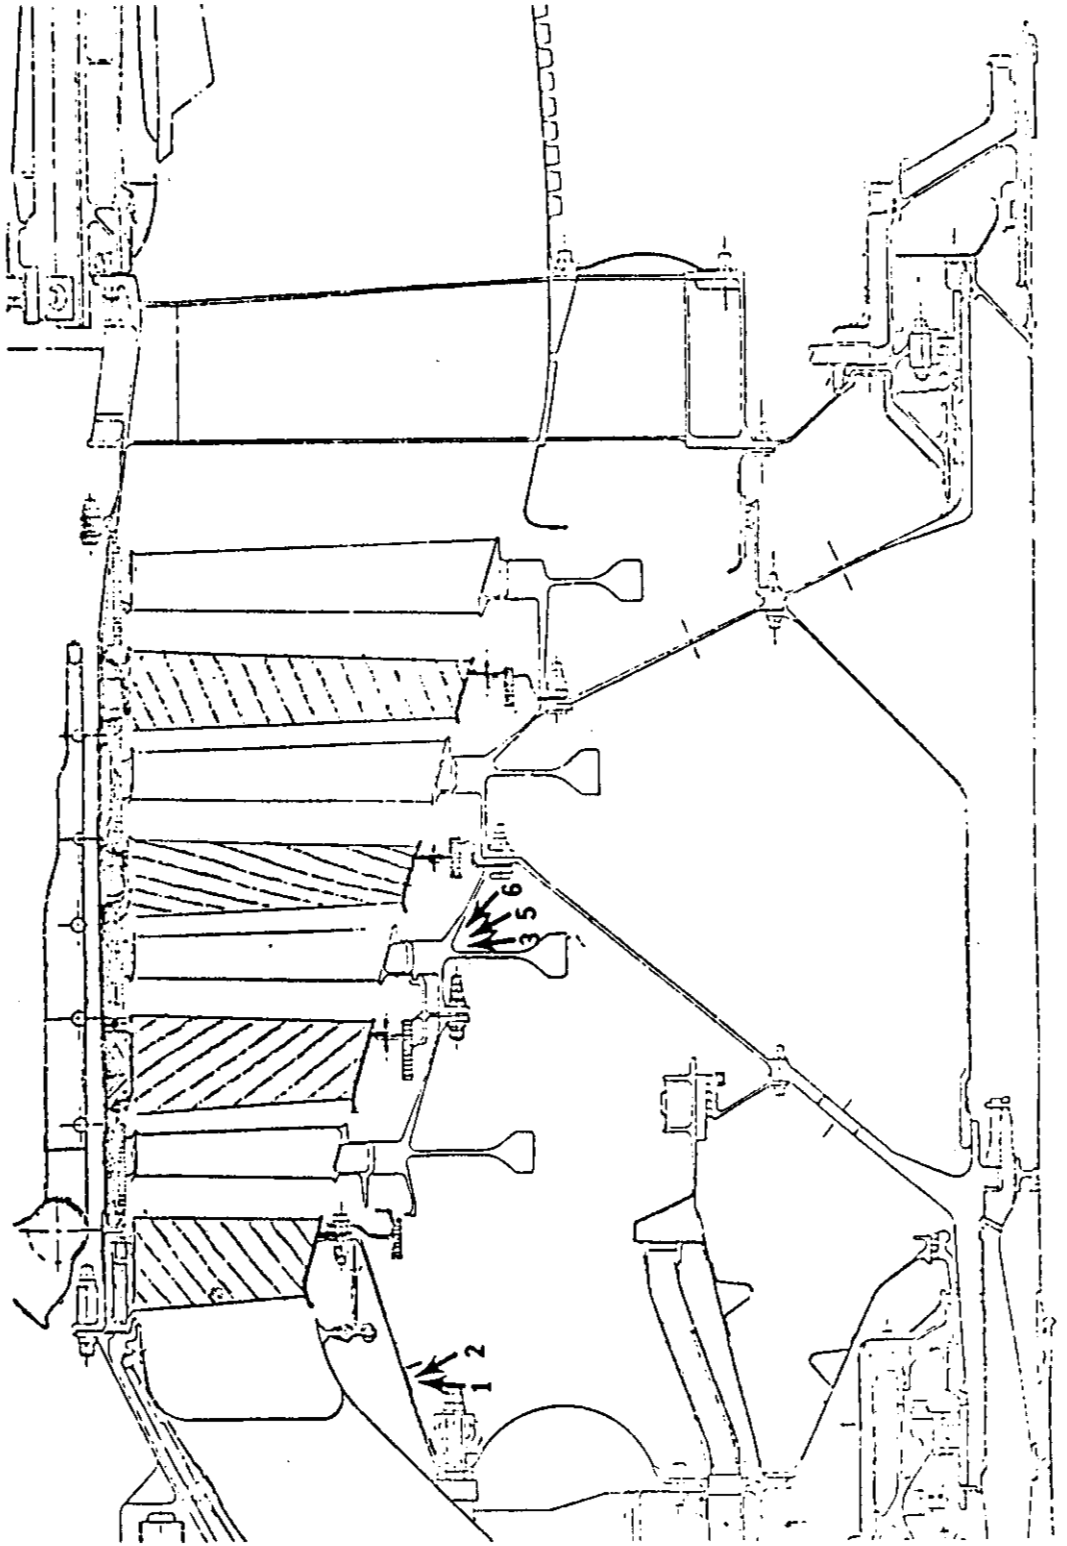
Figure 4

Six additional pieces of ferro magnetic material were found: one piece was found on the runway; three pieces were found in the low pressure turbine stage 2 rotor cavity; and two pieces were found in the low pressure turbine's stage 1 toroid cavity. EDAX analysis identified the material as M-50 alloy steel. All six pieces were severely battered and oxidized. Five of the six pieces were measured for thickness. One piece was too battered for thickness determination. The thickness of one piece ranged from 0.140 to 0.150 inches; one piece was 0.148 inches thick; and three pieces were 0.149 inches thick. (See figure 4.)

These six pieces were compared to a typical CP6-50 No. 5 roller bearing inner race which is manufactured from M-50 alloy steel. The specified thickness for this inner race is 0.146 inches to 0.148 inches. In addition, two of these six pieces had

Sketch of the low pressure turbine portion of CF6-50 engine S/N 455-103. After the low pressure turbine failure of this engine, six pieces of foreign material were recovered and submitted for examination. For identification purposes these six pieces were arbitrarily assigned numbers - #1 thru #6. Pieces #1 and #2 were found near the turbine mid frame stiffener (see arrows #1 and #2). Pieces #3, #5, and #6 (see arrows #3, #5, and #6) were found in the cavity formed by the Stage 2 low pressure turbine disk and the forward low pressure turbine shaft. Piece #4 was recovered from the runway near the location where the engine failure occurred.
