AIRCRAFT ACCIDENT REPORT

RONSON AVIATION
BELL 206B, N27670 AND
SEMINOLE AIR CHARTER
PIPER PA-34-200T, N8110R
MIDAIR COLLISION
EAST RUTHERFORD, NEW JERSEY
SEPTEMBER 23, 1981

NTSB-AAR-82-6

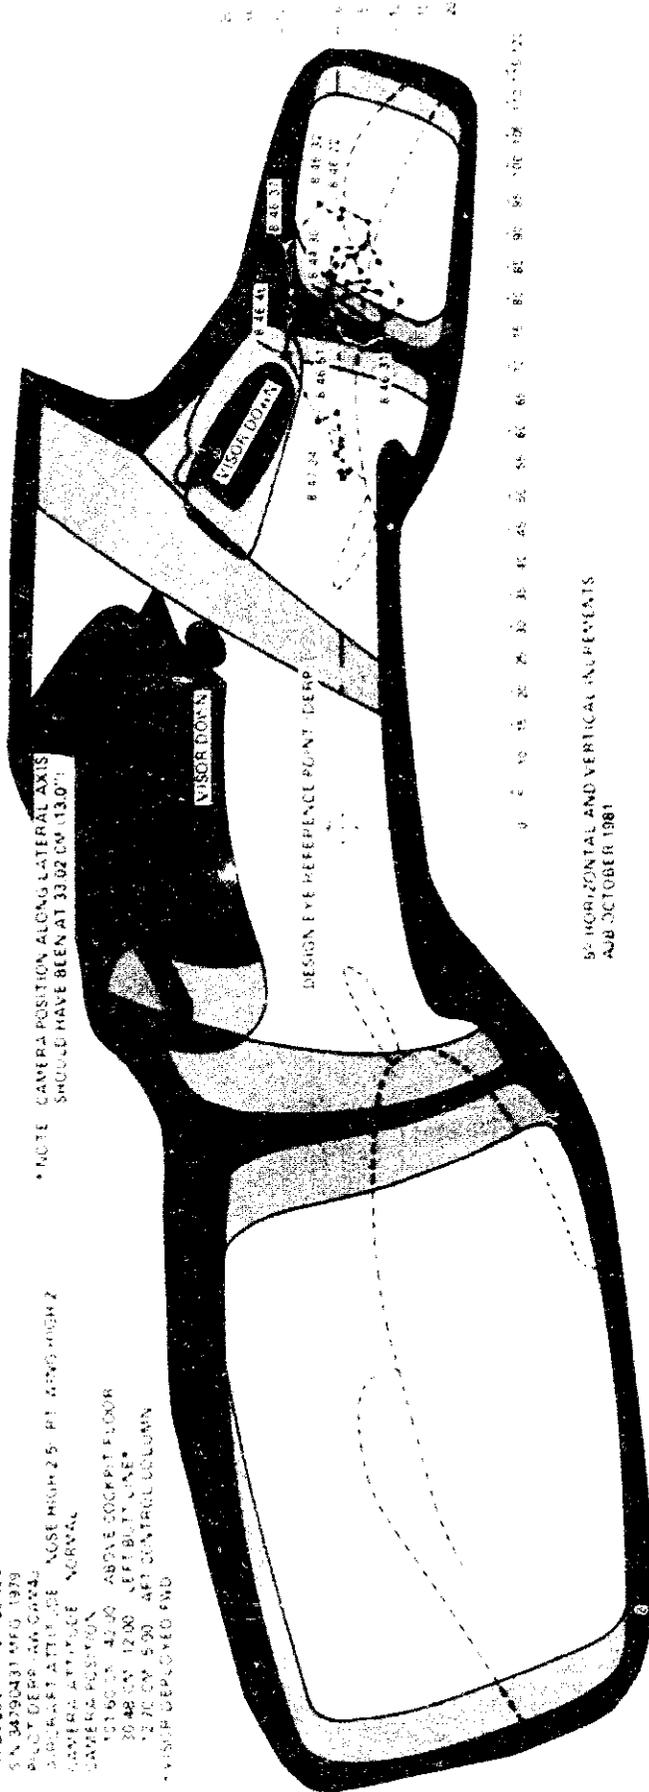
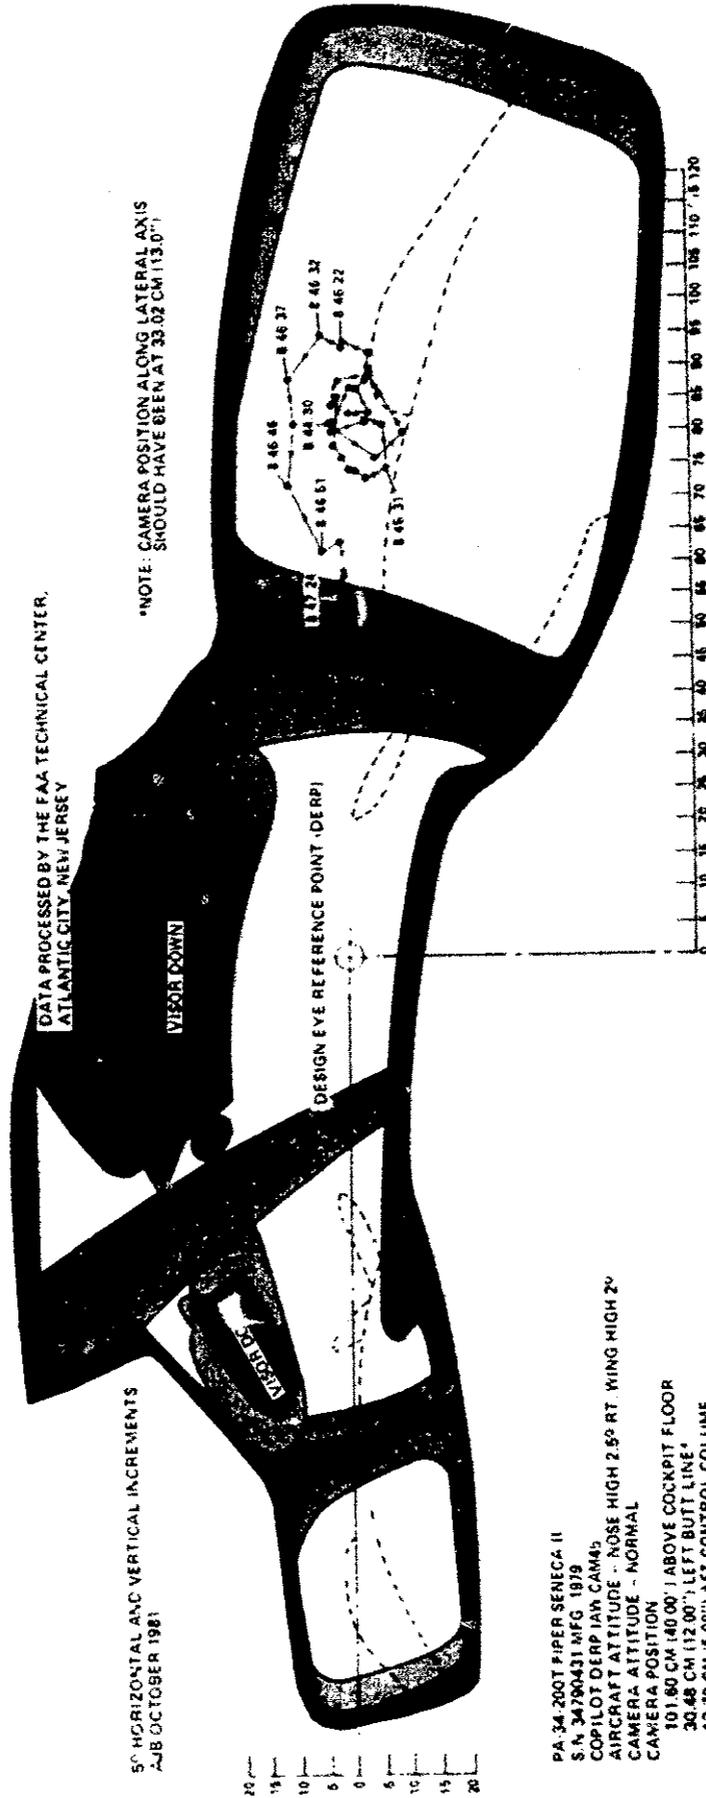
BINOCULAR PHOTOGRAPHS

The airplane viewing angles when plotted on the binocular photographs from the pilot's position placed the helicopter in the right front cabin window for the first 122 seconds starting 182 seconds before the collision. During this period the helicopter would have been obscured about 50 percent of the time by the wing, nacelle, or windshield side post. The turn to base caused the helicopter to move up and into the cabin overhead for about 15 seconds. When the wings were again leveled during the base leg, the helicopter moved down to just above the zero elevation line in the copilot's windshield just above the right engine for the 30 seconds of plotted data. The final point plotted occurred approximately 9 seconds before collision.

The view from the right seat of the airplane would have placed the helicopter nearly in the center of the right front cabin window forward of the wing and above the nacelle for nearly two thirds of the 122-second time period prior to turning base. During the turn to base, the helicopter would have moved up and forward for 30 seconds and then down as the wings were rolled level. The helicopter continued to move forward during the remaining points staying within the right-side window.

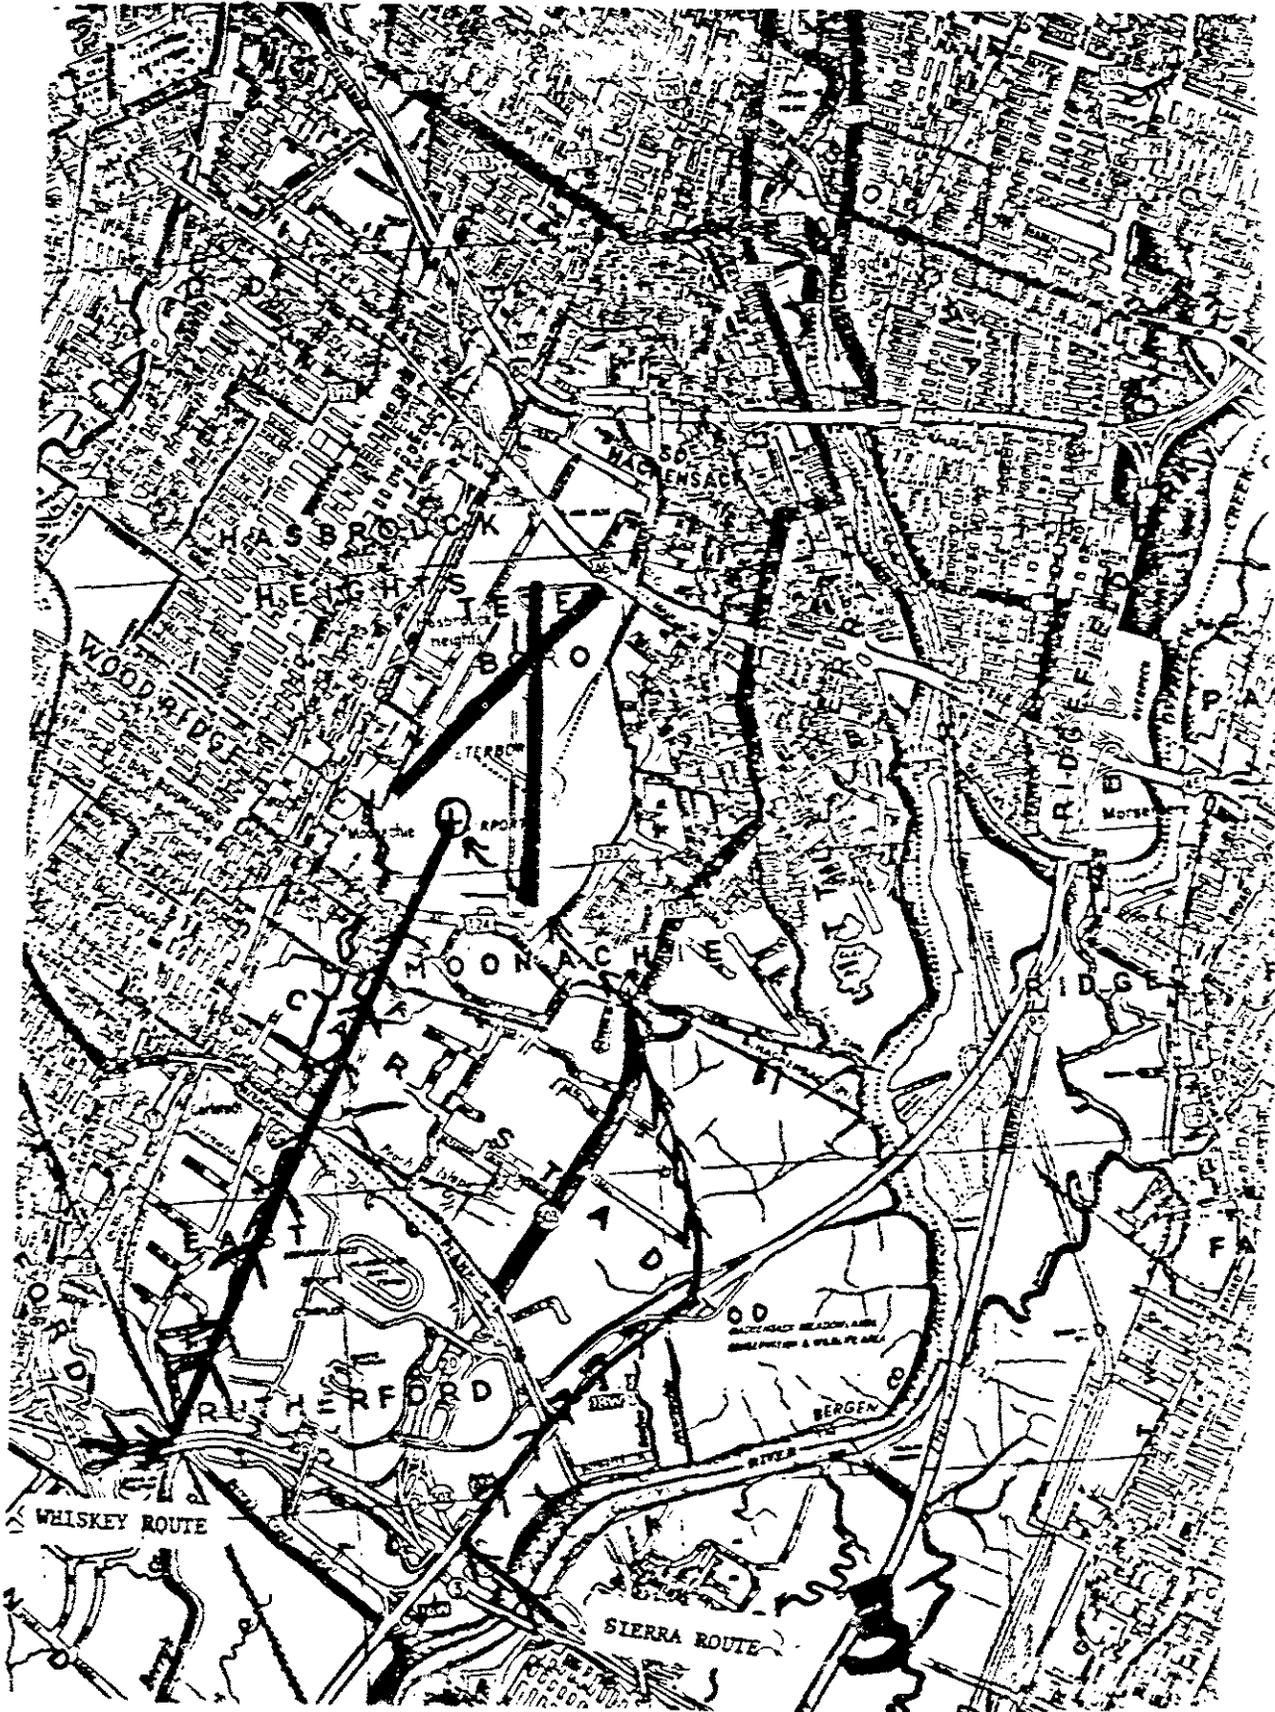
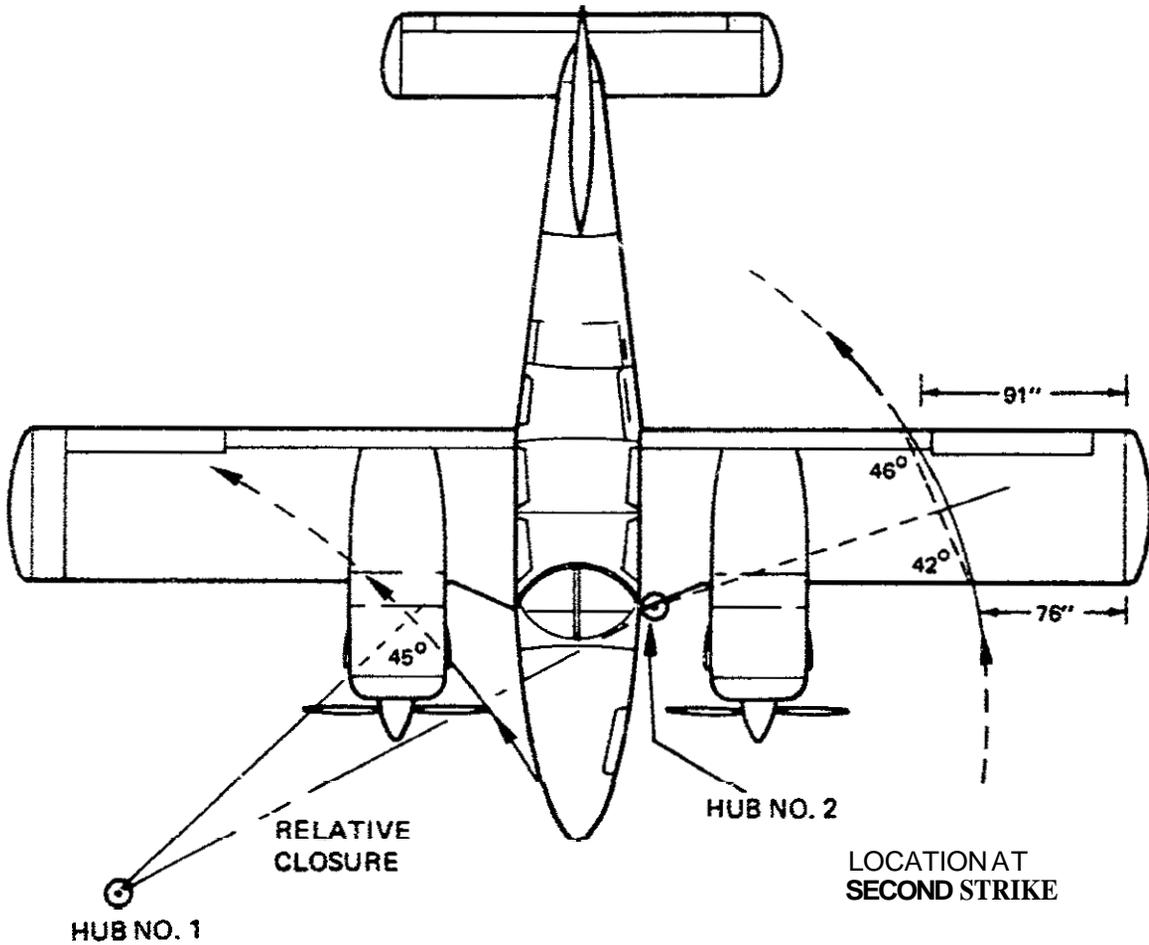
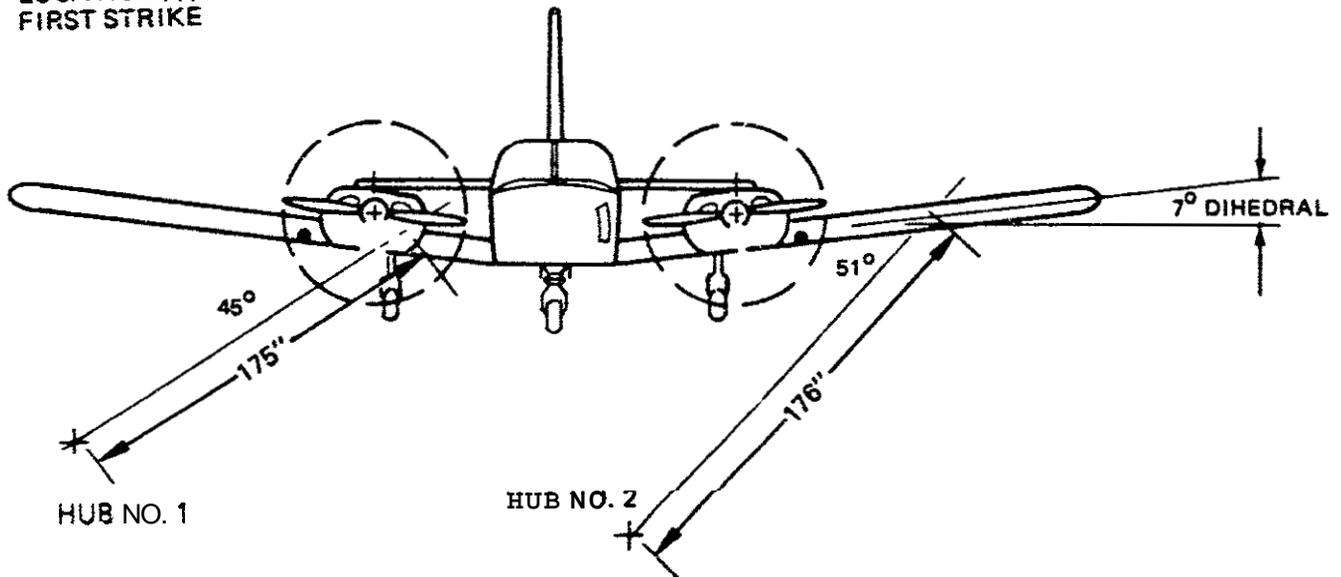
APPENDIX G
COLLISION DIAGRAM

Several witnesses stated that the two aircraft converged at an angle of nearly 90°, with the helicopter approaching from the right of the airplane. Some of these witnesses described a sudden bank to the right by the helicopter immediately before the collision. The angles and directions of separation of the airplane's right engine and left wing, taken together with the damage and marks on the helicopter main rotor blades,

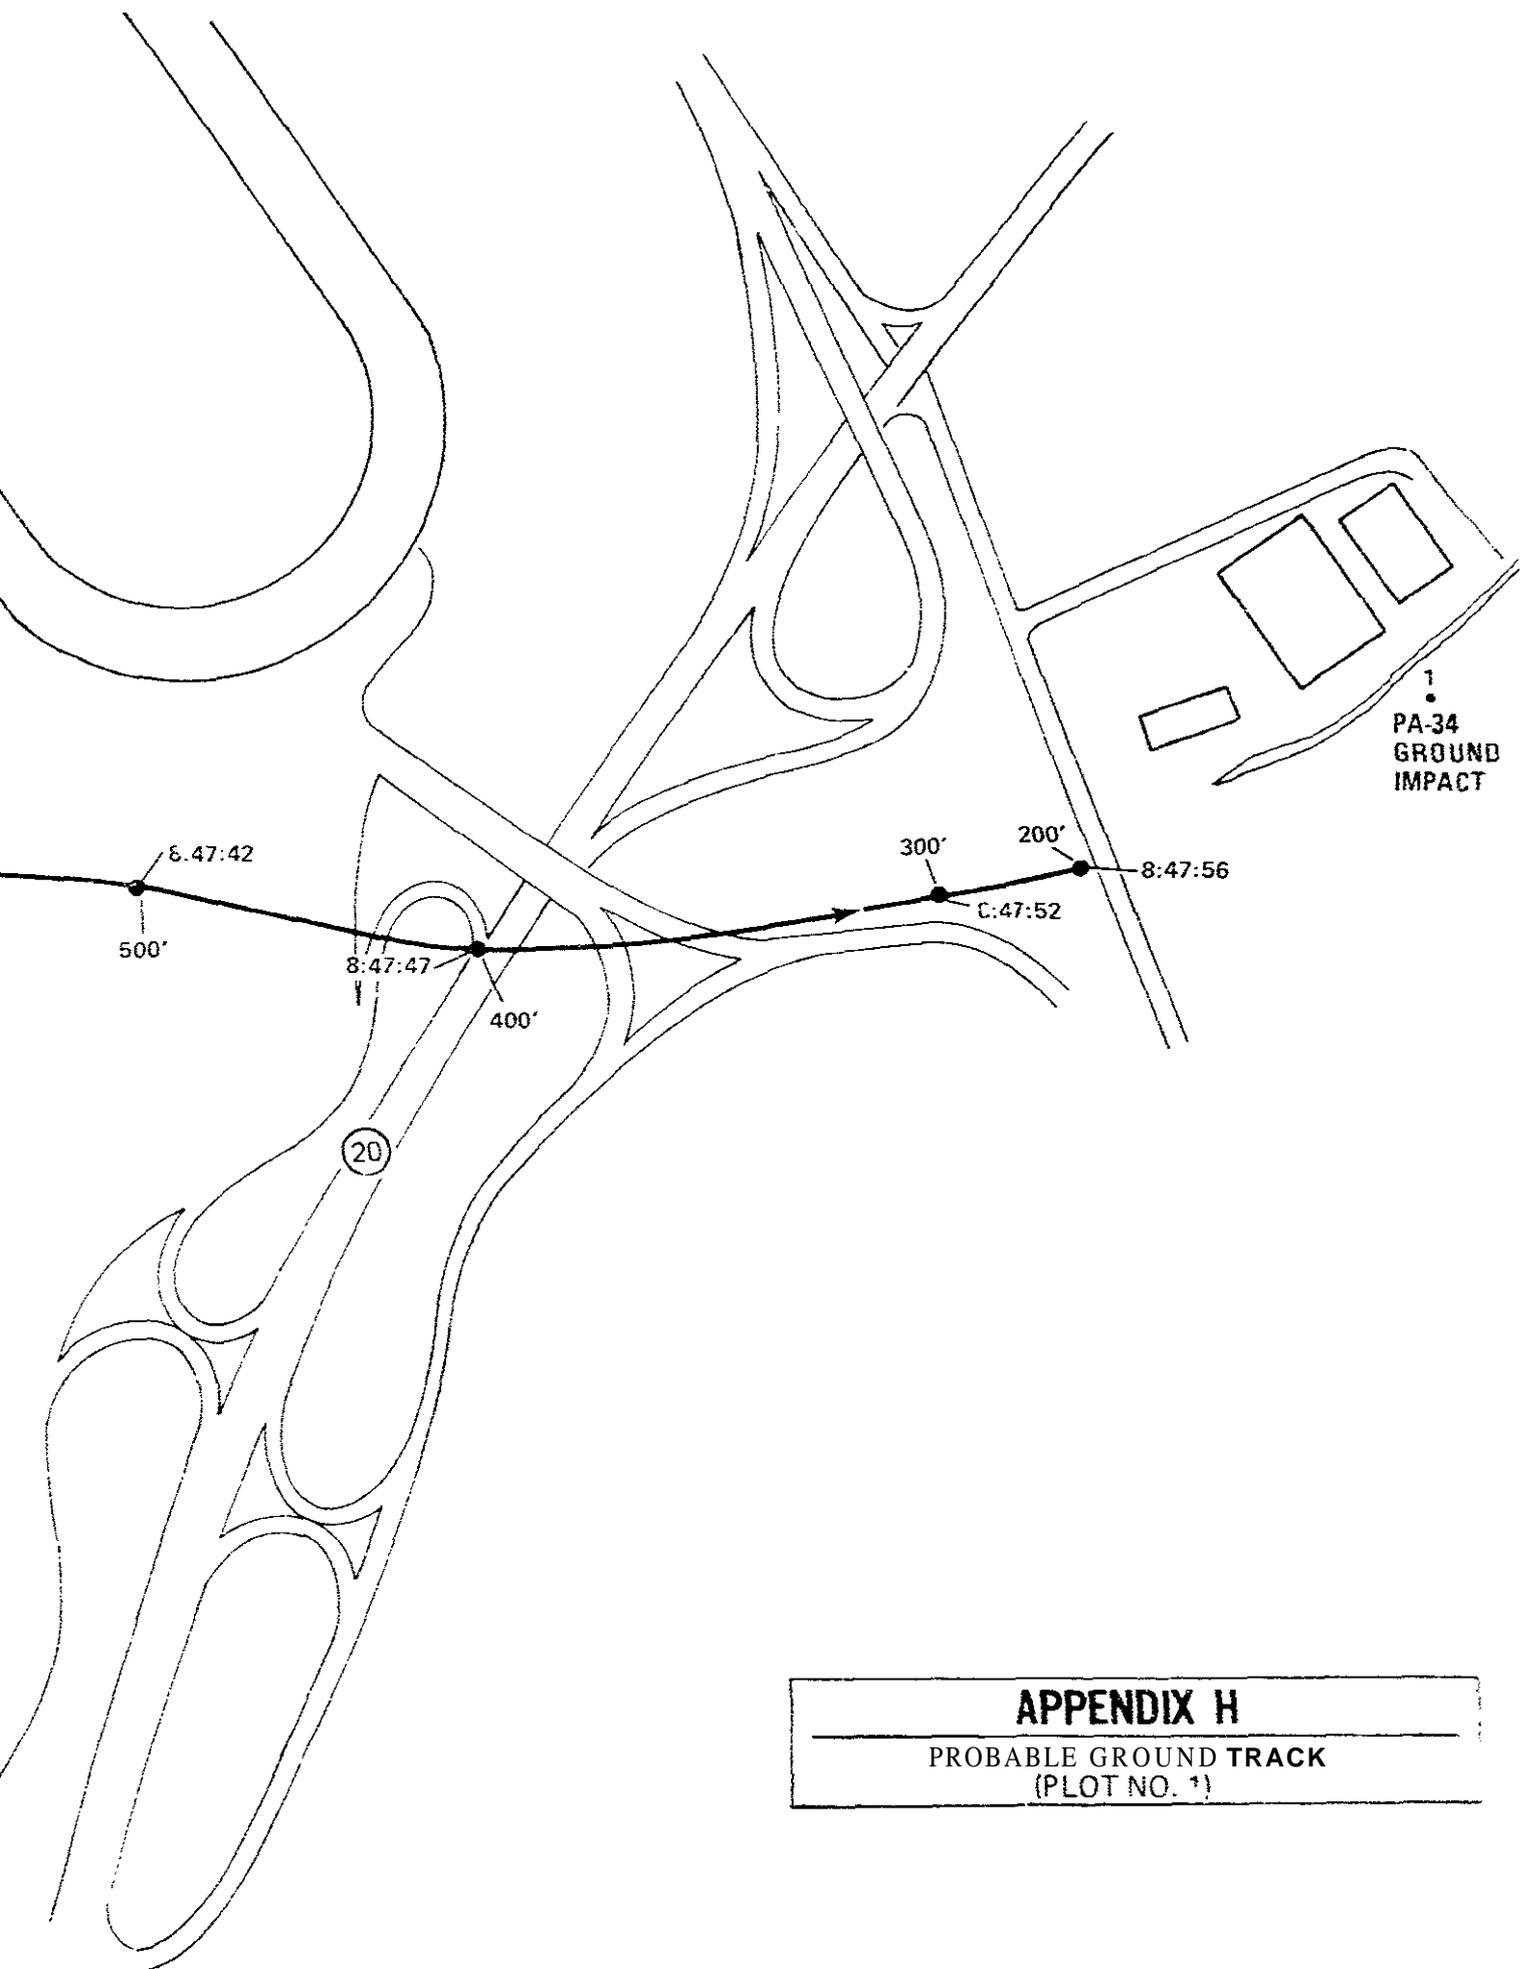
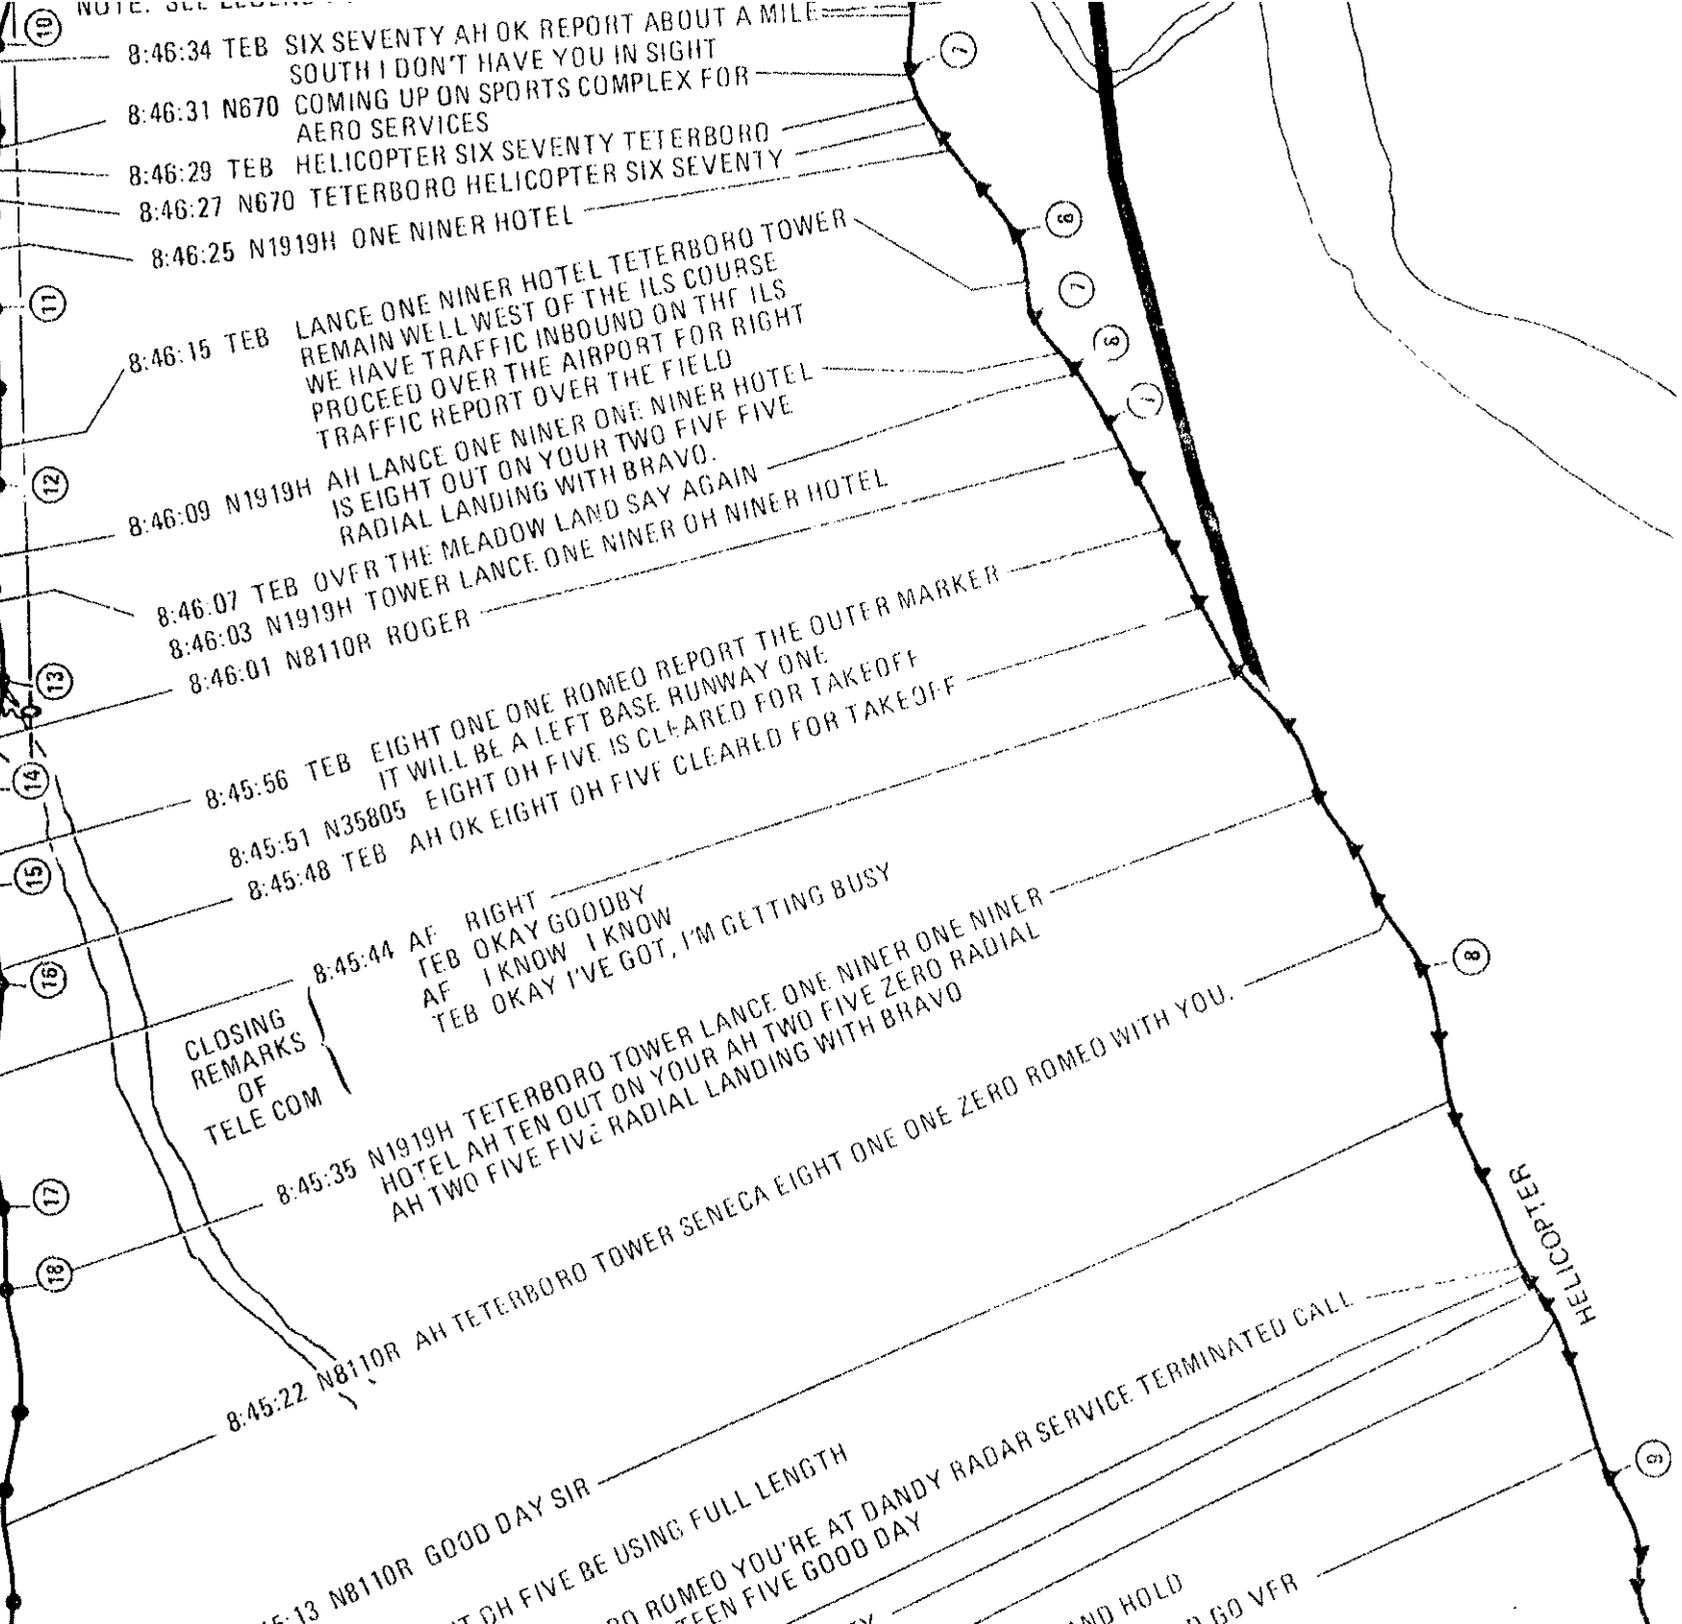
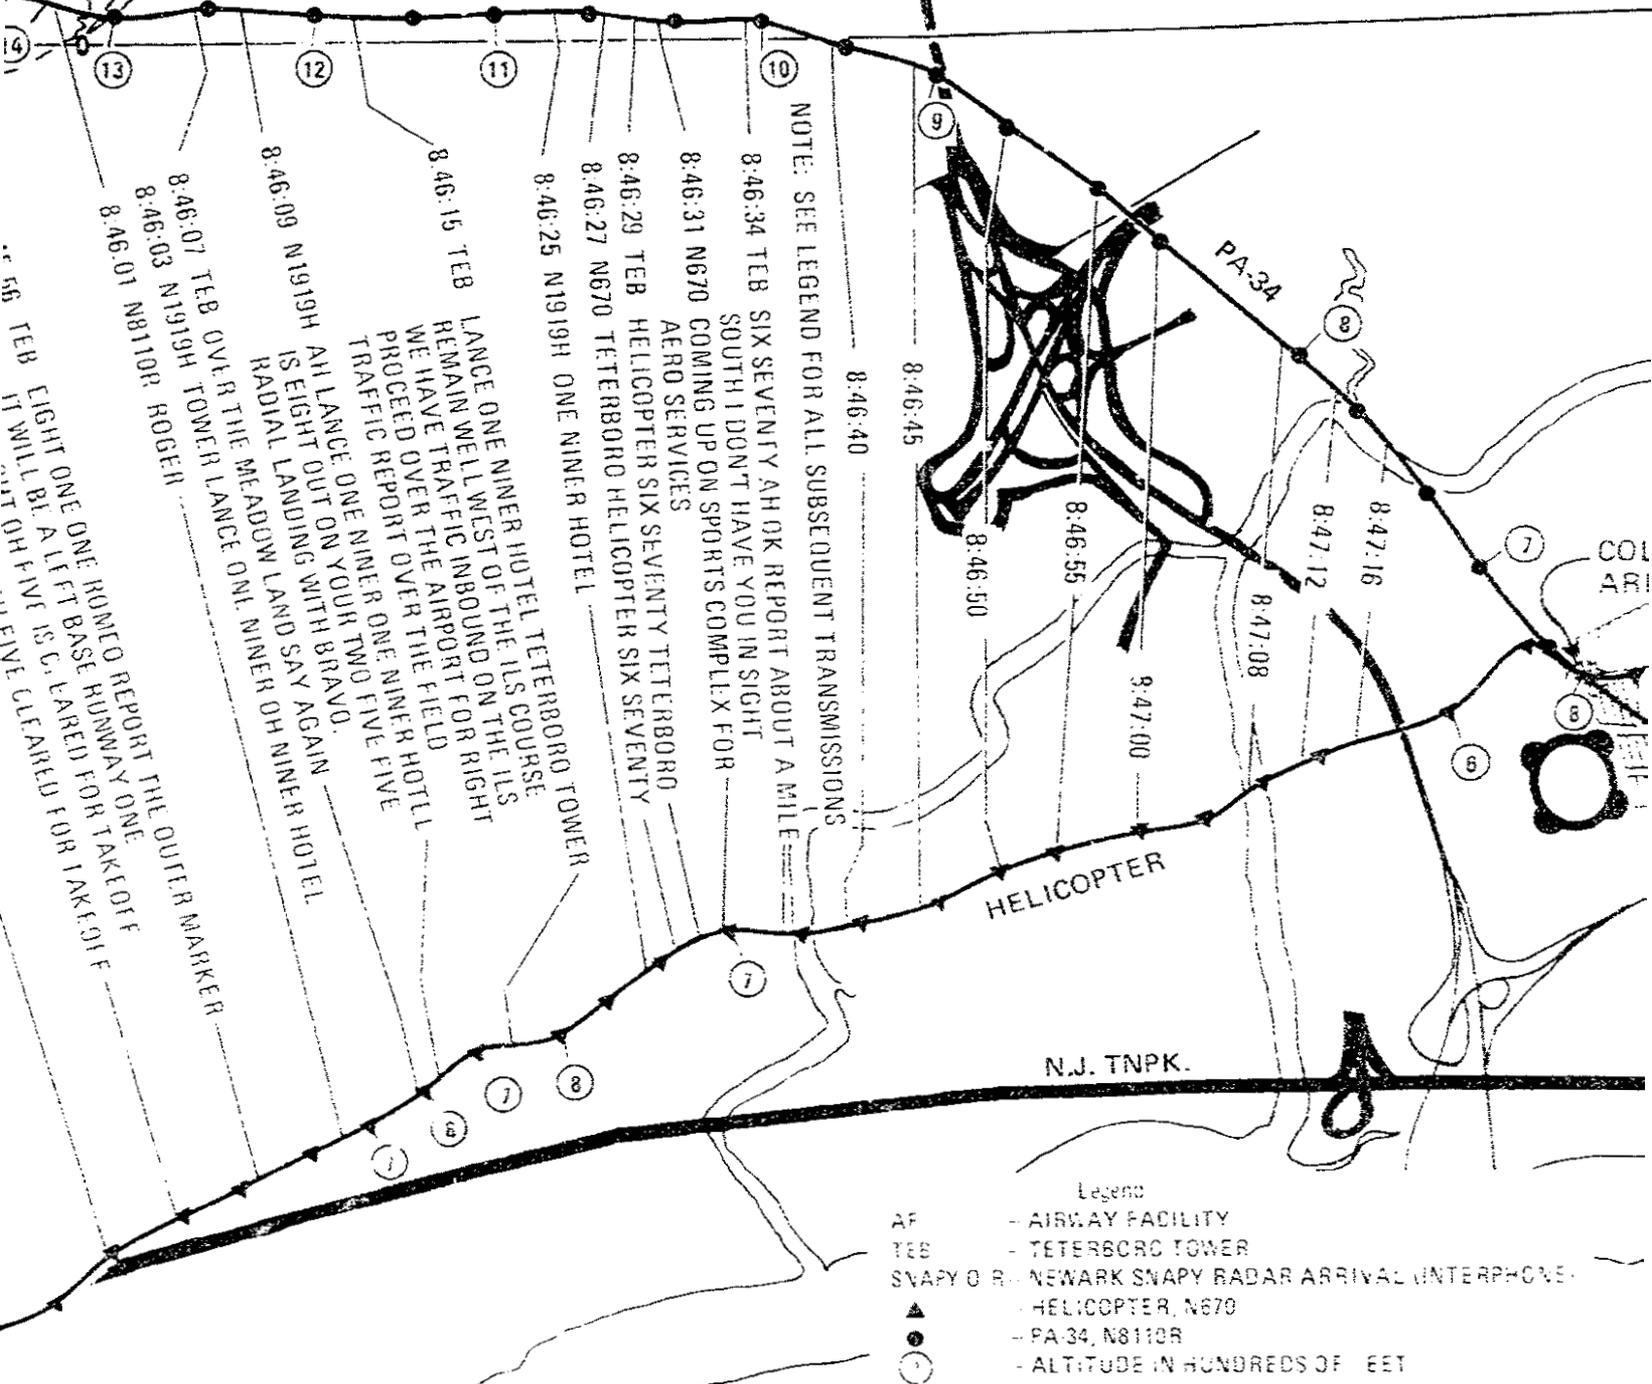
APPENDIX H
PROBABLE GROUND TRACK
(PLOT NO. 1)

The ground tracks showed that after crossing over Newark airport and leaving the control zone at an altitude of 1,300 feet, the helicopter maintained an essentially constant northerly heading toward Teterboro Airport and descended gradually to about 650 feet. The airplane tracked inbound on the Teterboro runway 6 ILS, just slightly left of centerline, for about 2 1/2 minutes, descending from 1,900 feet to 1,000 feet. At 0846:36, the airplane turned right to an easterly heading and continued to descend. This heading was maintained until the collision. At the time of collision, the transponder returns from both aircraft indicated about 650 feet.
