NATIONAL TRANSPORTATION SAFETY BOARD

AIRCRAFT ACCIDENT REPORT

ASHLAND PROPERTIES, INC.
CESSNA 414A, N2620L
NEAR HANOVER COUNTY AIRPORT
ASHLAND, VIRGINIA
JANUARY 3, 1982

NTSB-AAR-82-12

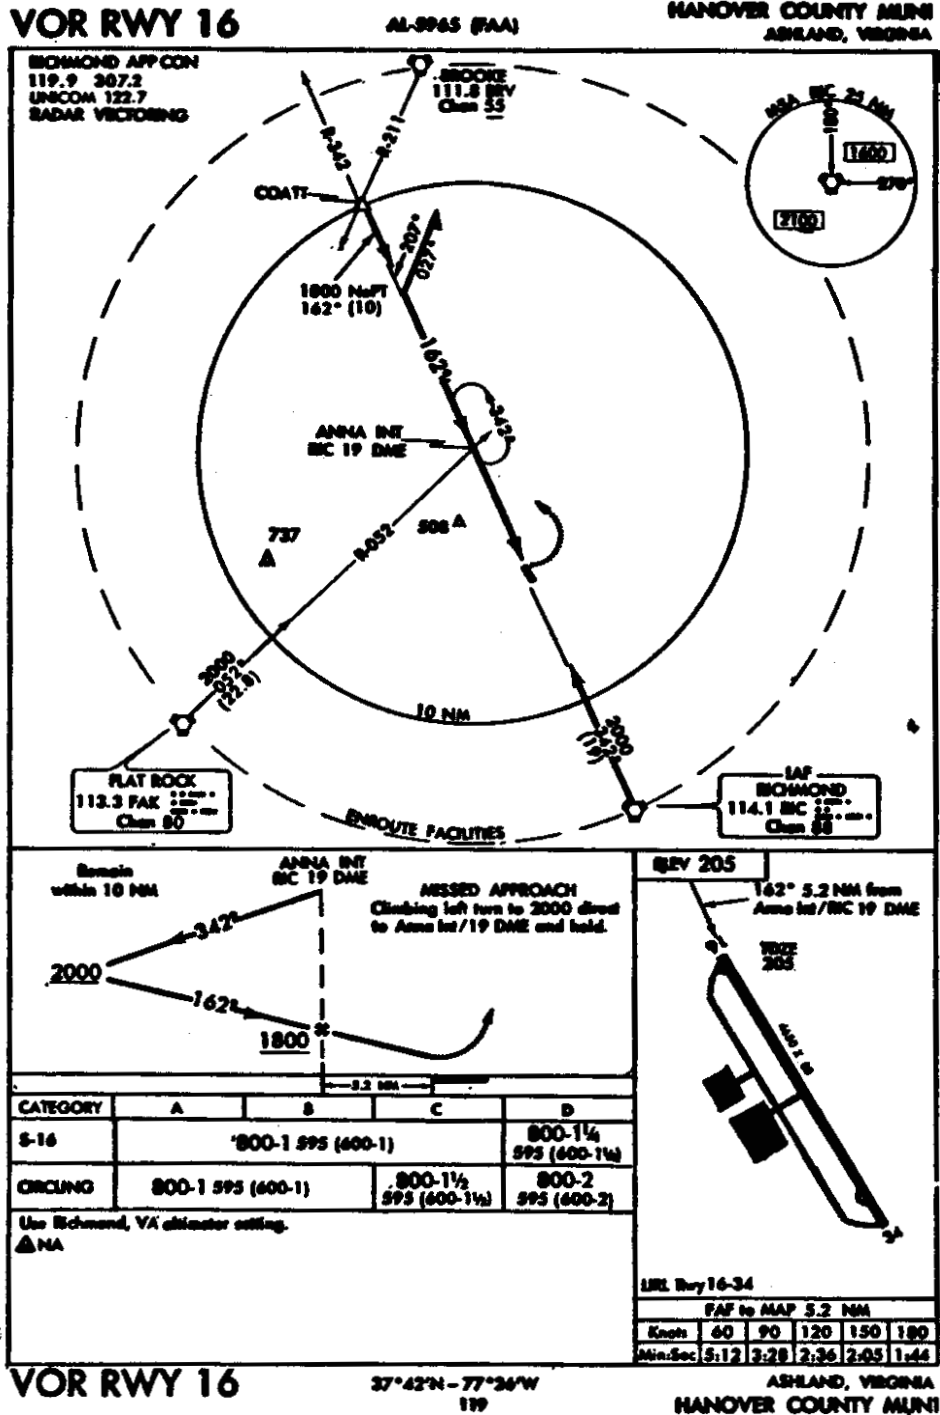
Figure 1.--Approach chart for Runway 16, Hanover County Municipal Airport, Ashland, Virginia.

The field elevation at Hanover County Airport is 205 feet. The approach chart for the nonprecision approach to runway 16 at Hanover County Airport depicts an inbound heading of 162° using the Richmond VOR 32° radial. The final approach fix, ANNA intersection, is defined as the intersection of that inbound track and the 02° radial from the Flat Rock VOR or the 19-mile distance measuring equipment (DME) point from the Richmond VOR. This intersection is 5.2 nmi northwest of the airport and 19 nmi northwest of the Richmond VOR. (See figure 1.) The approach chart specifies a crossing altitude of 1,800 feet at the final approach fix after which the pilot may descend to, but not below, the specified minimum descent altitude of 800 feet (595 feet above ground level). The minimum visibility specified on the approach chart for the approach is 1 mile.
