## AIRCRAFT ACCIDENT REPORT

WORLD AIRWAYS, INC., FLIGHT 30H  
MCDONNELL DOUGLAS DC-10-30CF, N113WA,  
BOSTON-LOGAN INTERNATIONAL AIRPORT  
BOSTON, MASSACHUSETTS  
JANUARY 23, 1982

NTSB-AAR-82-15

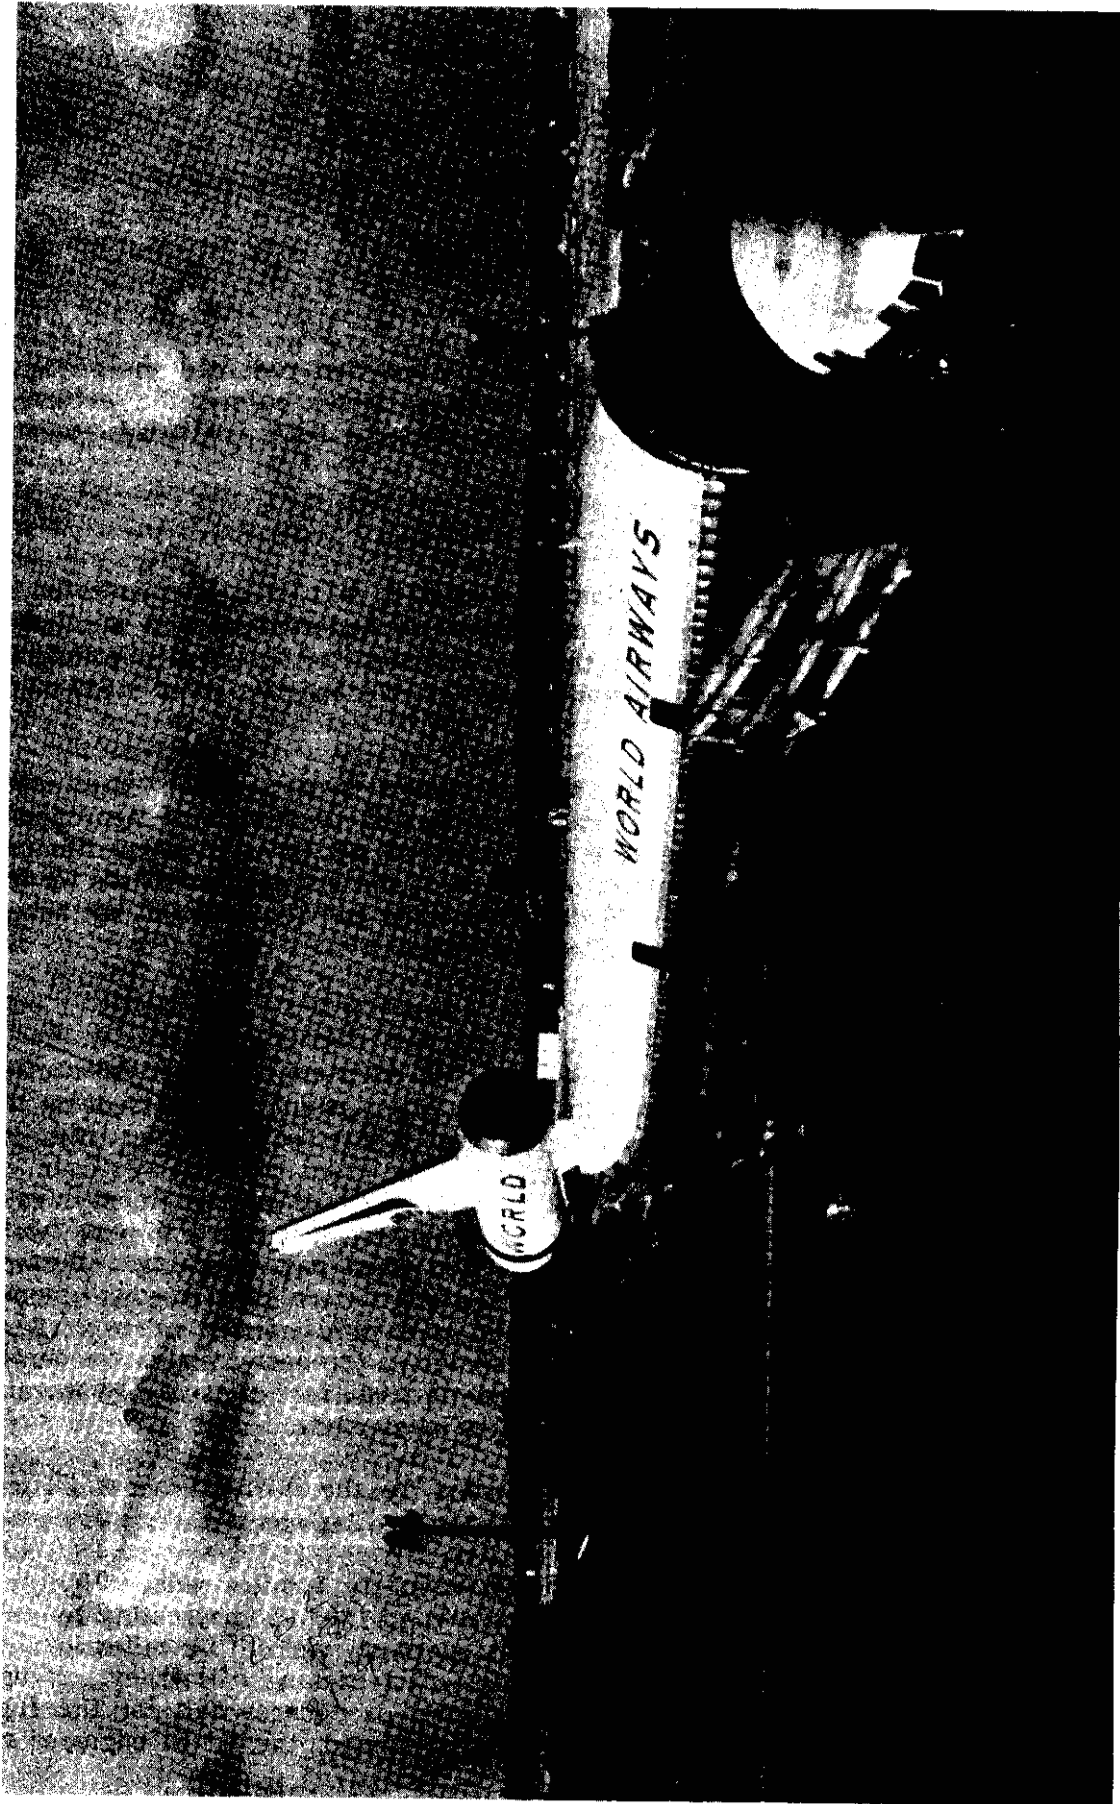
Figure 1.--Flight 30H as it rested in Boston Harbor.

The airplane came to rest immersed in water up to the wings at high tide and in a slightly nosedown attitude. The nose section, which included the cockpit area and first row of main cabin passenger seats, separated from the fuselage along a fracture line from fuselage station (FS) 370 to 475. The nose section remained attached to the main fuselage structure by control cables and electrical wire bundles. The pressure bulkhead at FS 275 had been crushed aft at the fuselage bottom centerline. The main cabin floor beams from FS 392 to FS 475 failed with a progressively downward displacement of each floor beam. The aft edge of this floor section was hanging down at a 45° angle. The cabin

seat tracks in this area had fractured into short sections. The fractures were clean and bright, with the fractured surfaces about 45° to the local surface. There was no evidence of compression buckling or previous cracking. The first row of passenger seats, which consisted of a left side module of three seats, a center seat module of two seats, and a right module of three seats, had separated from the floor structure as the result of the seat track fragmentation. The three seat modules were installed in the immediate area of the nose-section/main-fuselage separation. The pressure bulkhead at the forward end of the nose wheel landing gear well had been crushed inward and aft. The shear web on the fore and aft nose landing gear support beams contained a 2-foot vertical fracture at the nose gear drag link support fittings. The fuselage attach fittings for the nose gear drag braces were torn from the fore and aft nose gear support beams, and the gear had folded aft while pivoting about the strut trunnion axis.
