# NATIONAL TRANSPORTATION SAFETY BOARD

## AIRCRAFT ACCIDENT REPORT

NORTH AMERICAN ROCKWELL AERO COMMANDER  
MODEL 560E, N3827C  
AND CESSNA 182Q, N96402  
MIDAIR COLLISION  
LIVINGSTON, NEW JERSEY  
NOVEMBER 20, 1982

NTSB/AAR-83/03

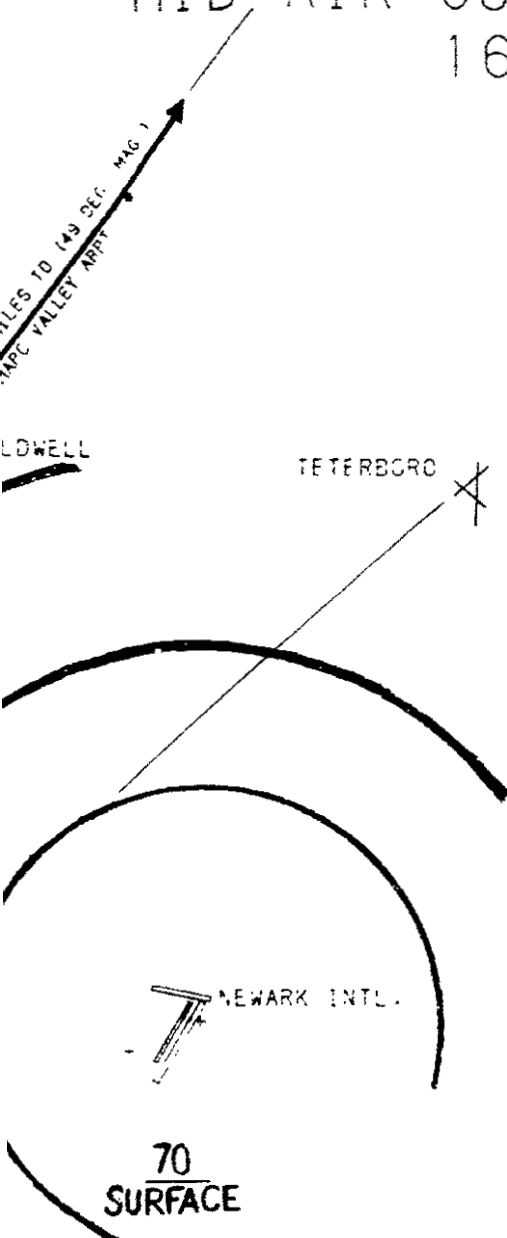
Figure 1.—Collision tracks and excerpts from ATC transcript.

At the time of these transmissions, N96-202, a white with red trim Cessna 182Q, was about 7 nautical miles away, at a point that would have been between the 1 to 2 o'clock positions in relation to the pilot's view from the cockpit of N3827C. N96402 had departed Rupper Airport, Manville, New Jersey, about 1600 for a flight to Ramapo Valley Airport near Spring Valley, New York. The airplane was equipped with a 4096-code transponder, which was in use and which caused N96402 to appear as a VFR radar target on air traffic control (ATC) equipment; however, because N96402 did not have mode-C altitude reporting equipment, the airplane's altitude was not shown on the radar. The pilot, who was unaccompanied, apparently intended to fly a direct course, VFR, between the airports. He did not file a flight plan, and there is no evidence that he made radio contact with any Federal Aviation Administration (FAA) facility during his flight. The airplane was equipped with a two-way radio capable of communicating with ATC facilities. When interviewed, the controller handling N3827C said that there were numerous targets in the area at that time, but that he could not recall the movements of the VFR targets, nor did he recall having seen the radar returns of any conflicting traffic. N96402's pilot had flown the direct course several times, and he had marked his intended route on a New York Area chart. His course line passed through the New York Terminal Control Area (TCA) and touched the perimeter boundary where the TCA floor lowers from 3,000 feet mean sea level (m.s.l.) to 1,800 feet m.s.l. (See figure 1.)

Several ground witnesses saw N3827C and N96402 collide in midair about 1614. They stated unanimously that both airplanes appeared to be in level flight when first sighted, with X46102 slightly above N3827C, and that moments before colliding, N96402 banked steeply. The witnesses did not agree on the direction of N96402's attempted evasive maneuver. The point of collision was about 1 mile to the right of the course from Manville to Spring Valley that N96402's pilot had marked on his New York Area chart. The chart was found in the airplane wreckage.

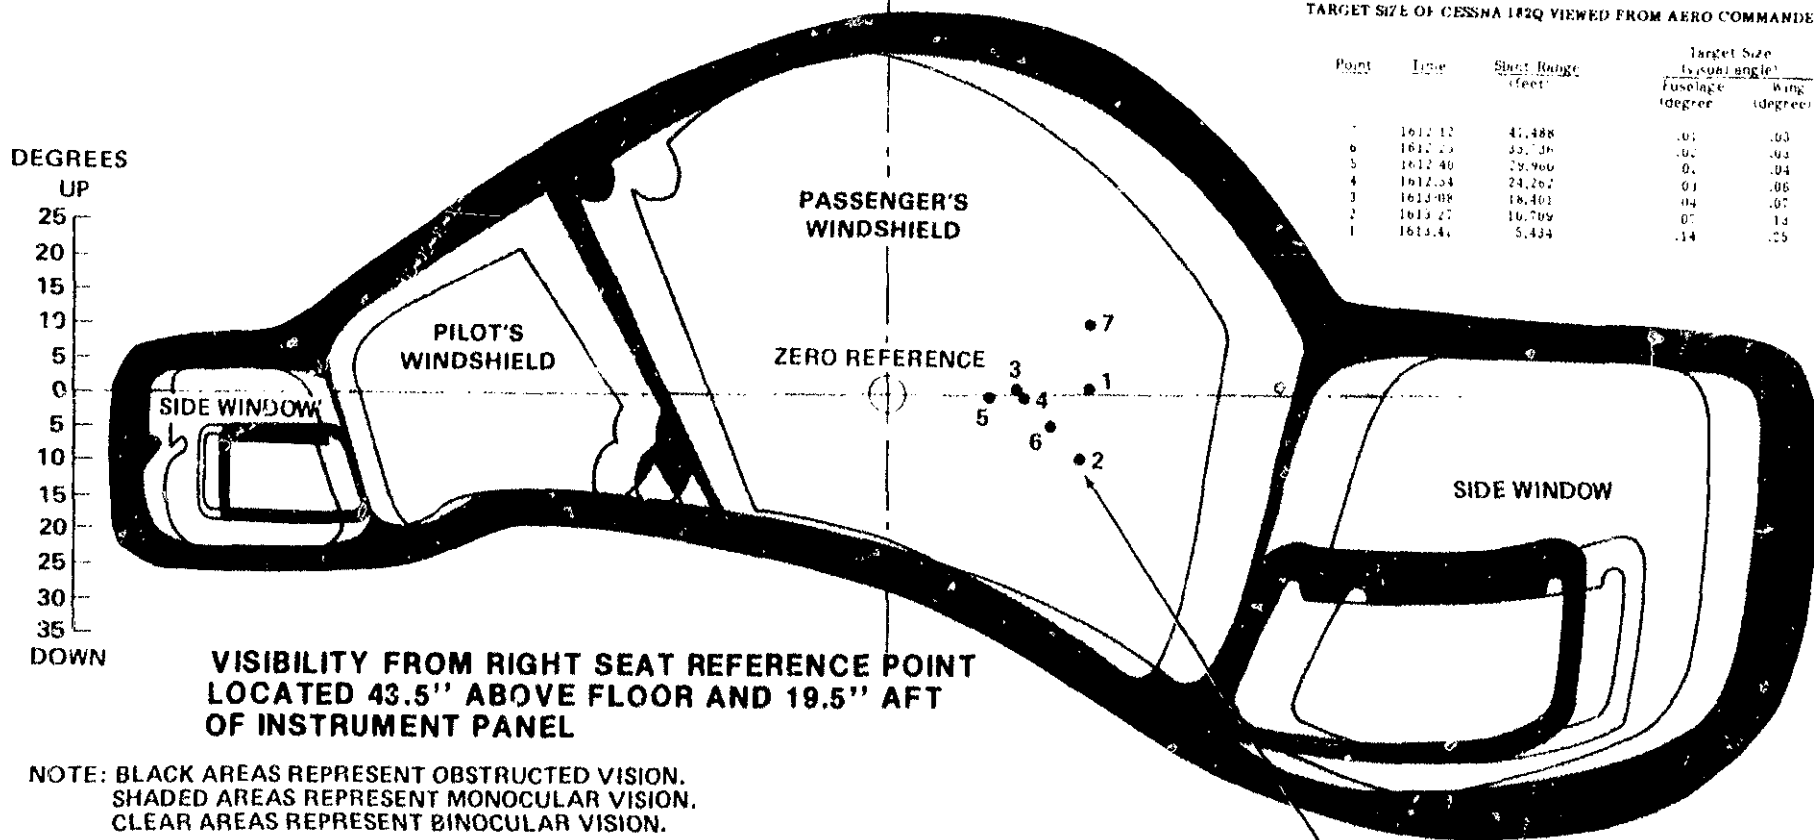
TARGET SIZE OF CESSNA 182Q VIEWED FROM AERO COMMANDER 560E

In this accident, during intervals several seconds before collision, both pilots were limited to monocular vision caused by the windshield framing, which minimized the ability of the pilots to detect the other traffic.

The visual angles of the subject airplanes would have caused the airplanes to be relatively small targets along the collision tracks, and at Point 1 and Point 2 of the binocular photographs (see appendix B), the opposing targets were in the monocular vision of both pilots. The cockpit visibility study indicated that **during** the 45-second period before the collision, the detection of N96402 was restricted by the windshield centerpost in the vision envelope of N3827C's pilot, and that during the 15-second period before the collision, the image of N3827C was unrestricted in the forward vision envelope of the pilot of N96402; however, **in** the prior 30-second period, N3827C was **in** only the monocular vision of N96402's pilot. **During** the last 30 to 45 seconds before collision, neither pilot had a totally unobstructed view of the other airplane, at least until the target size filled the windshield at some time between 15 seconds and collision. During the 107 seconds before the collision, the passenger in N3827C had the image of N96402 in full view near his zero eye reference.

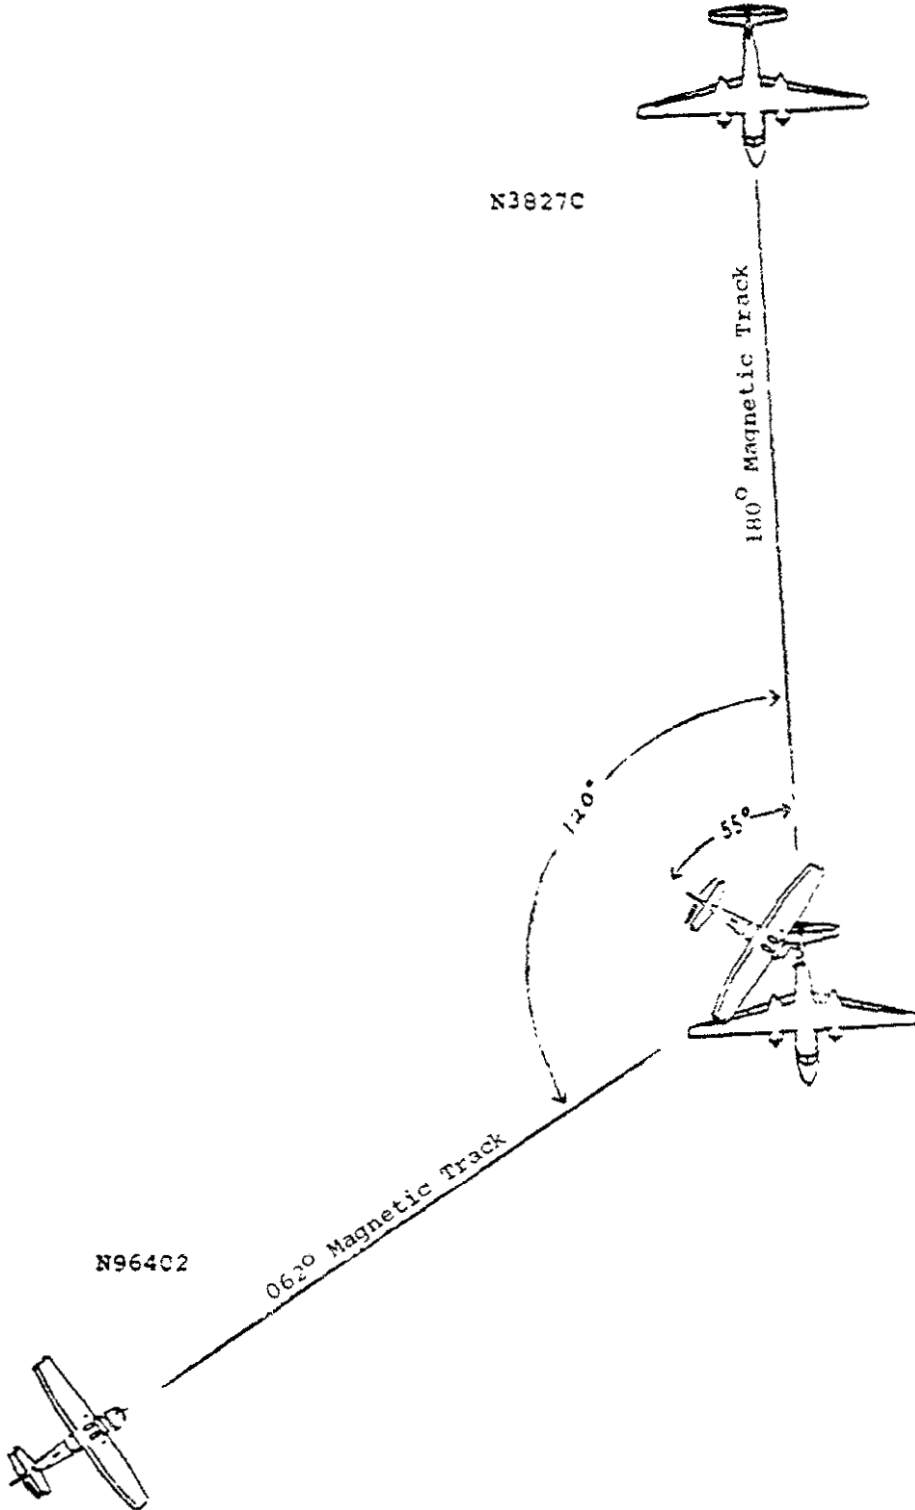
RELATIVE AIRPLANE POSITIONS AT IMPACT

The collision damage to N3827C was consistent with witness accounts that the front of N96402 collided with the side of N3827C's rear fuselage and sheared off the latter's empennage. Paint transfer marks and inward crush damage on N3827C indicated that it was hit from the right (see appendix C). Propeller slicing across the rear fuselage and the left stabilizer of N3827C revealed that N96402's engine went across N3827C's tail section at a 55-degree angle. Based upon the ATC radar tracking data, the relative approach angle was 120 degrees, and the 55-degree propeller marks indicate that N96402's heading was turned significantly to the right when it struck N3827C's fuselage. This direction change is believed to have been due to the evasive maneuver by N96402's pilot and the slewing of N96402 after an initial collision between the right wings of the airplanes.
